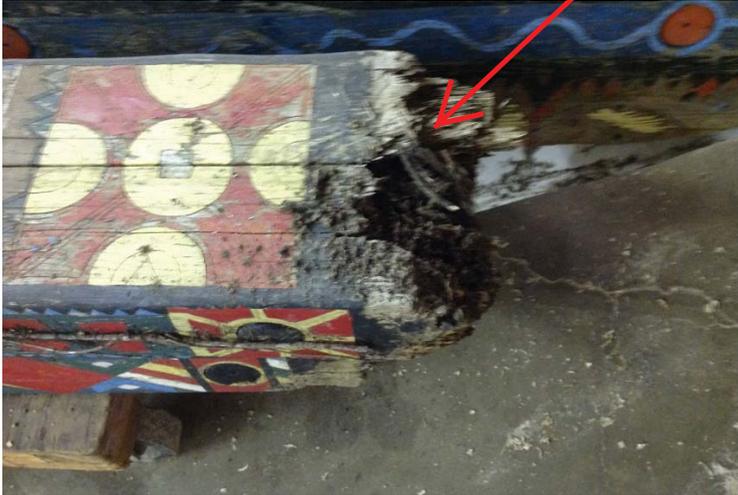
Base of Vertical Post

Significant rot where post was in contact with the ground

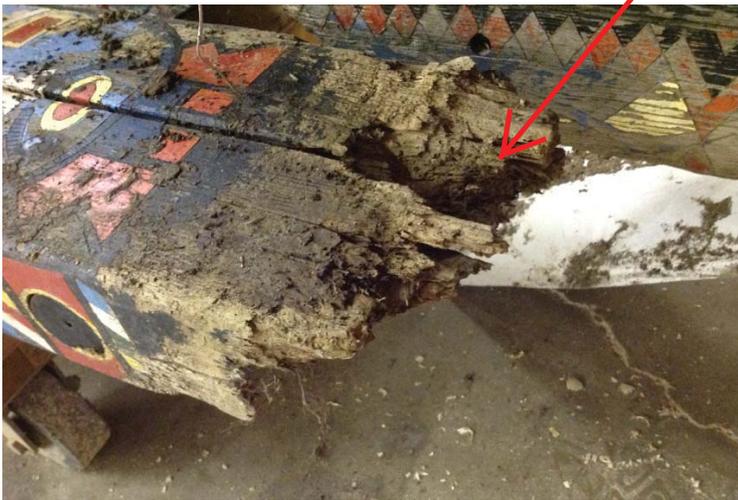
Base of Vertical Post

Significant rot where post was in contact with the ground

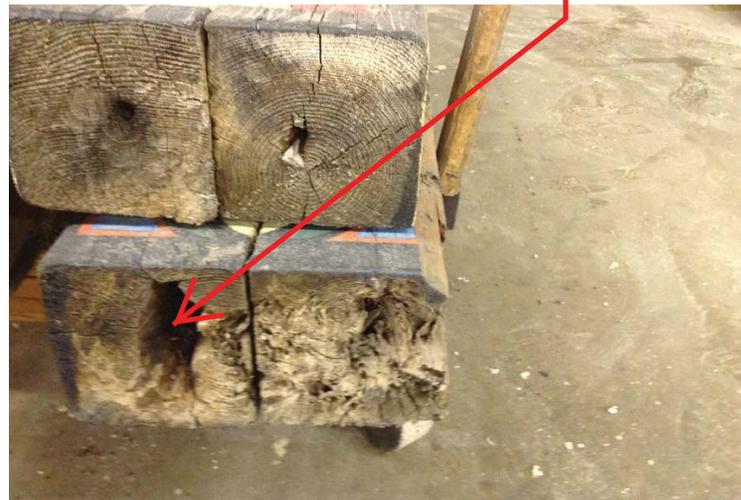
Top of Vertical Posts

Significant rot where beam bolted into post

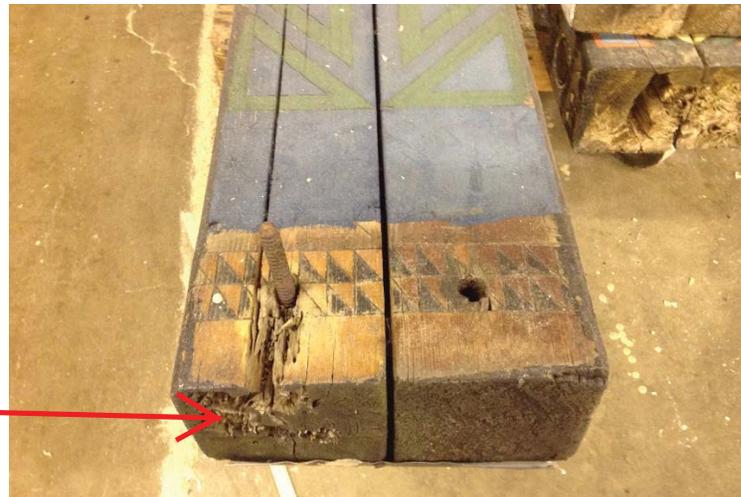
End of Horizontal Beam

Rot at end of beam
