City of Columbus Stormwater NPDES Permit

January 1, 2020 – December 31, 2020 (Ohio EPA Permit Number: 4PI00000*CD)

ANNUAL REPORT

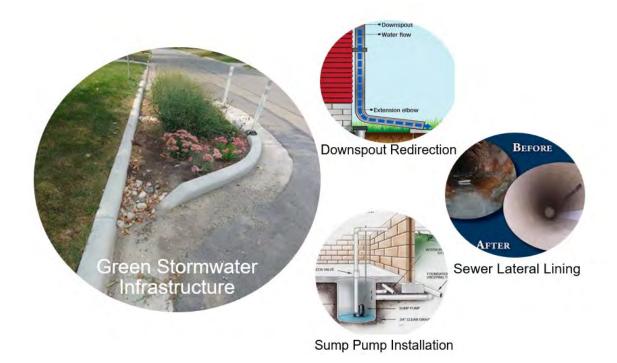
Figure 1. Four pillars of the Blueprint Columbus project.

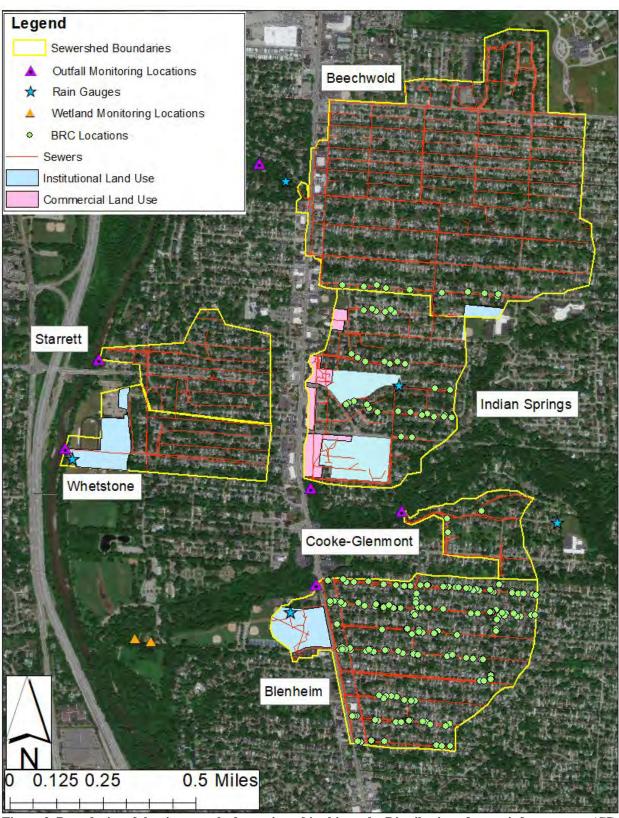
Figure 2. Boundaries of the six sewersheds monitored in this study. Distribution of green infrastructure (GI), monitoring locations, and land use within each sewershed also shown. Remaining area within each sewershed not identified as Commercial or Institutional is Residential land use.

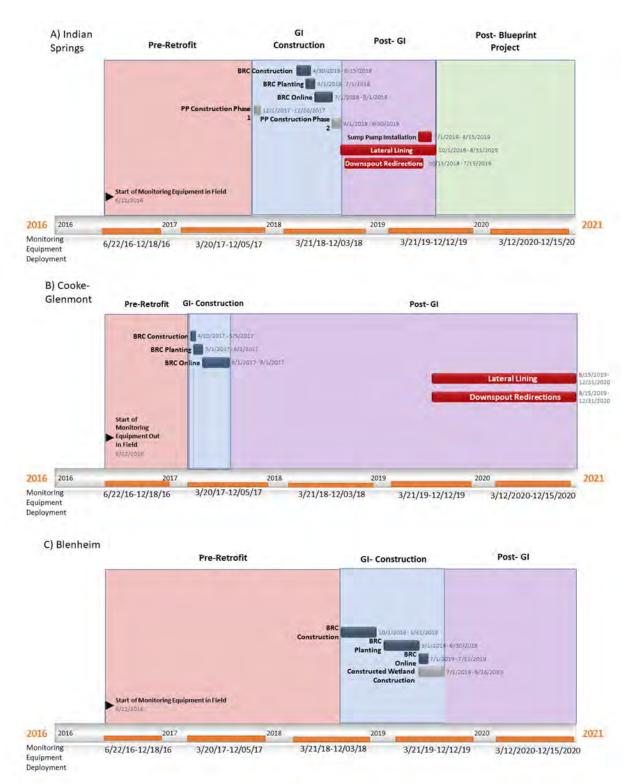
Figure 3. Project timelines of treatment sewersheds during the monitoring period.

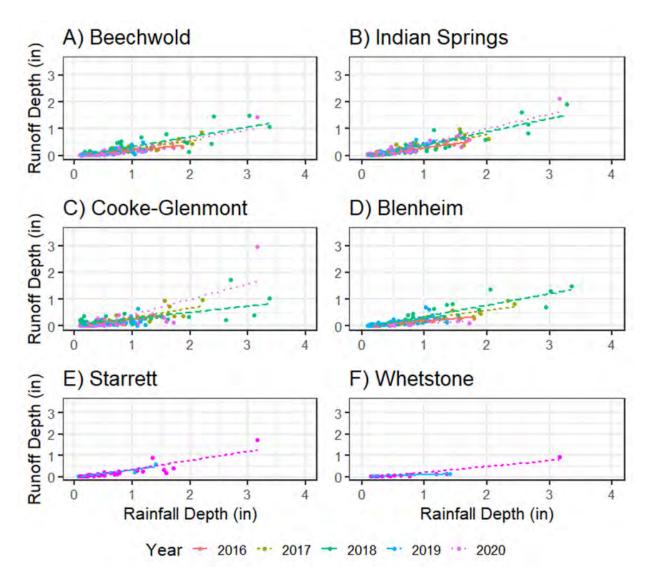
Figure 6: Plots of rainfall-runoff responses by year in the six monitored sewersheds.

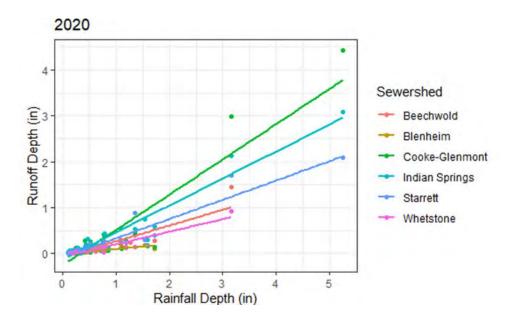
Figure 7: Rainfall-runoff responses observed in the six monitored sewersheds in 2020.

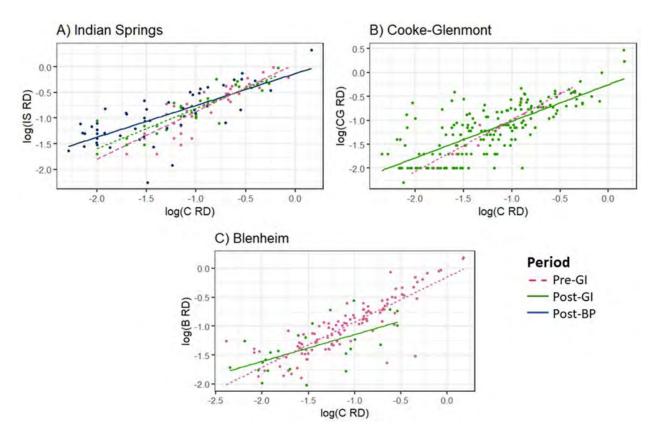
Figure 8. Runoff depth (RD) relationships for the treatment sewersheds and control (Beechwold) during the various project periods. Note that runoff depths are log transformed. Changes in slope indicate differences in the runoff depth relationship between the control and treatment sewershed between the pre-GI and post-GI (or post-Blueprint) project phases.

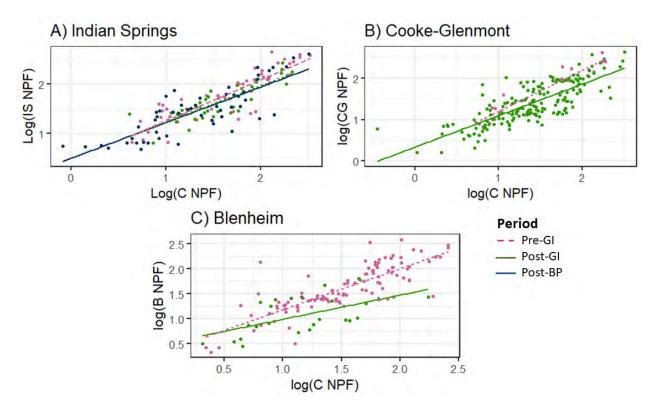
Figure 9. Area normalized peak flow (NPF), also referred to as areal peak discharge (in/hr), in the treatment sewersheds compared to the control (Beechwold). Note that data from the monitored sewersheds have been log transformed. Changes in slope indicate differences in the normalized peak flow relationship between the control and treatment sewershed between the pre-GI and post-GI (or post-Blueprint) project phases.

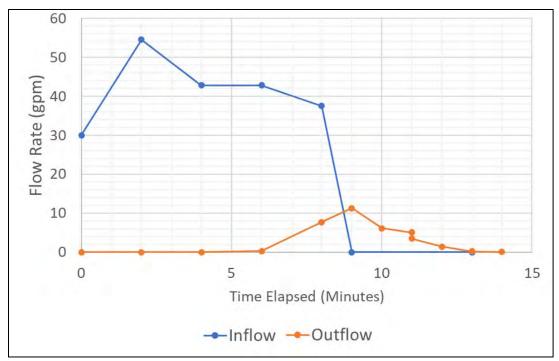
Figure 10. Inflow and outflow hydrographs from simulated storm testing performed at a bioretention cell in the Indian Springs sewershed (270 Village Dr). The increase in inflow rate between 0 and 2 minutes reflects the full opening of the valve after the test began, which more commonly occurred immediately after tests commenced.

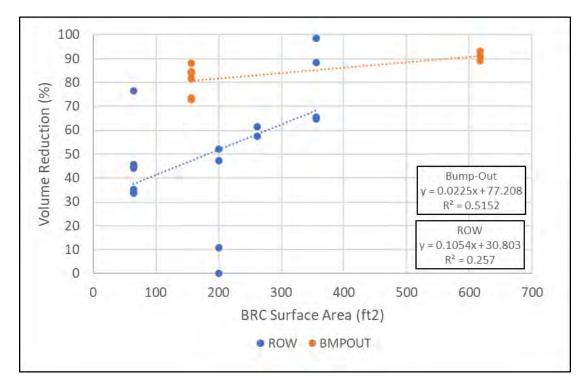
Figure 11: Volume reduction as a function of bioretention cell (BRC) surface area for practices constructed in the right-of-way (ROW) or as bump-outs (BMPOUT) into roadside parking areas.

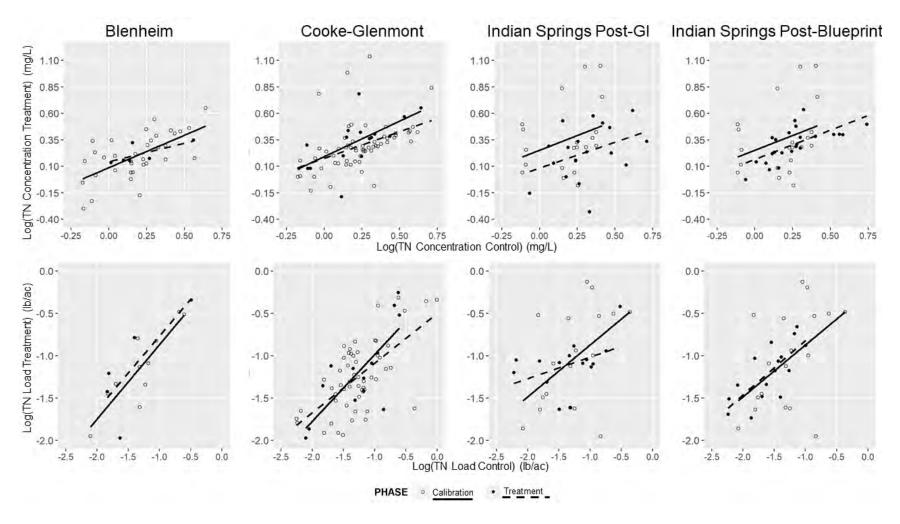
Figure 12: ANCOVA analysis for TN concentration and storm event load at all three treatment sites in relationship to the control (Beechwold). Calibration phase includes pre-GI at Blenheim and Indian Springs and baseline at Cooke-Glenmont. Treatment phase includes post-GI for all plots except the rightmost column, where it is post-Blueprint.

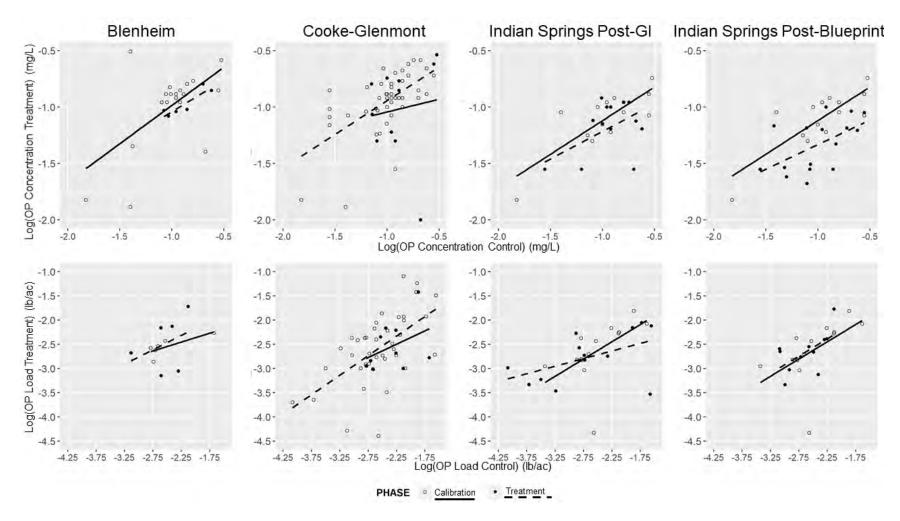
Figure 13: ANCOVA analysis for OP concentration and storm event load at all three treatment sites in relationship to the control (Beechwold). Calibration phase includes pre-GI at Blenheim and Indian Springs and baseline at Cooke-Glenmont. Treatment phase includes post-GI for all plots except the rightmost column, where it is post-Blueprint.

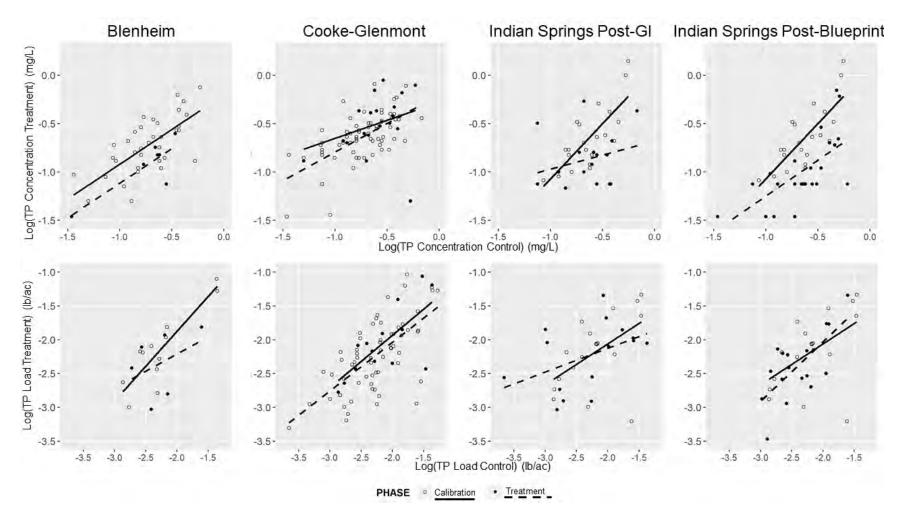
Figure 14: ANCOVA analysis for TP concentration and storm event load at all three treatment sites in relationship to the control (Beechwold). Calibration phase includes pre-GI at Blenheim and Indian Springs and baseline at Cooke-Glenmont. Treatment phase includes post-GI for all plots except the rightmost column, where it is post-Blueprint.

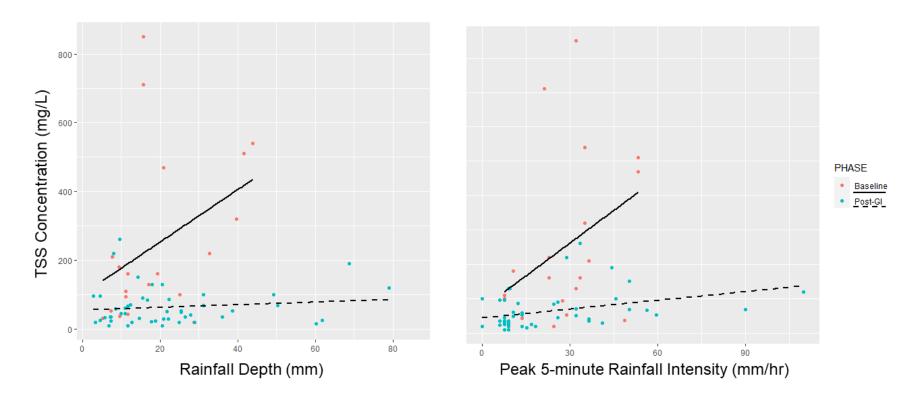
Figure 16: Total suspended solids (TSS) and rainfall depth, peak 5-minute rainfall intensity for baseline and post-GI phases at Cooke-Glenmont.

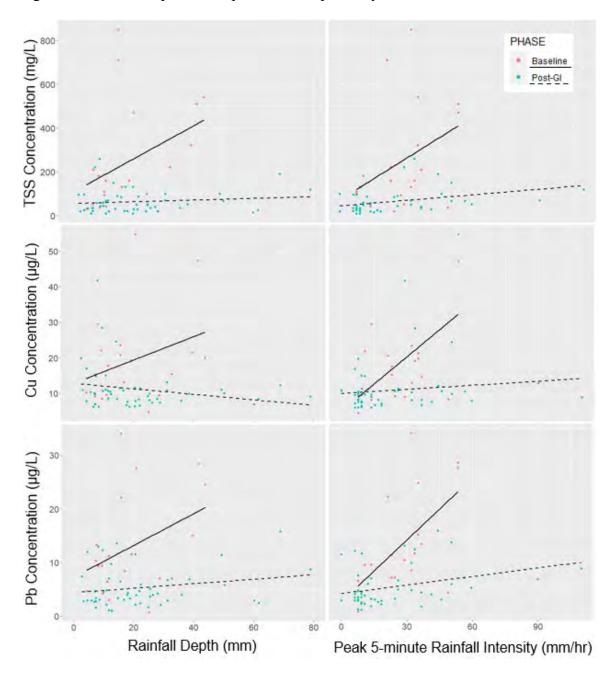
Figure 17: Total suspended solids (TSS), Cu, and Pb concentration plotted against rainfall depth and peak 5-minute rainfall intensity for baseline and post-GI phases at Cooke-Glenmont. Bioretention in the sewershed mitigated pollutant concentrations for larger storm events with high peak 5-minute rainfall intensities.

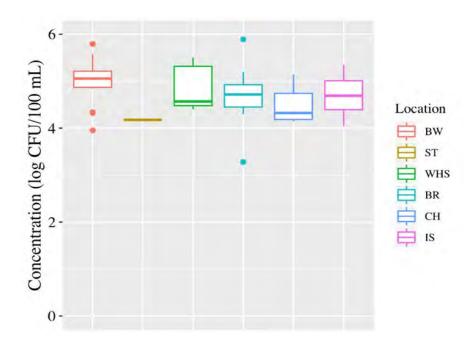
Figure 18: Mean concentration of E. coli (log10 CFU/100 mL) for each location in 2019.

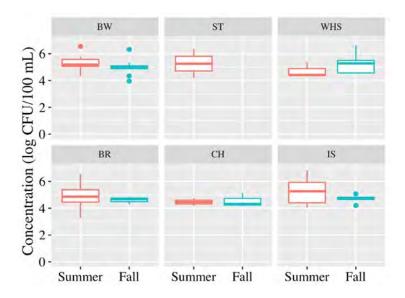
Figure 19: Mean concentration of E. coli (log10 CFU/100 mL) for each location by season in 2019.

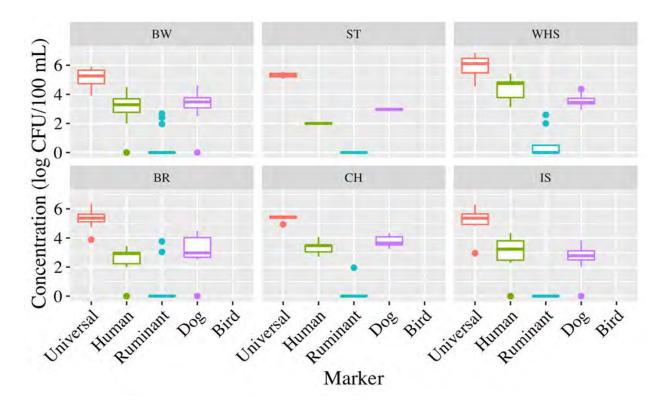
Figure 20: Comparison of concentrations of five MST markers (log10 CFU/100 mL) for each sewershed outfall in 2019.

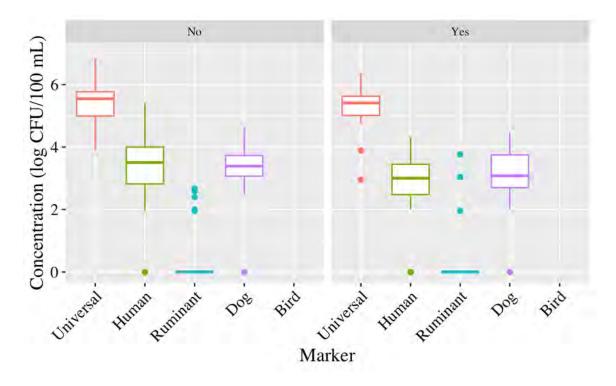
Figure 21: Summary of mean concentrations of five host-specific fecal bacteria markers (log10 CFU/100 mL) between sites with ("Yes") and without ("No") GI in 2019.

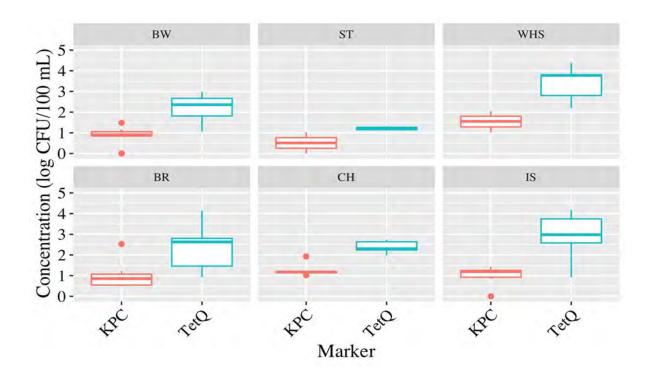
Figure 22: Summary of mean concentration of two antibiotic resistance genes (log10 CFU/100 mL) for each location in 2019.

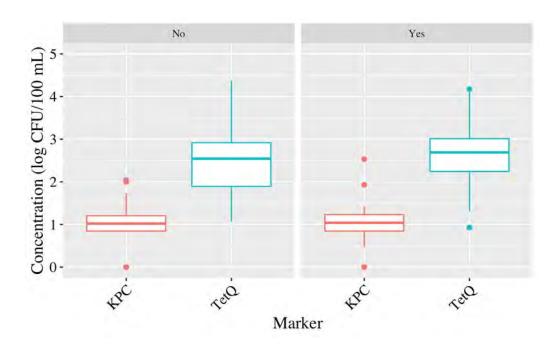
Figure 23: Comparison of mean concentrations of two antibiotic resistance genes (log10 CFU/100 mL) between with ("Yes") and without ("No") green infrastructure implementation in 2019.

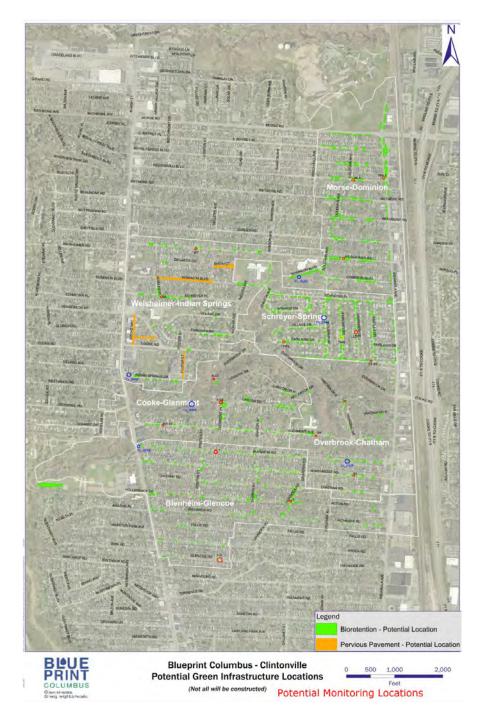
Figure 24. Locations of bioretention (green) and permeable pavement (orange) retrofits planned for the Clintonville neighborhood. The areas of Clintonville being monitored are outlined in blue (control sewershed) and white (green infrastructure retrofits).

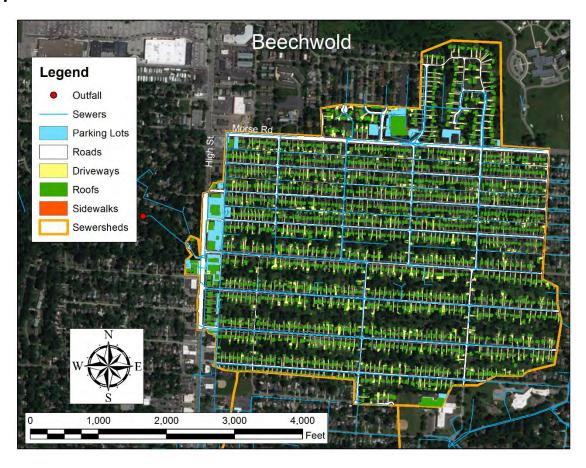
Figure 25. Map showing impervious surface types in the Beechwold sewershed. Pervious areas in the sewershed are not highlighted with color.

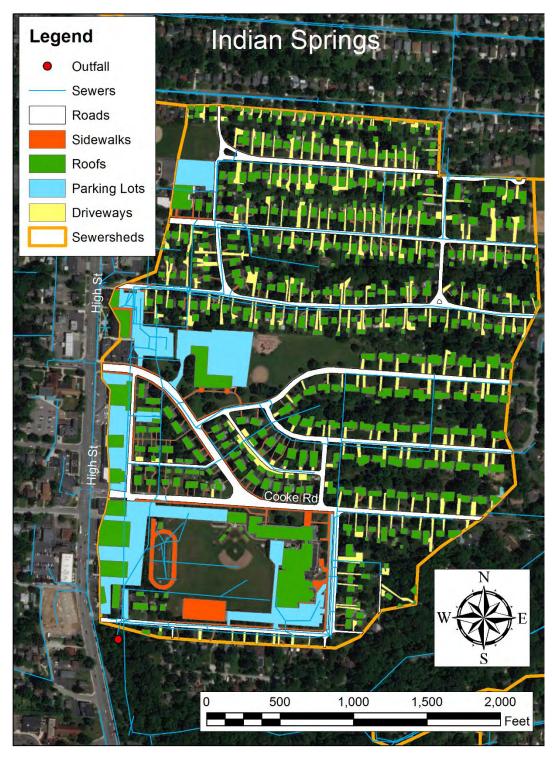
Figure 26. Map showing impervious surface types in the Indian Springs sewershed. Pervious areas in the sewershed are not highlighted with color.

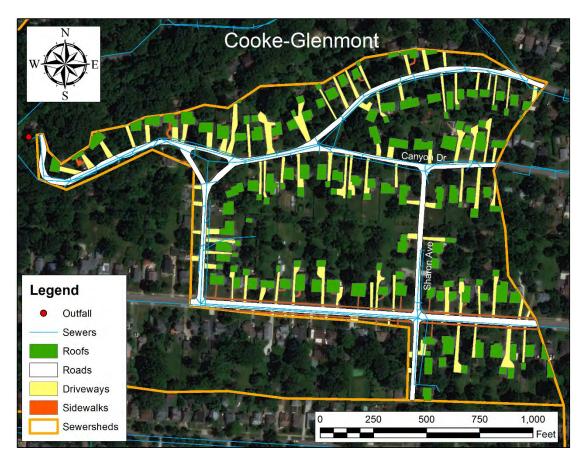
Figure 27. Map showing impervious surface types in the Cooke-Glenmont sewershed. Pervious areas in the sewershed are not highlighted with color.

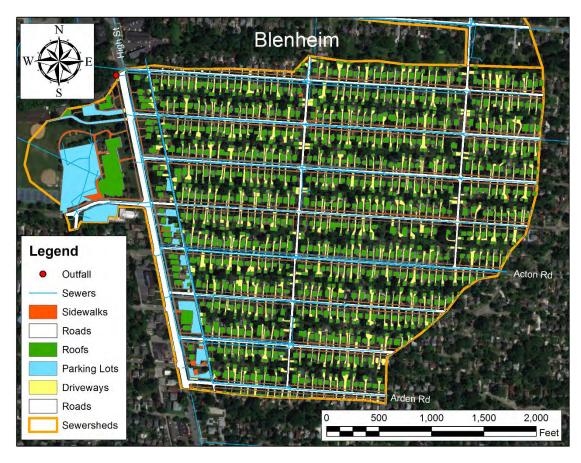
Figure 28. Map showing impervious surface types in the Blenheim sewershed. Pervious areas in the sewershed are not highlighted with color.

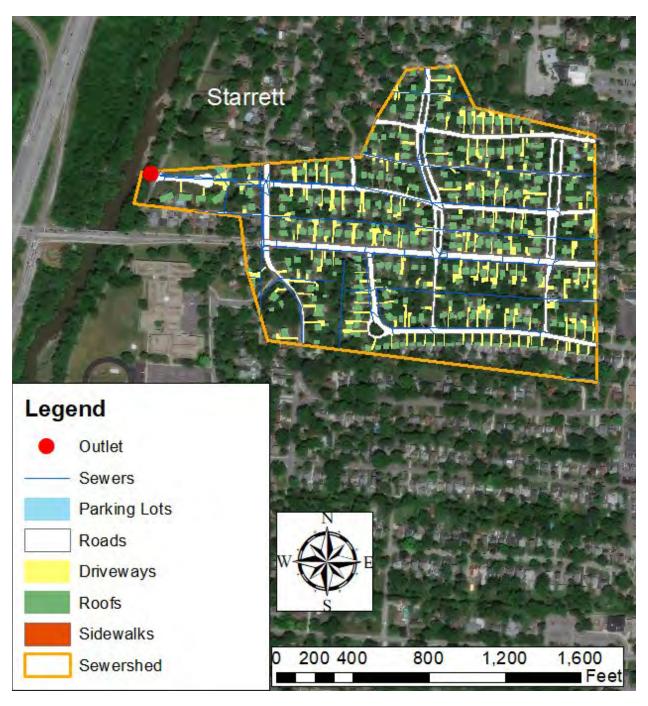
Figure 29. Map showing impervious surface types in the Starrett sewershed. Pervious areas in the sewershed are not highlighted with color.

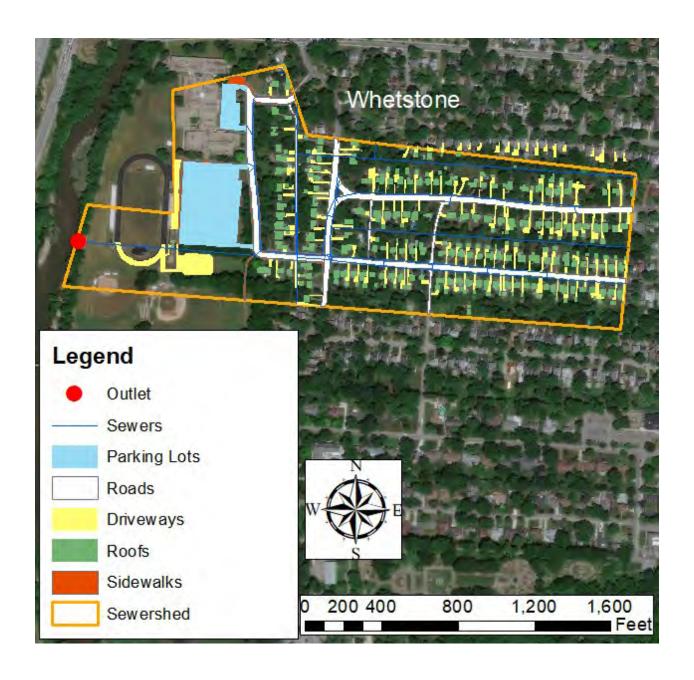
Figure 30. Map showing impervious surface types in the Whetstone sewershed. Pervious areas in the sewershed are not highlighted with color.

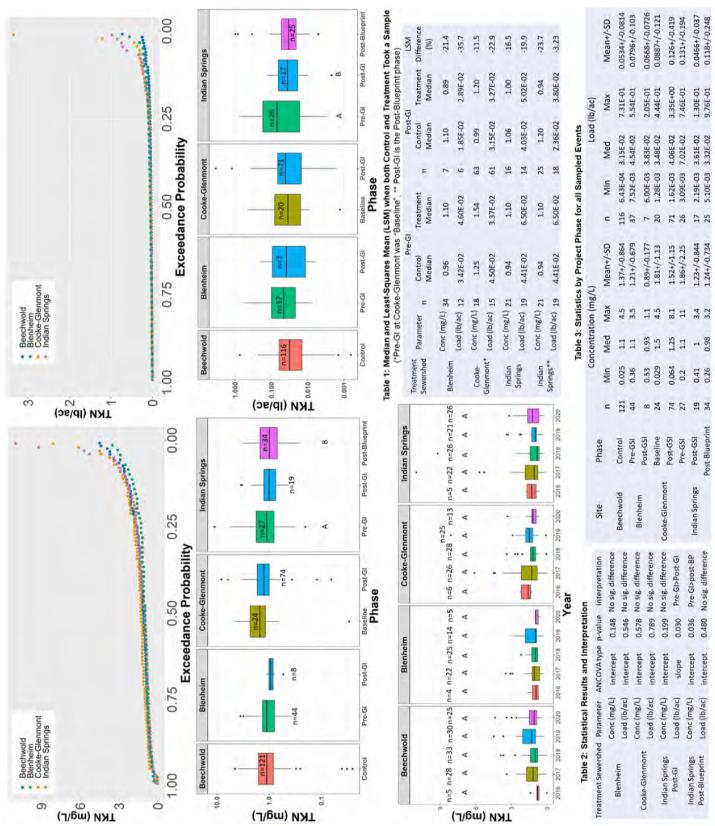
Figure 31. Summary statistics of TKN in water quality samples collected from Clintonville sewersheds and results of analyses comparing project phases. Significant differences (p<0.05), determined from Kruskal-Wallis/Dunn's test with Bonferroni corrections, are represented by different letters in box plots. Asterisk denotes differences were significant at p<0.1.

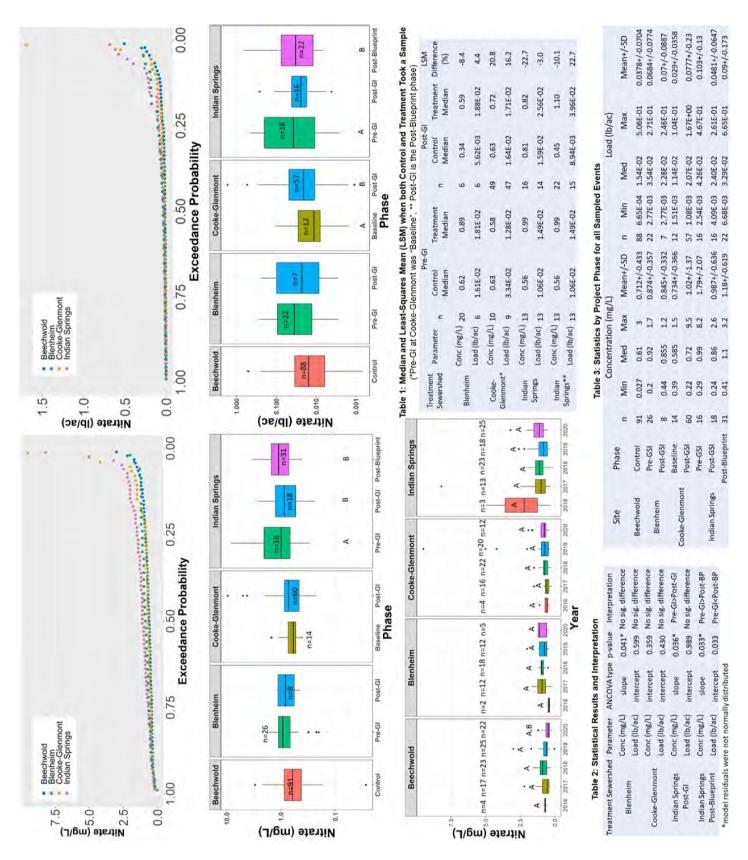
Figure 32. Summary statistics of Nitrate in water quality samples collected from Clintonville sewersheds and results of analyses comparing project phases. Significant differences (p<0.05), determined from Kruskal-Wallis/Dunn's test with Bonferroni corrections, are represented by different letters in box plots. Asterisk denotes differences were significant at p<0.1.

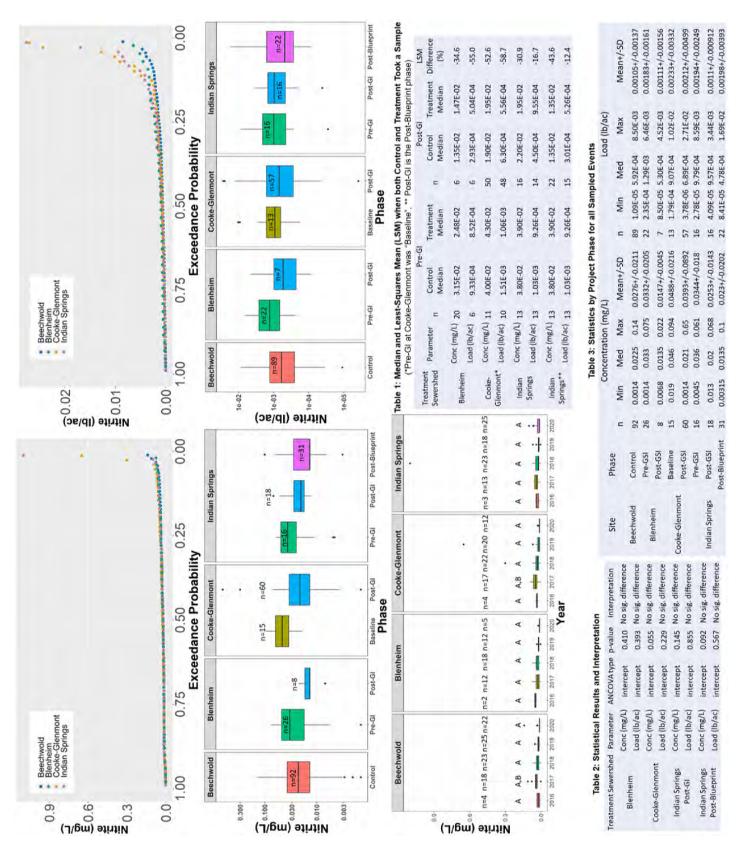
Figure 33. Summary statistics of Nitrite in water quality samples collected from Clintonville sewersheds and results of analyses comparing project phases. Significant differences (p<0.05), determined from Kruskal-Wallis/Dunn's test with Bonferroni corrections, are represented by different letters in box plots. Asterisk denotes differences were significant at p<0.1.

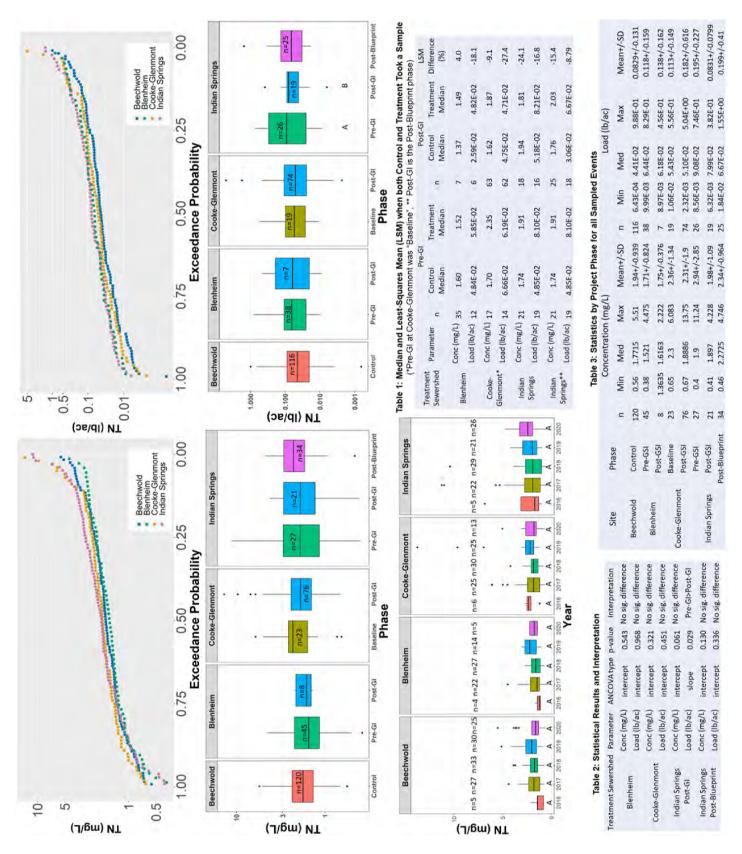
Figure 34. Summary statistics of TN in water quality samples collected from Clintonville sewersheds and results of analyses comparing project phases. Significant differences (p<0.05), determined from Kruskal-Wallis/Dunn's test with Bonferroni corrections, are represented by different letters in box plots. Asterisk denotes differences were significant at p<0.1.

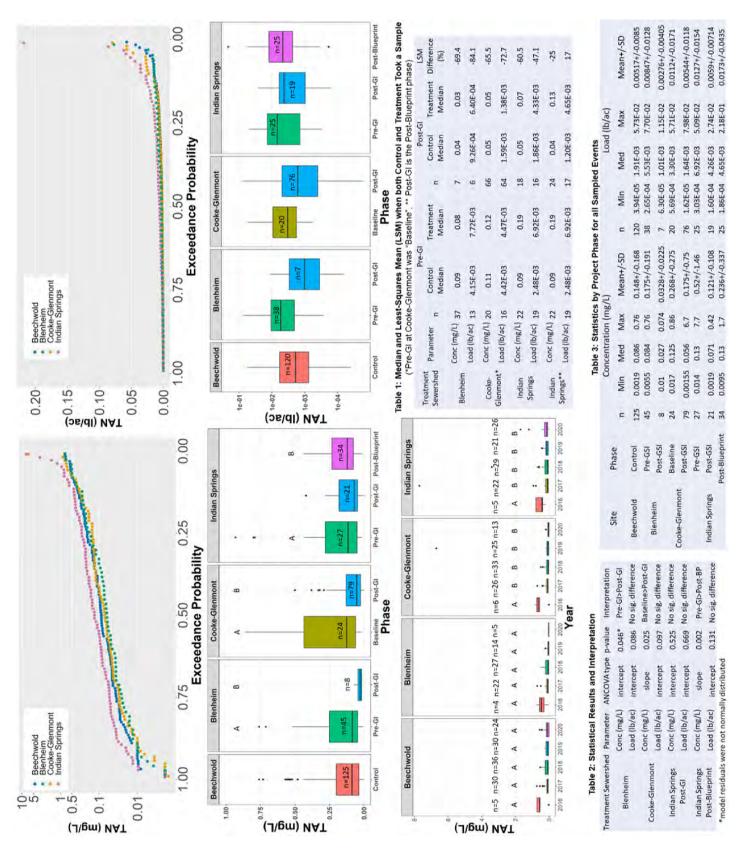
Figure 35. Summary statistics of TAN in water quality samples collected from Clintonville sewersheds and results of analyses comparing project phases. Significant differences (p<0.05), determined from Kruskal-Wallis/Dunn's test with Bonferroni corrections, are represented by different letters in box plots. Asterisk denotes differences were significant at p<0.1.

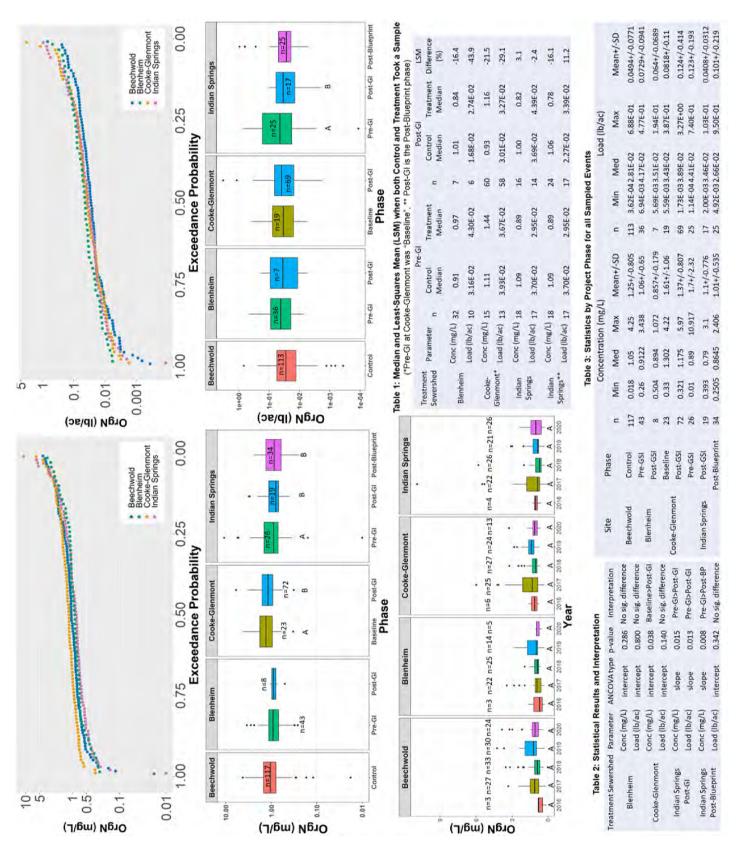
Figure 36. Summary statistics of OrgN in water quality samples collected from Clintonville sewersheds and results of analyses comparing project phases. Significant differences (p<0.05), determined from Kruskal-Wallis/Dunn's test with Bonferroni corrections, are represented by different letters in box plots. Asterisk denotes differences were significant at p<0.1.

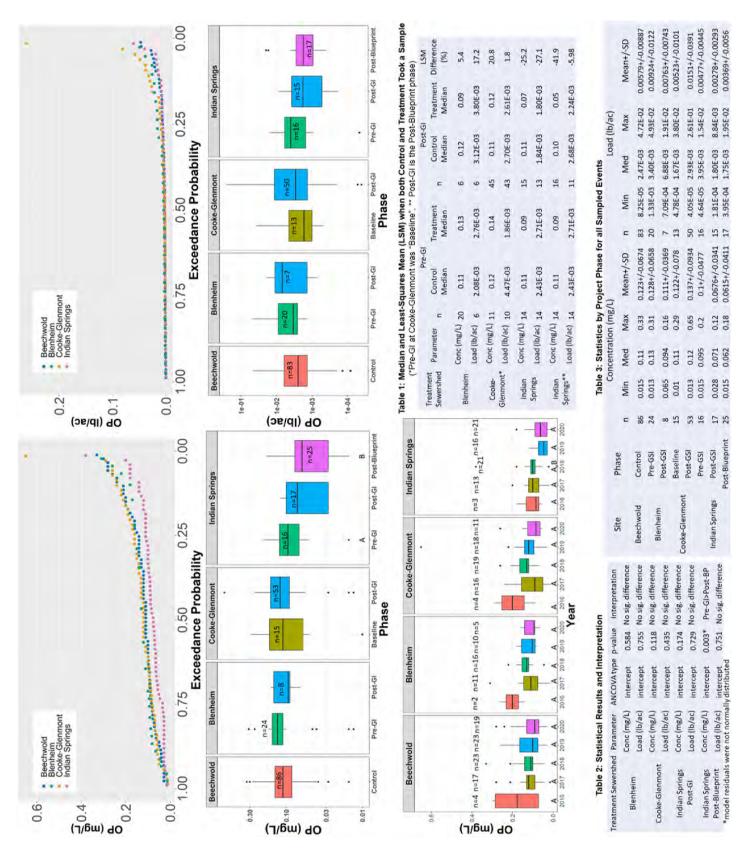
Figure 37. Summary statistics of OP in water quality samples collected from Clintonville sewersheds and results of analyses comparing project phases. Significant differences (p<0.05), determined from Kruskal-Wallis/Dunn's test with Bonferroni corrections, are represented by different letters in box plots. Asterisk denotes differences were significant at p<0.1.

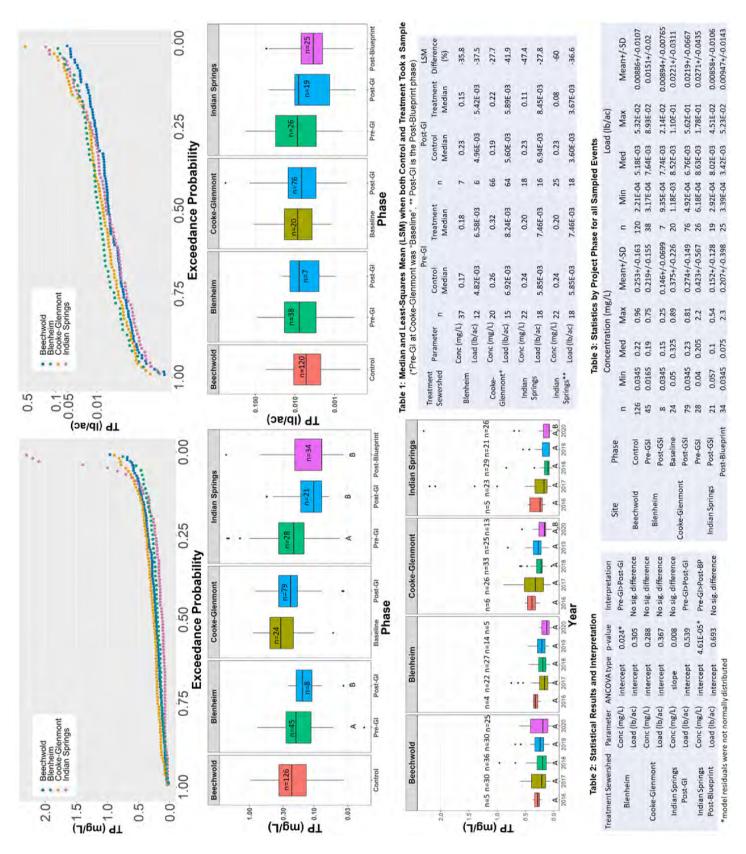
Figure 38. Summary statistics of TP in water quality samples collected from Clintonville sewersheds and results of analyses comparing project phases. Significant differences (p<0.05), determined from Kruskal-Wallis/Dunn's test with Bonferroni corrections, are represented by different letters in box plots. Asterisk denotes differences were significant at p<0.1.

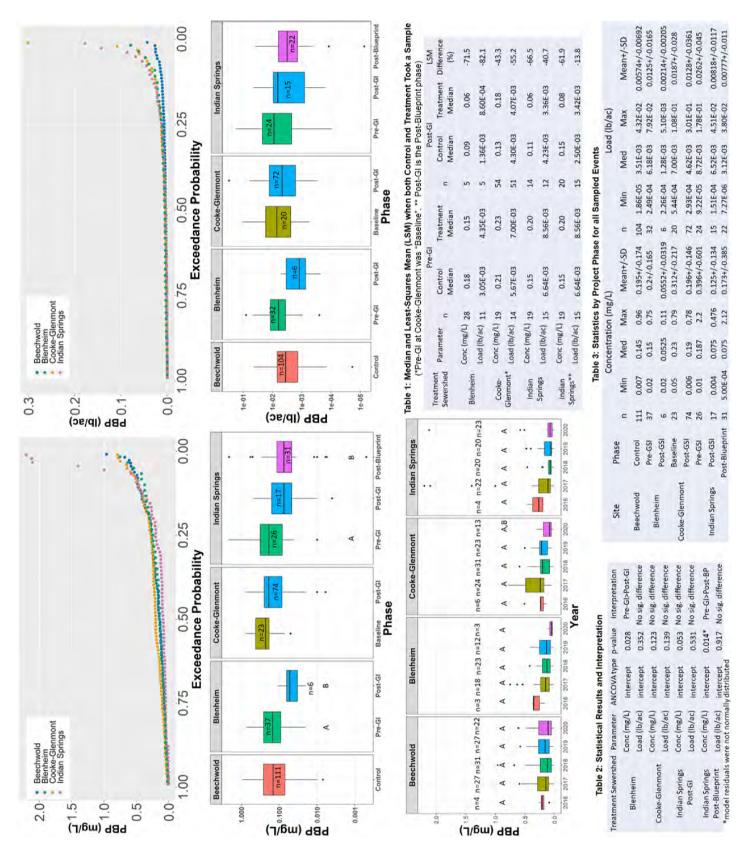
Figure 39. Summary statistics of PBP in water quality samples collected from Clintonville sewersheds and results of analyses comparing project phases. Significant differences (p<0.05), determined from Kruskal-Wallis/Dunn's test with Bonferroni corrections, are represented by different letters in box plots. Asterisk denotes differences were significant at p<0.1.

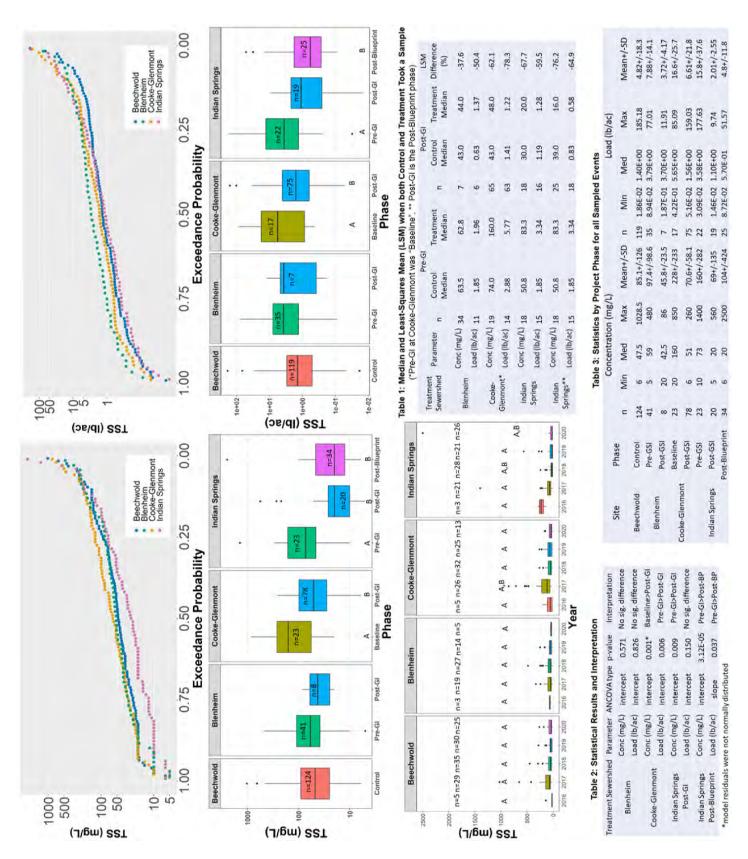
Figure 40. Summary statistics of TSS in water quality samples collected from Clintonville sewersheds and results of analyses comparing project phases. Significant differences (p<0.05), determined from Kruskal-Wallis/Dunn's test with Bonferroni corrections, are represented by different letters in box plots. Asterisk denotes differences were significant at p<0.1.

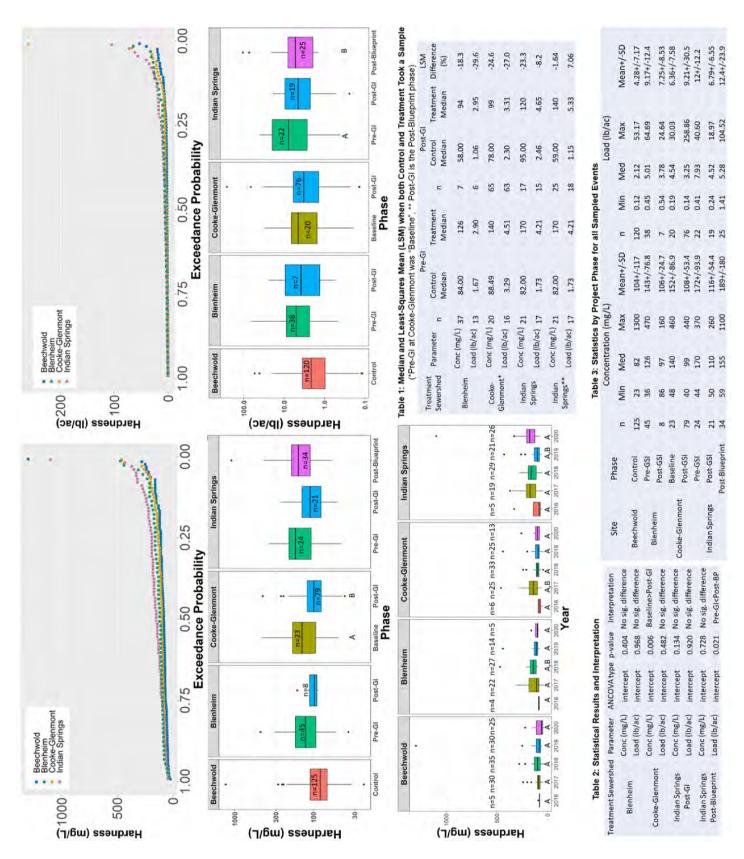
Figure 41. Summary statistics of Hardness in water quality samples collected from Clintonville sewersheds and results of analyses comparing project phases. Significant differences (*p*<0.05), determined from Kruskal-Wallis/Dunn's test with Bonferroni corrections, are represented by different letters in box plots. Asterisk denotes differences were significant at *p*<0.1.

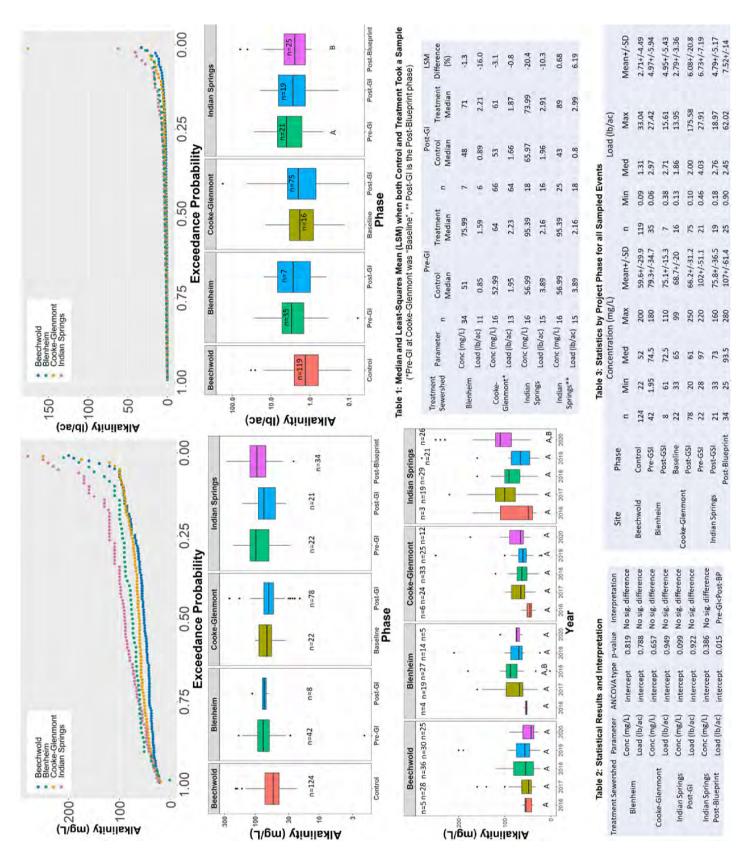
Figure 42. Summary statistics of Alkalinity in water quality samples collected from Clintonville sewersheds and results of analyses comparing project phases. Significant differences (*p*<0.05), determined from Kruskal-Wallis/Dunn's test with Bonferroni corrections, are represented by different letters in box plots. Asterisk denotes differences were significant at *p*<0.1.

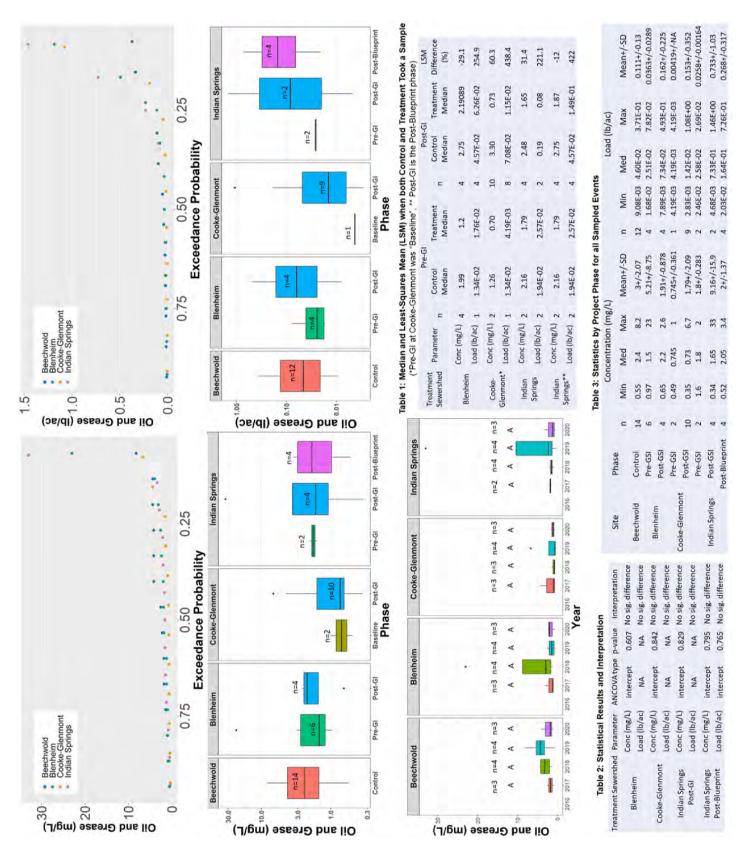
Figure 43. Summary statistics of Oil and Grease in water quality samples collected from Clintonville sewersheds and results of analyses comparing project phases. Significant differences (p<0.05), determined from Kruskal-Wallis/Dunn's test with Bonferroni corrections, are represented by different letters in box plots. Asterisk denotes differences were significant at p<0.1.

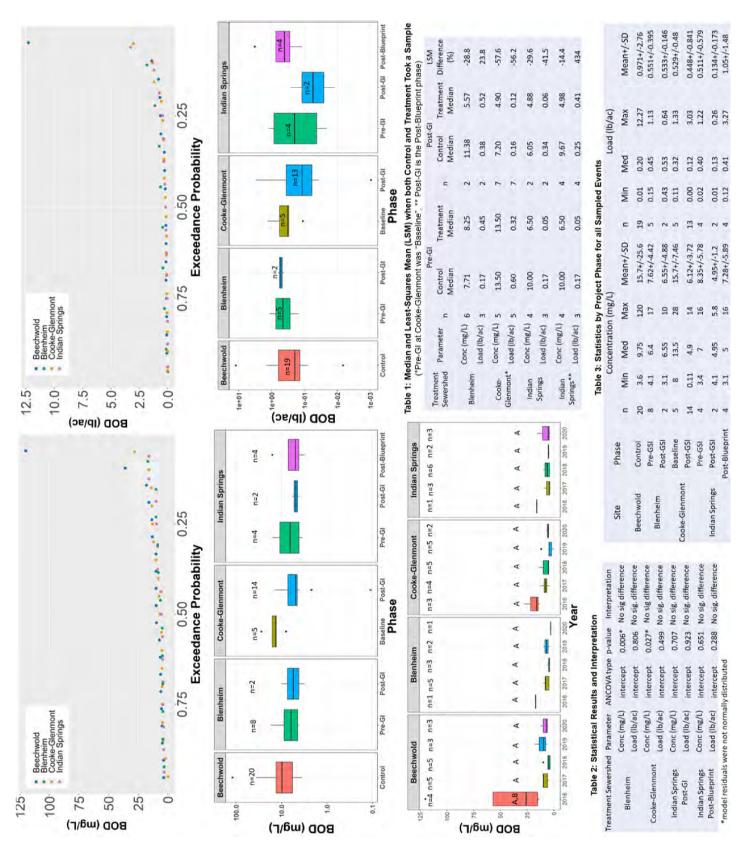
Figure 44. Summary statistics of BOD in water quality samples collected from Clintonville sewersheds and results of analyses comparing project phases. Significant differences (p<0.05), determined from Kruskal-Wallis/Dunn's test with Bonferroni corrections, are represented by different letters in box plots. Asterisk denotes differences were significant at p<0.1.

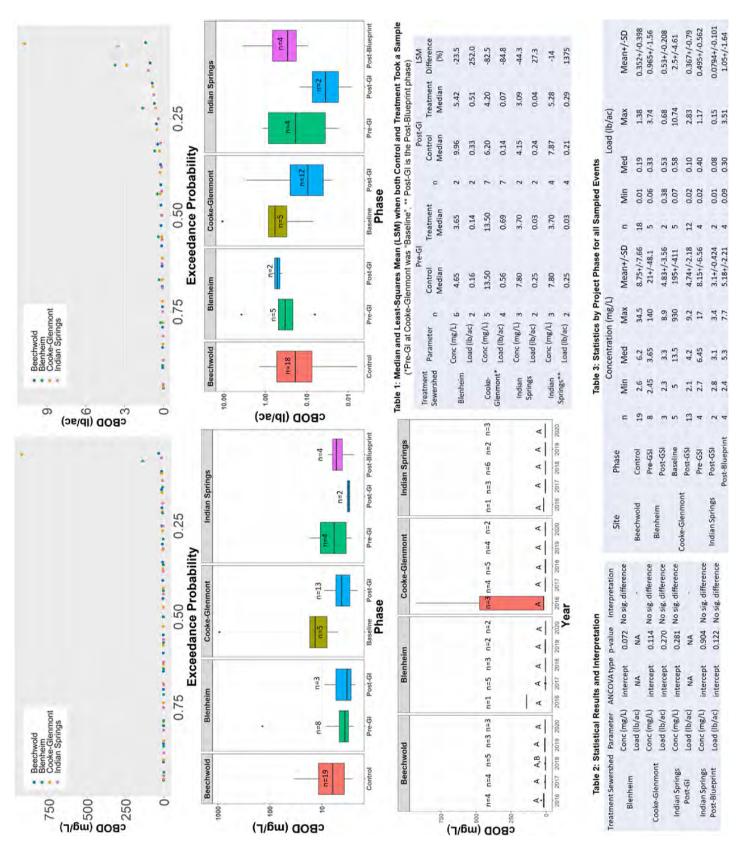
Figure 45. Summary statistics of cBOD in water quality samples collected from Clintonville sewersheds and results of analyses comparing project phases. Significant differences (p<0.05), determined from Kruskal-Wallis/Dunn's test with Bonferroni corrections, are represented by different letters in box plots. Asterisk denotes differences were significant at p<0.1.

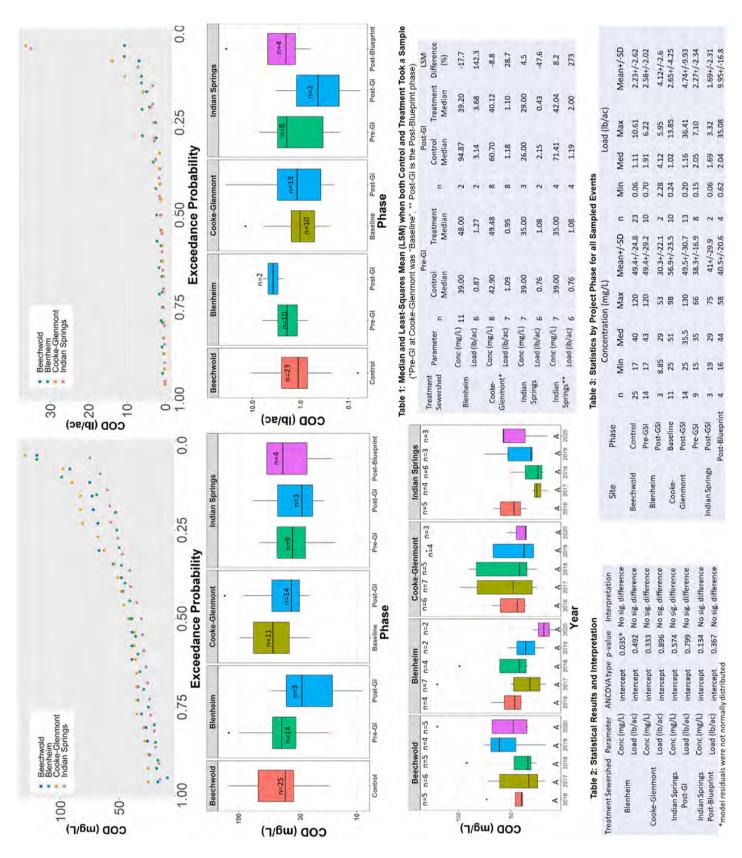
Figure 46. Summary statistics of COD in water quality samples collected from Clintonville sewersheds and results of analyses comparing project phases. Significant differences (p<0.05), determined from Kruskal-Wallis/Dunn's test with Bonferroni corrections, are represented by different letters in box plots. Asterisk denotes differences were significant at p<0.1.

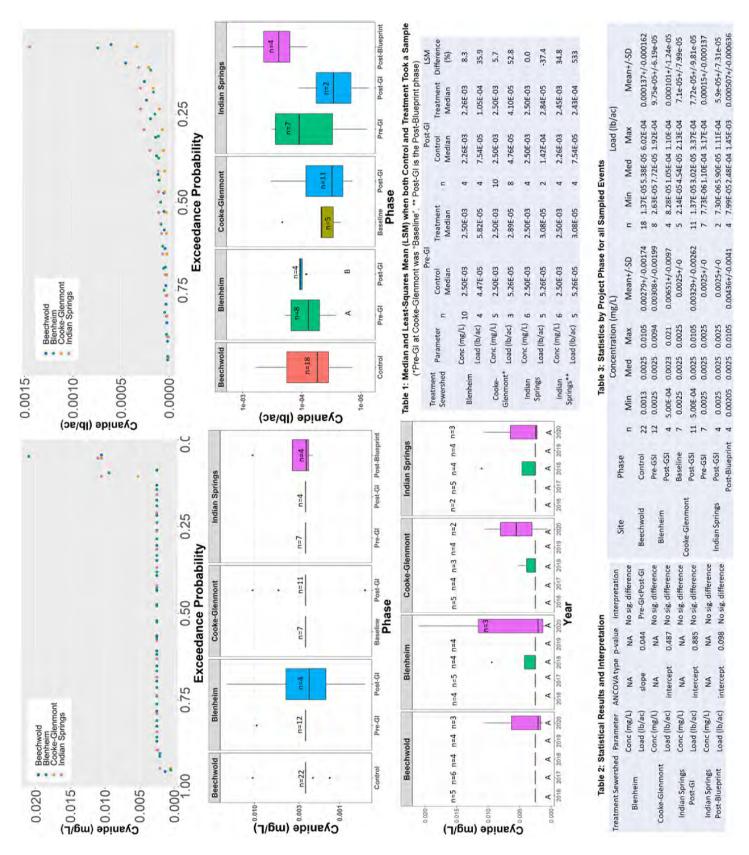
Figure 47. Summary statistics of Cyanide in water quality samples collected from Clintonville sewersheds and results of analyses comparing project phases. Significant differences (p<0.05), determined from Kruskal-Wallis/Dunn's test with Bonferroni corrections, are represented by different letters in box plots. Asterisk denotes differences were significant at p<0.1.
