City of Columbus Stormwater NPDES Permit

January 1, 2020 – December 31, 2020 (Ohio EPA Permit Number: 4PI00000*CD)

ANNUAL REPORT

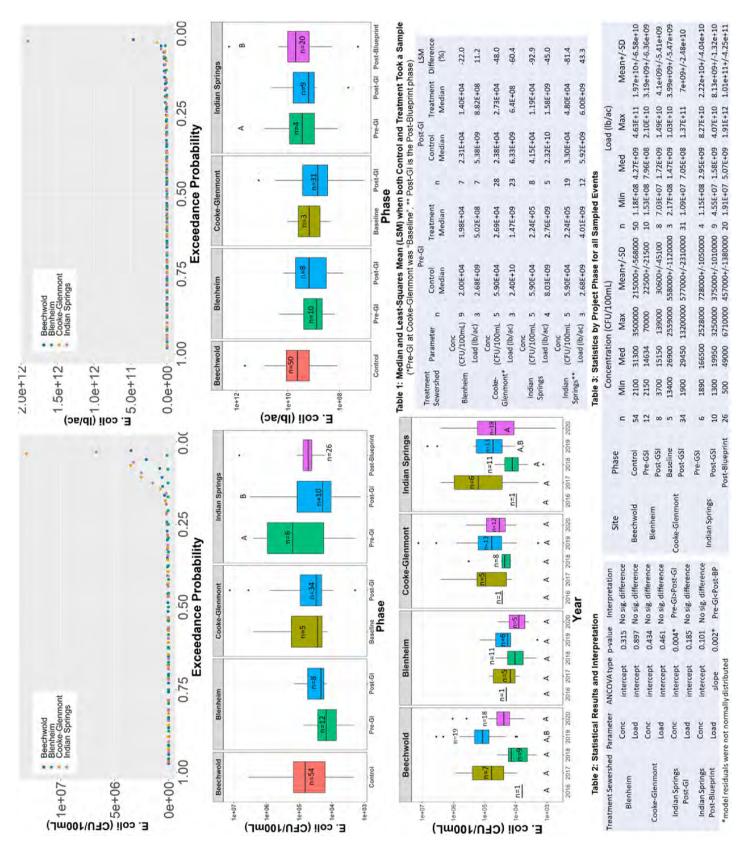
Figure 48. Summary statistics of *E. coli* in water quality samples collected from Clintonville sewersheds and results of analyses comparing project phases. Significant differences (p<0.05), determined from Kruskal-Wallis/Dunn's test with Bonferroni corrections, are represented by different letters in box plots. Asterisk denotes differences were significant at p<0.1.

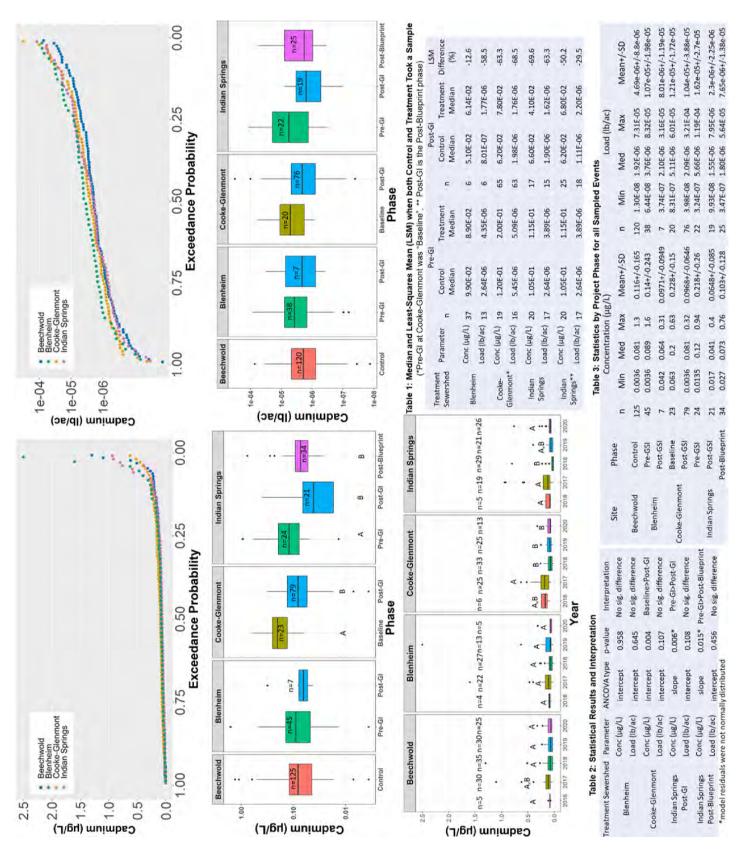
Figure 49. Summary statistics of Cadmium in water quality samples collected from Clintonville sewersheds and results of analyses comparing project phases. Significant differences (*p*<0.05), determined from Kruskal-Wallis/Dunn's test with Bonferroni corrections, are represented by different letters in box plots. Asterisk denotes differences were significant at *p*<0.1.

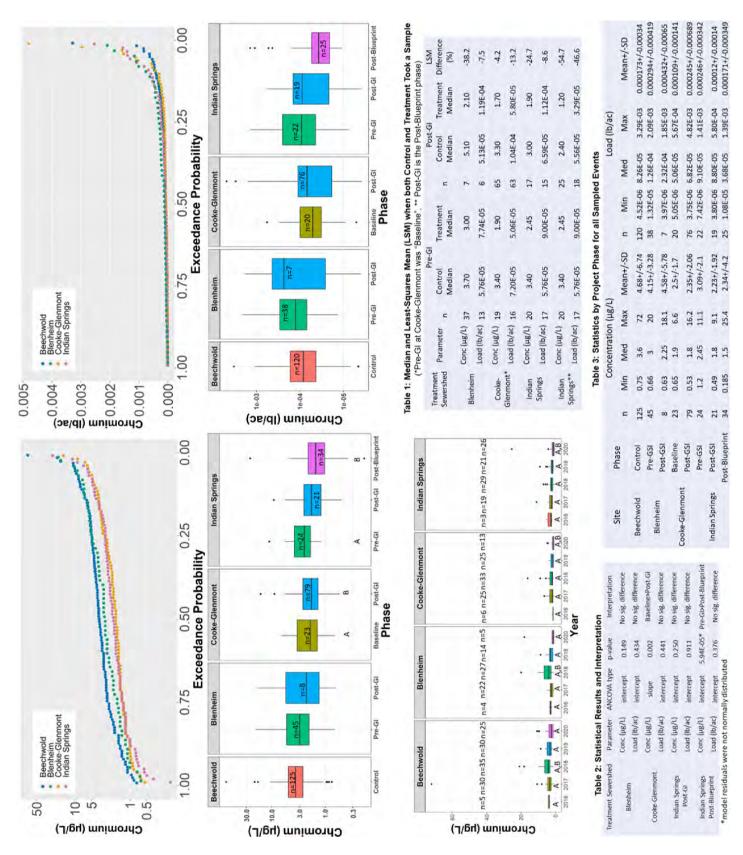
Figure 50. Summary statistics of Chromium in water quality samples collected from Clintonville sewersheds and results of analyses comparing project phases. Significant differences (p<0.05), determined from Kruskal-Wallis/Dunn's test with Bonferroni corrections, are represented by different letters in box plots. Asterisk denotes differences were significant at p<0.1.

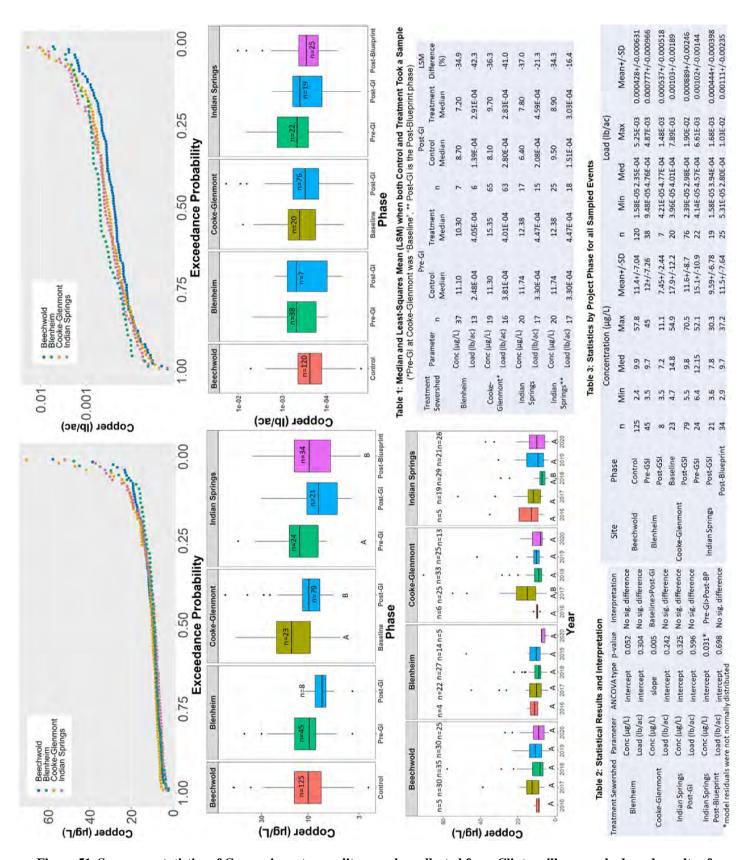
Figure 51. Summary statistics of Copper in water quality samples collected from Clintonville sewersheds and results of analyses comparing project phases. Significant differences (p<0.05), determined from Kruskal-Wallis/Dunn's test with Bonferroni corrections, are represented by different letters in box plots. Asterisk denotes differences were significant at p<0.1.

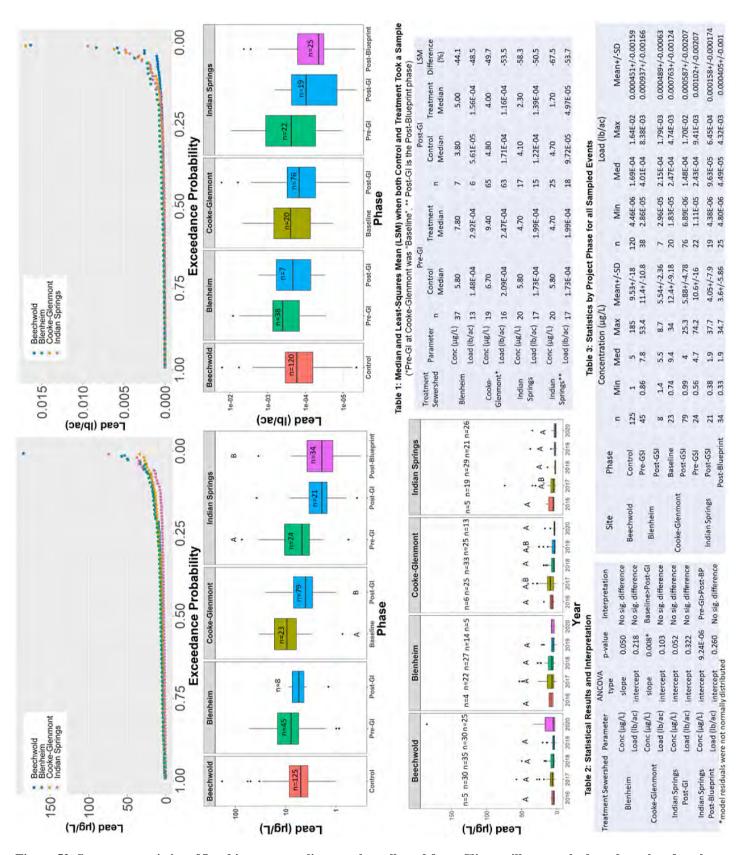
Figure 52. Summary statistics of Lead in water quality samples collected from Clintonville sewersheds and results of analyses comparing project phases. Significant differences (p<0.05), determined from Kruskal-Wallis/Dunn's test with Bonferroni corrections, are represented by different letters in box plots. Asterisk denotes differences were significant at p<0.1.

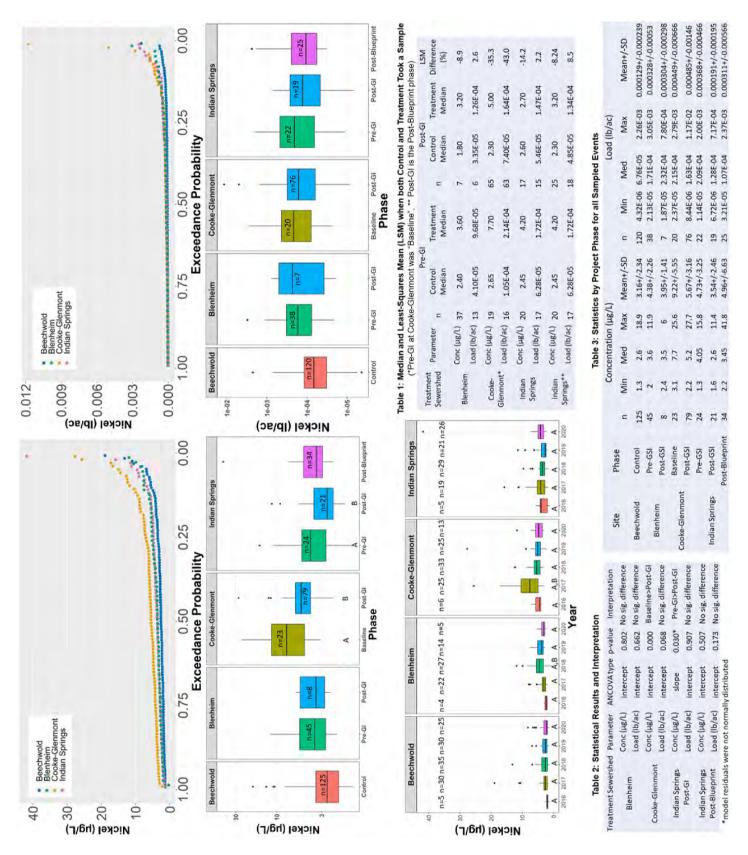
Figure 53. Summary statistics of Nickel in water quality samples collected from Clintonville sewersheds and results of analyses comparing project phases. Significant differences (p<0.05), determined from Kruskal-Wallis/Dunn's test with Bonferroni corrections, are represented by different letters in box plots. Asterisk denotes differences were significant at p<0.1.

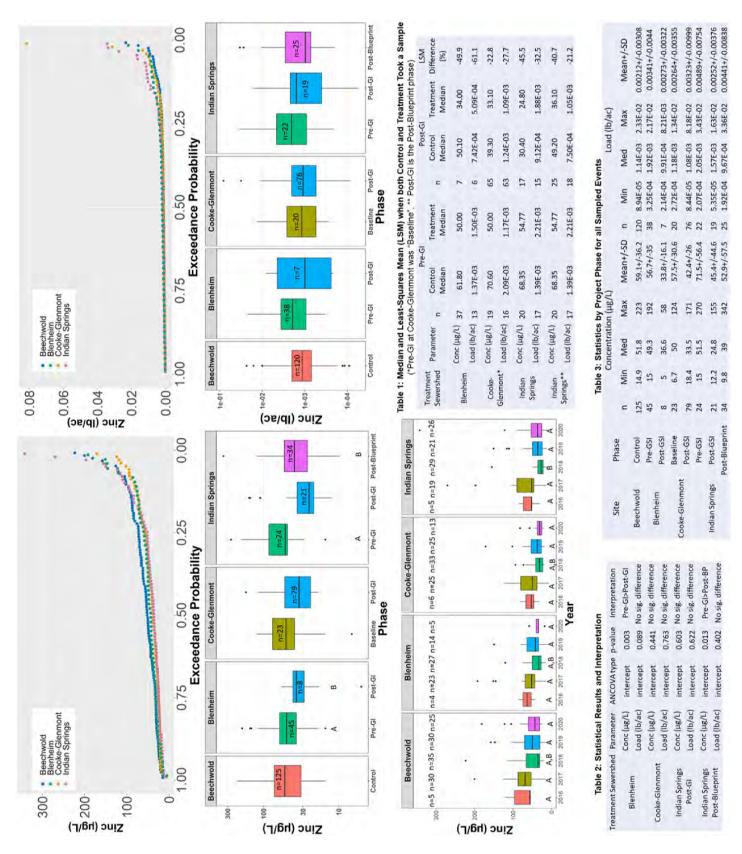
Figure 54. Summary statistics of Zinc in water quality samples collected from Clintonville sewersheds and results of analyses comparing project phases. Significant differences (p<0.05), determined from Kruskal-Wallis/Dunn's test with Bonferroni corrections, are represented by different letters in box plots. Asterisk denotes differences were significant at p<0.1
