**REQUEST FOR TYPE III
VARIANCE FROM CITY OF
COLUMBUS SWDM**

Del Taco – 1466 Harrisburg Pike
Columbus, Ohio 43223
January 15, 2020

VARIANCE REPORT

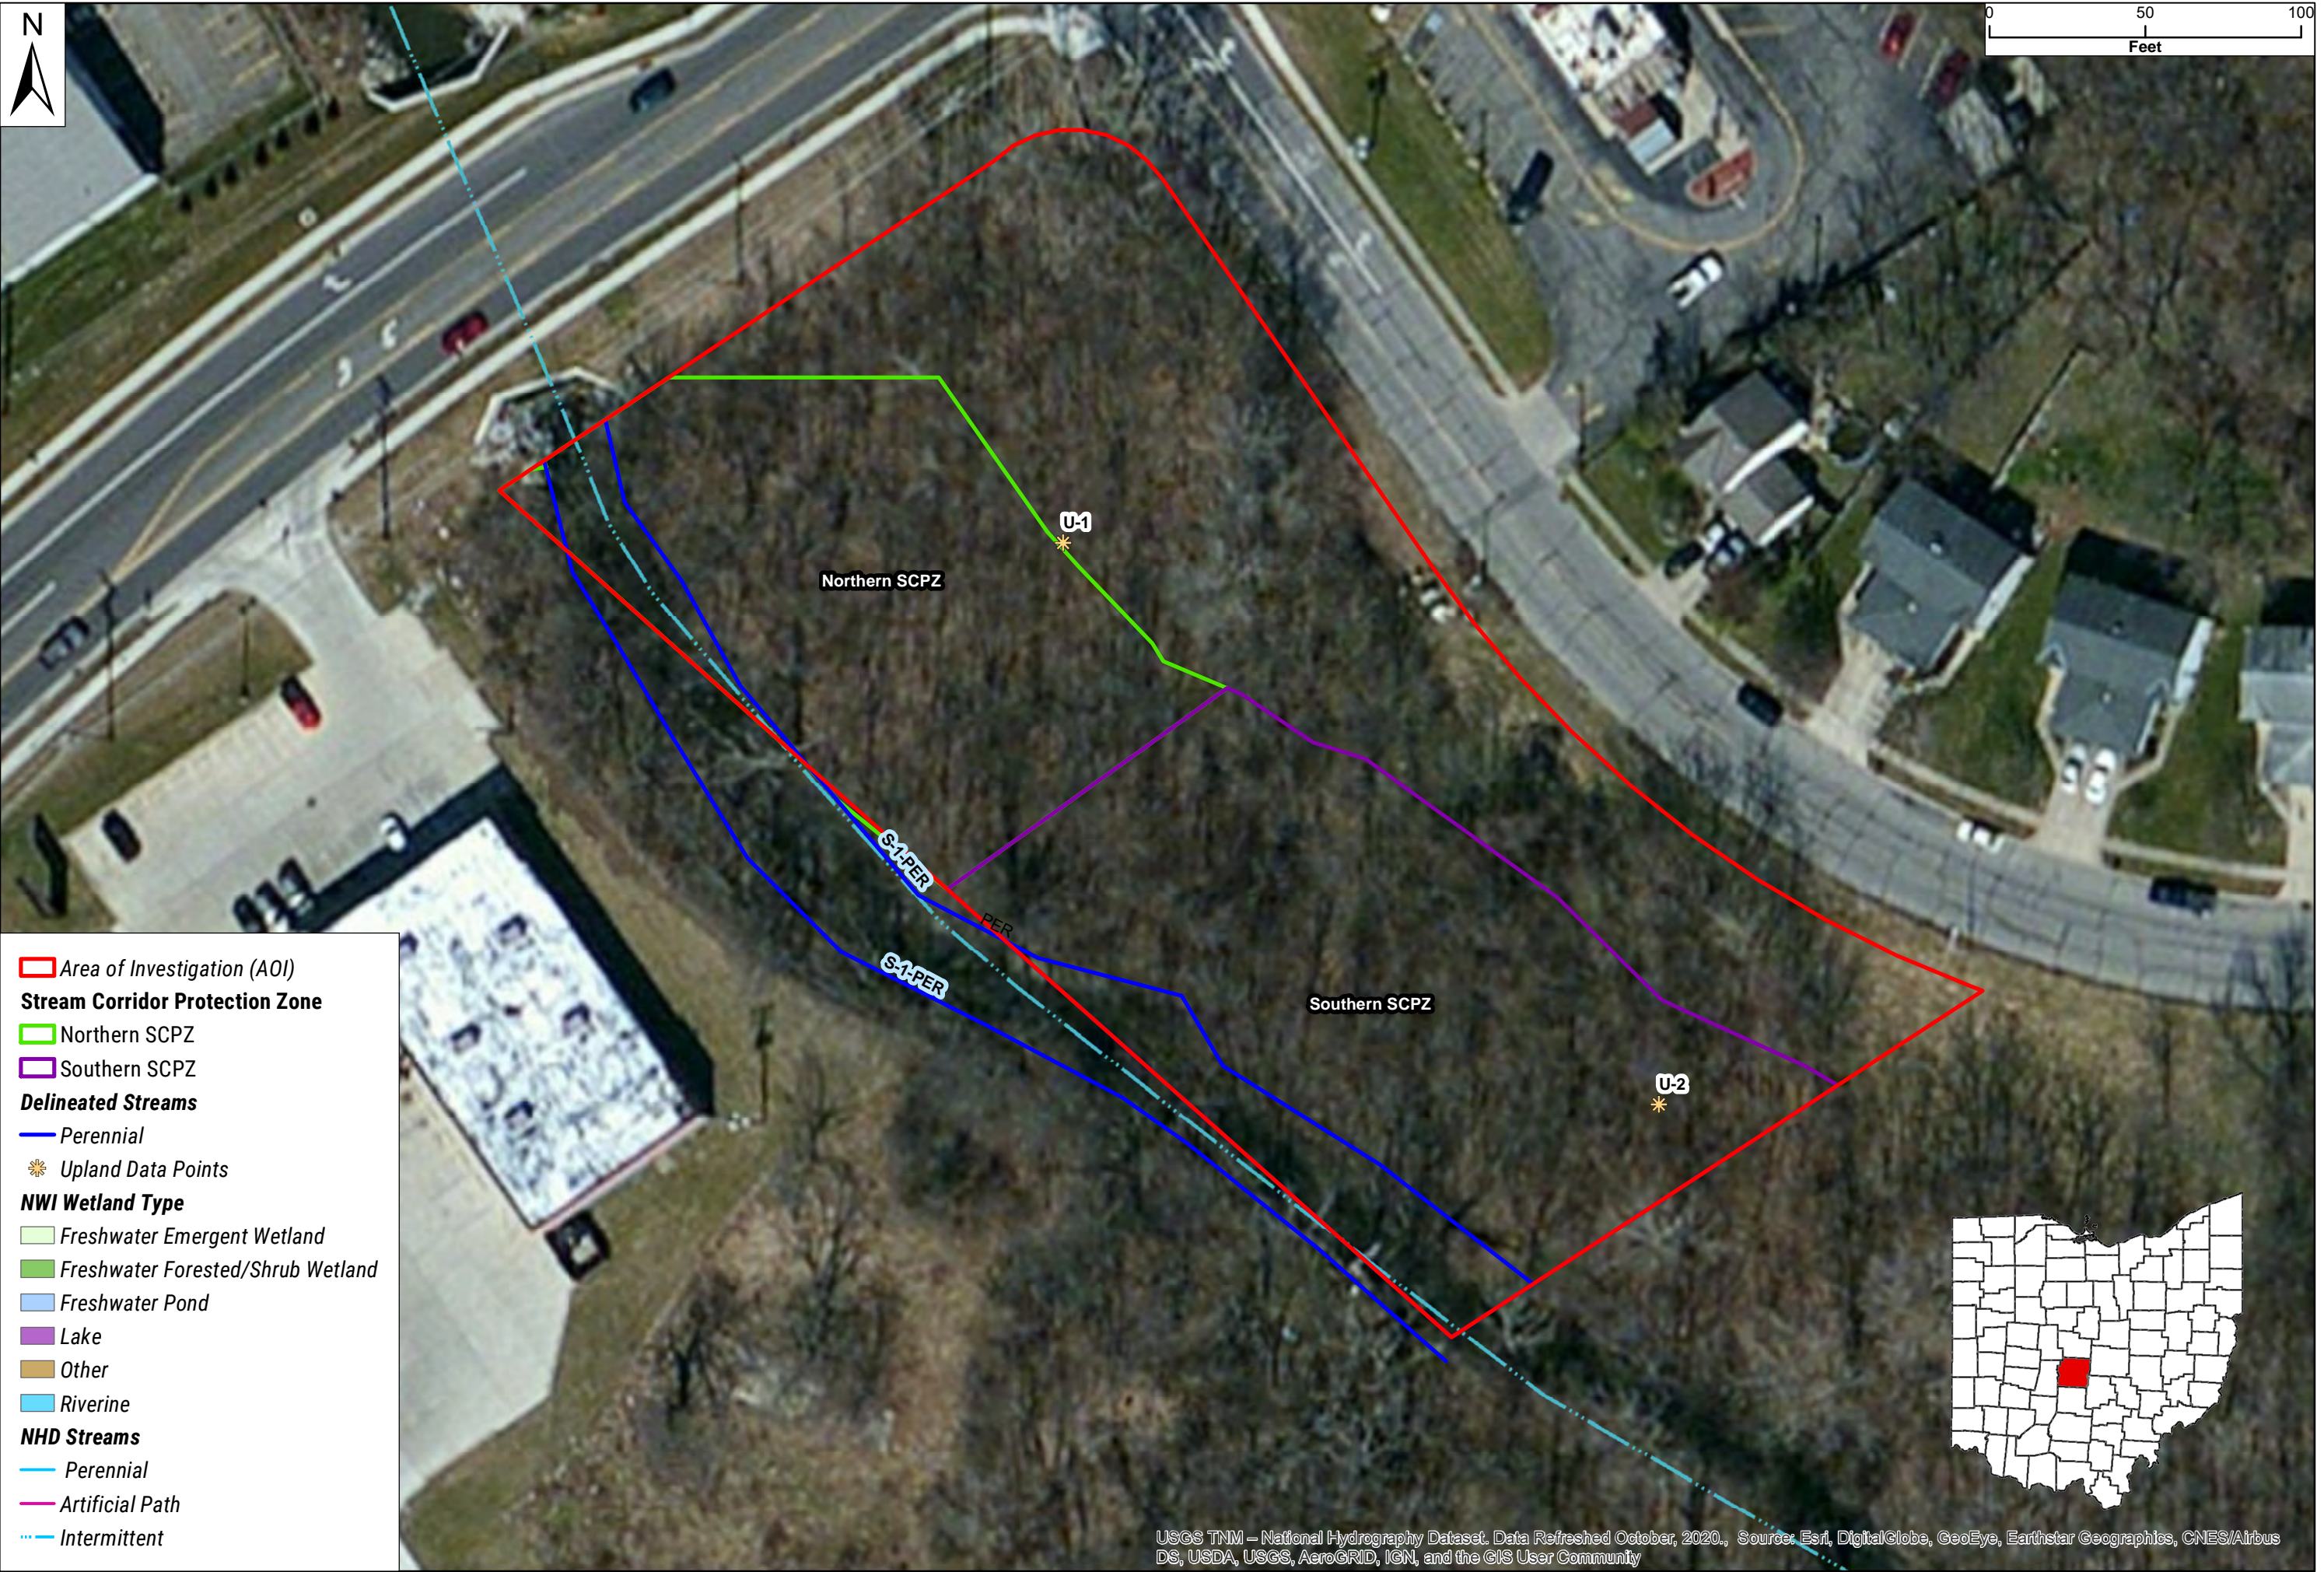
Attachment 2: Existing Environmental Conditions Map

Del Taco - Columbus, OH
 Existing Environmental Conditions Map
 Franklin Township, Franklin County, Ohio

CESO, Inc. conducted a botanical study within the stream corridor protection zone (SCPZ). The SCPZ boundary was divided into northern and southern zones to differentiate different vegetative communities if present. Dominant vegetation within the established corridor (e.g. mature trees, canopy, shrub, field etc.) was identified and documented in both the northern half and southern half SCPZ areas. The Existing Environmental Conditions Map portrays the SCPZ boundaries within the AOI.

Attachment 2 includes the Existing Environmental Conditions Map which displays the AOI and the stream identified. Color photographs of the identified stream and AOI are included as Attachment 4.

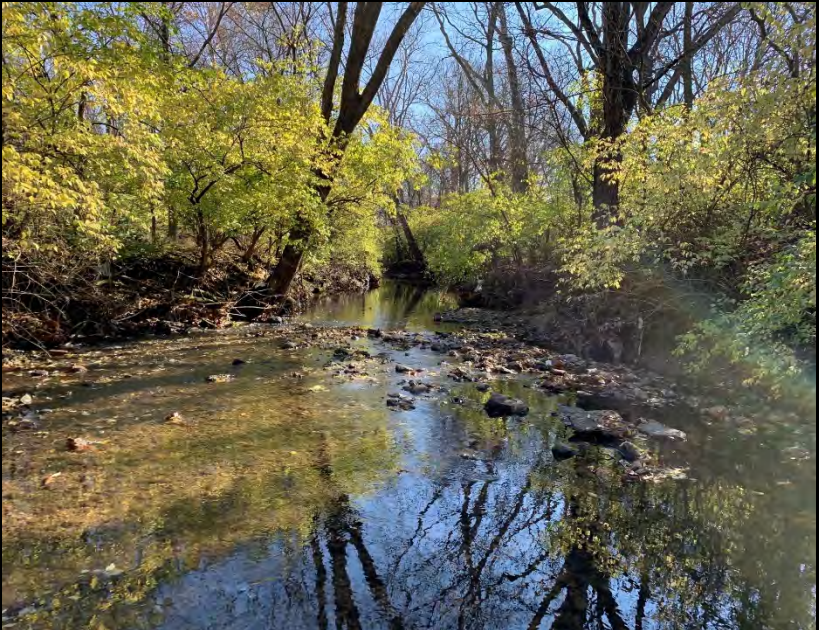
Photograph #	1

Date:	11-12-2020	
Description:	View of perennial stream S-1-PER facing downstream.

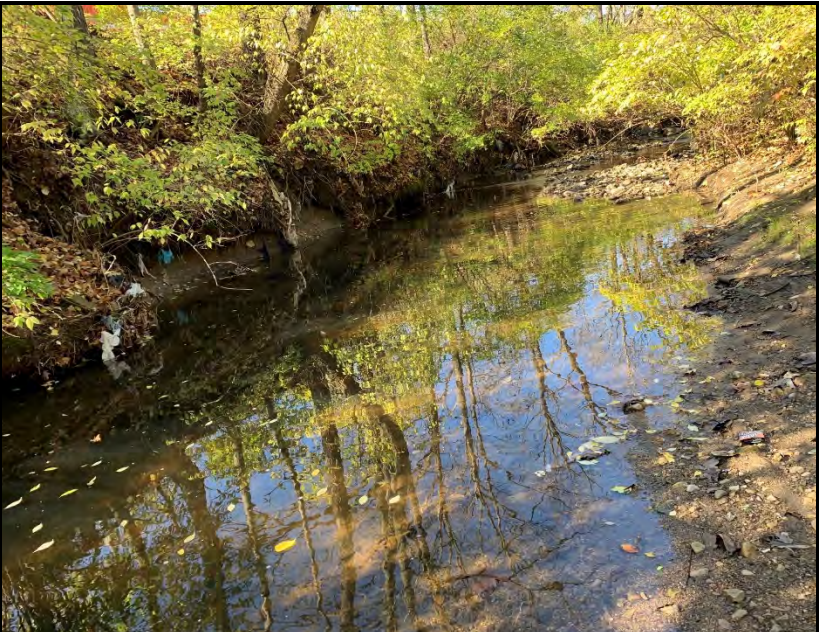
Photograph #	2

Date:	11-12-2020	
Description:	View of perennial stream S-1-PER facing upstream.

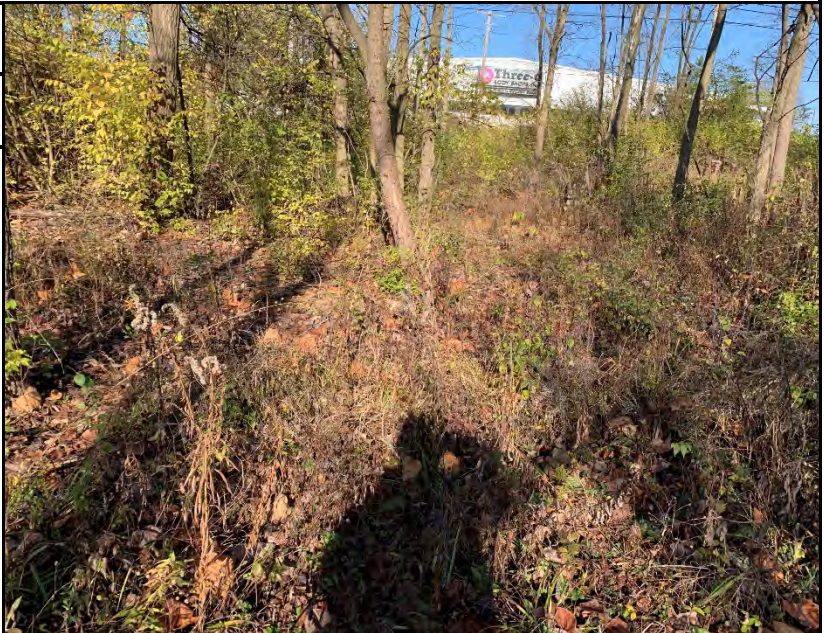
Photograph #	3
Date:	11-12-2020
Description:	<p>View of upland data point U-1 along the eastern edge of the SCPZ facing north.</p>

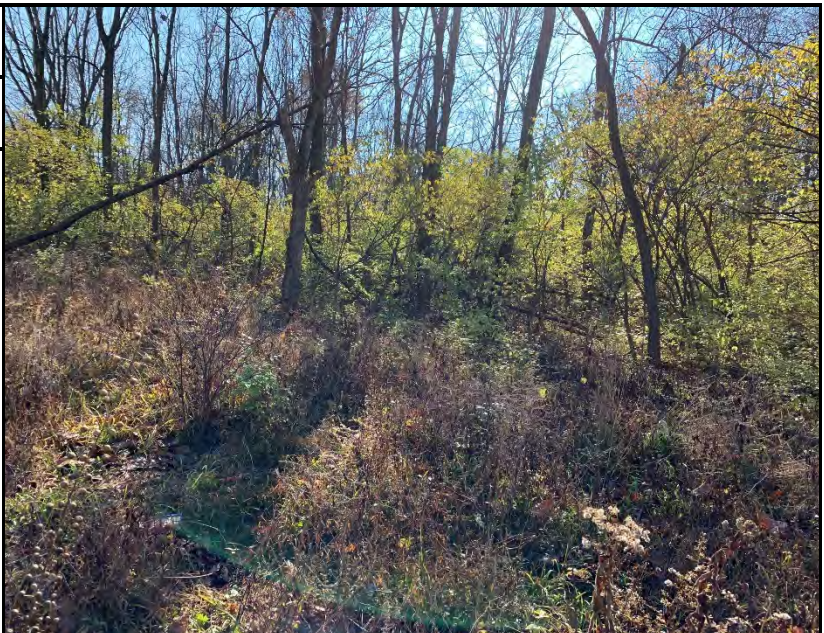
Photograph #	4
Date:	11-12-2020
Description:	<p>View of upland data point U-1 along the eastern edge of the SCPZ facing west.</p>

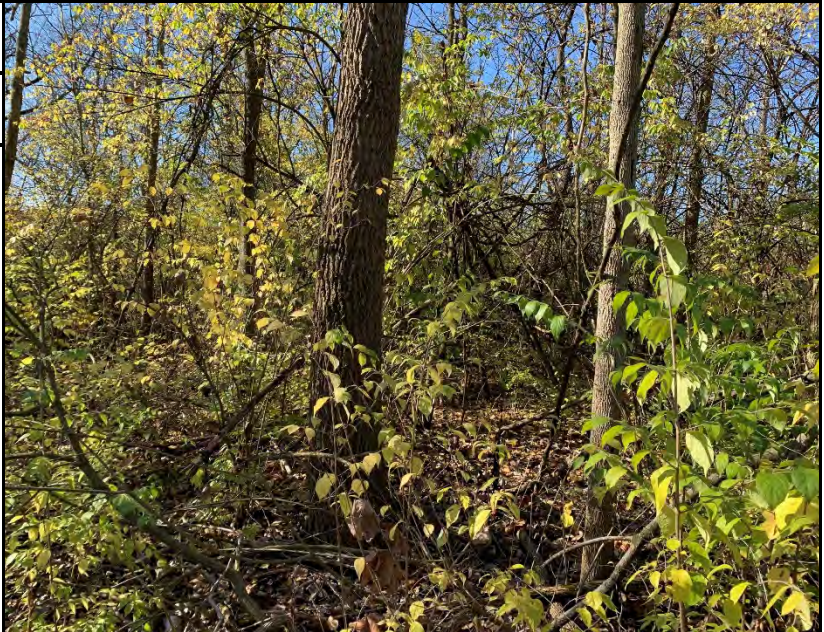
Photograph #	5
Date:	11-12-2020
Description:	View of upland data point U-2 in the southern SCPZ facing northeast.

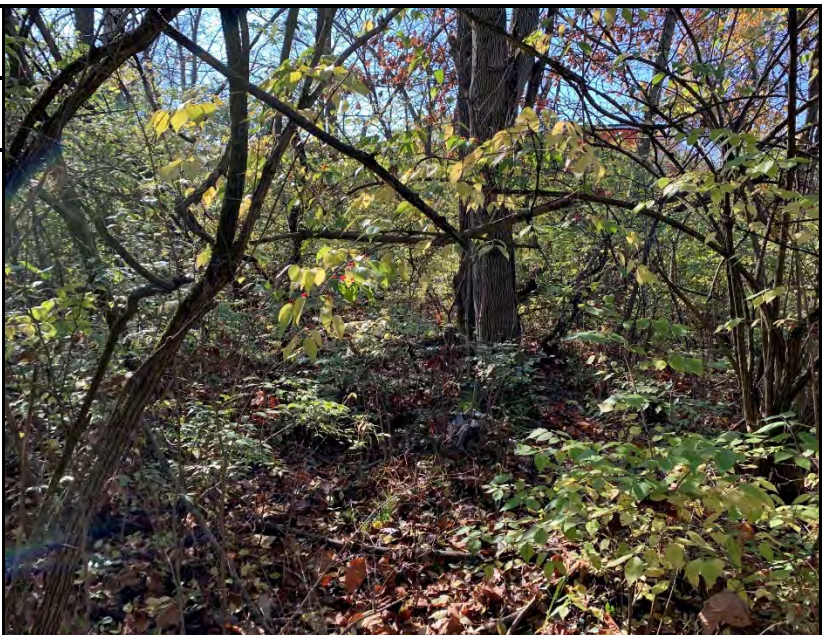
Photograph #	6
Date:	11-12-2020
Description:	View of upland data point U-2 in the southern SCPZ facing west.

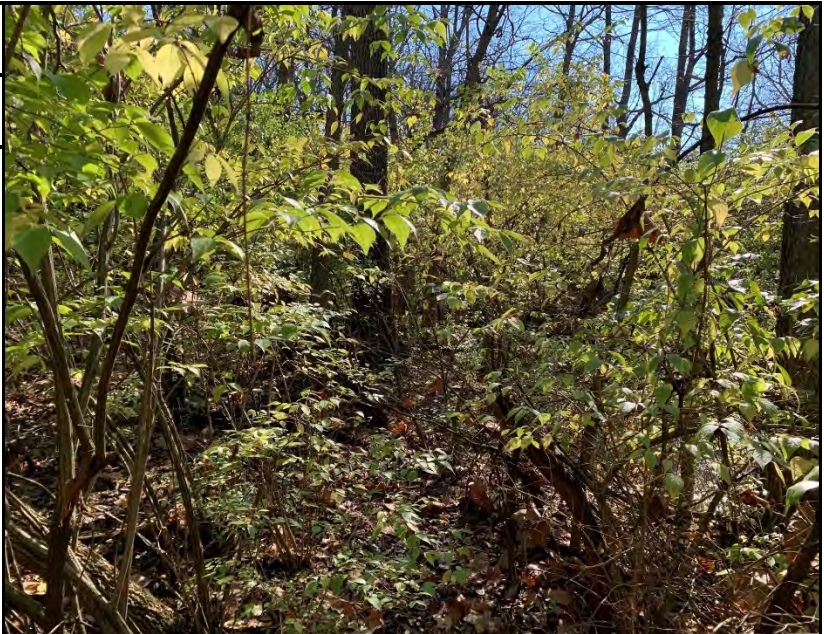
Photograph #	7
Date:	11-12-2020
Description:	<i>View of northern SCPZ in the northwestern portion of AOI facing east.</i>

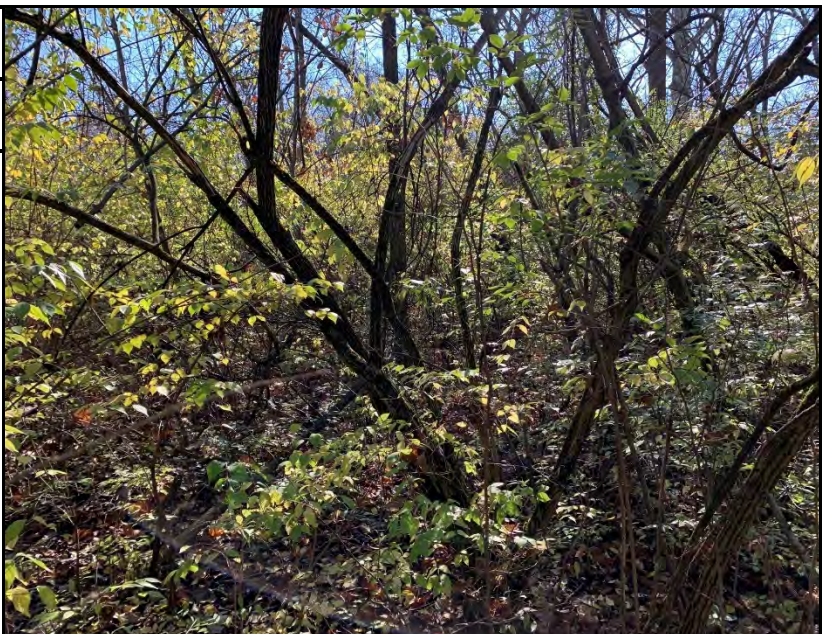
Photograph #	8
Date:	11-12-2020
Description:	<i>View of southern SCPZ in the southwestern portion of AOI facing east.</i>

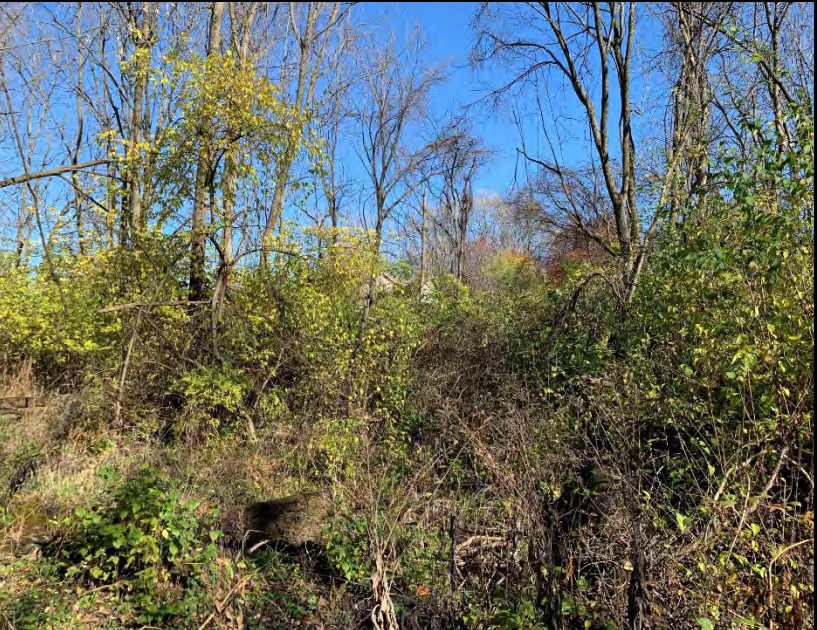
Photograph #	9

Date:	11-12-2020	
Description:	View in the middle portion of the AOI facing east.

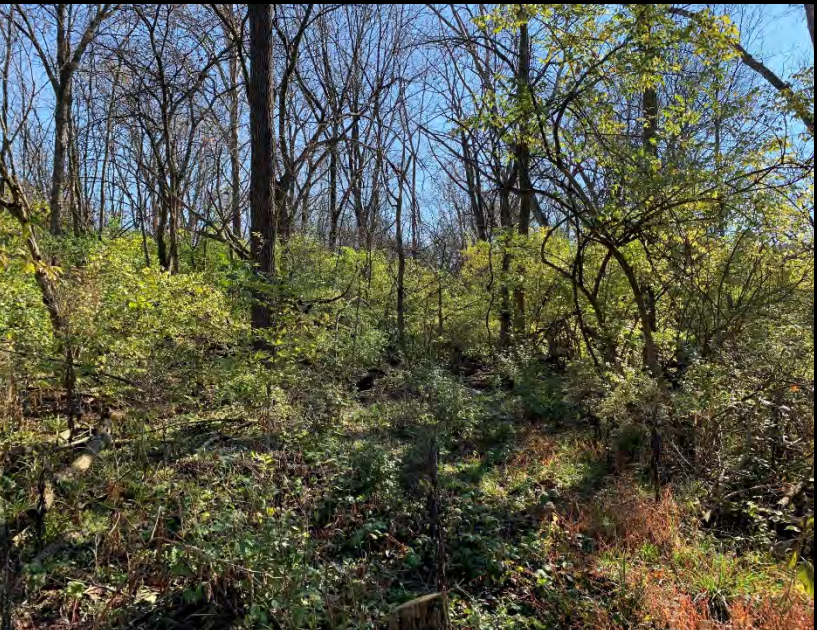
Photograph #	10

Date:	11-12-2020	
Description:	View of the middle portion of AOI facing south.

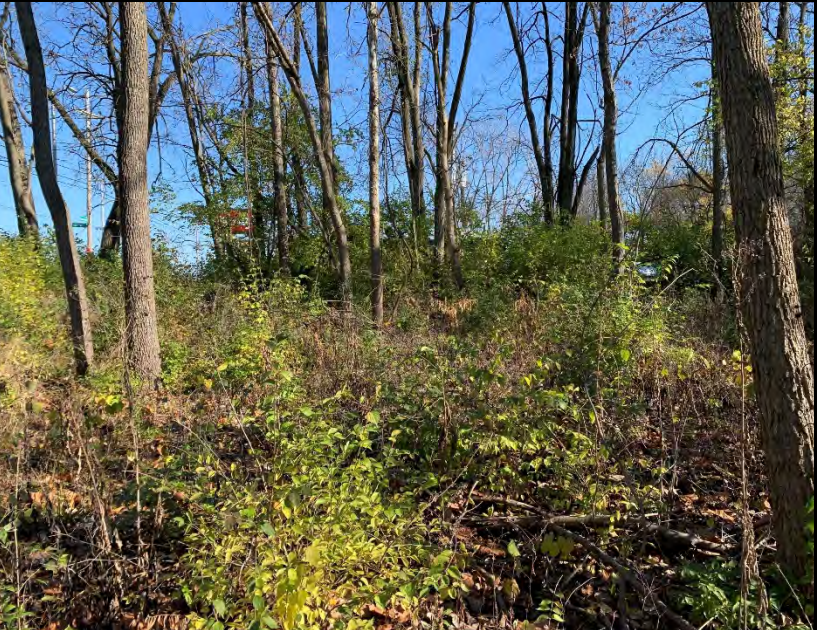
Photograph #	11

Date:	11-12-2020	
Description:	View of the northcentral portion of AOI facing east.

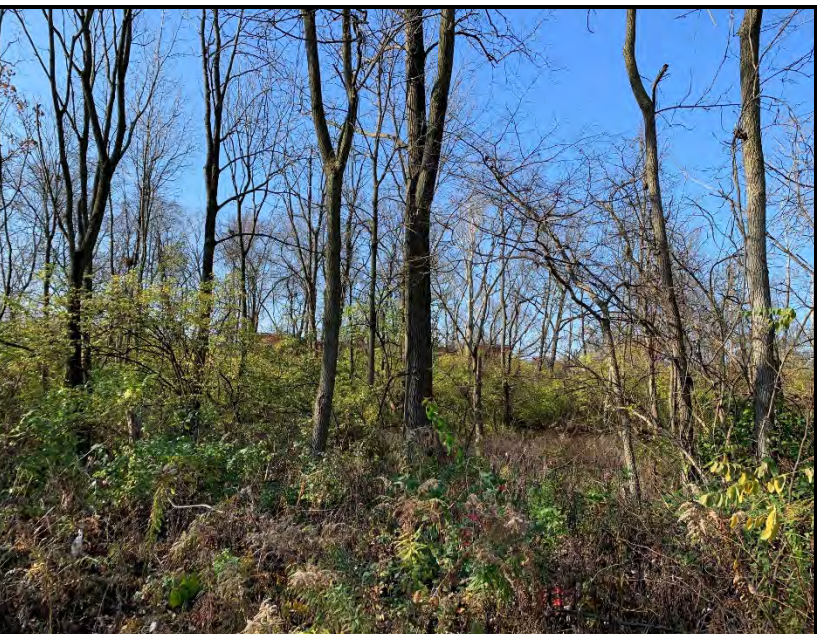
Photograph #	12

Date:	11-12-2020	
Description:	View in the middle of eastern edge of AOI facing west.
