Marble Cliff Quarry Development Project

Type II Variance Request

June 12, 2017

Re: Type II Variance Request
Marble Cliff Quarry Property

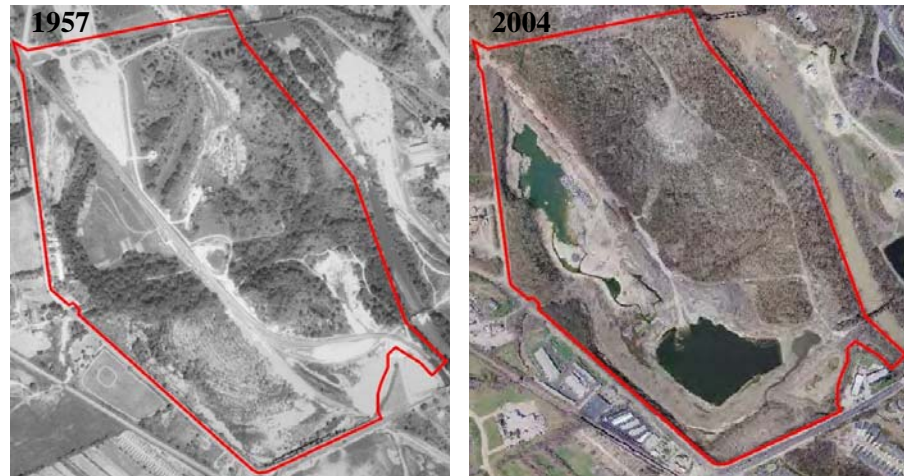
Figure 6: Surface feature comparison between 1957 and 2004.

The project's final unique circumstance is that it intends to place fill within a 100-year floodplain that results from significant mining operations and altered surface features. It can be projected based on research of the site's conditions and aerial photographs that millions of cubic yards of material were mined around the

proposed fill locations, which directly impacted the 100-year floodplain within this site (Figure 6). According to conservative projections, the proposed fill back into the current 100-year floodplain only replaces a fraction of what has been mined out over the quarry's operation. The relatively minor amount of fill required by this site within the current floodplain is essentially replacing mined material and is not expected to significantly alter flood conditions as substantial landfilling and mining operations have in the past. An explanation of anticipated floodplain impacts due to the project's fill within the 100-year floodplain can be found in Appendix D.

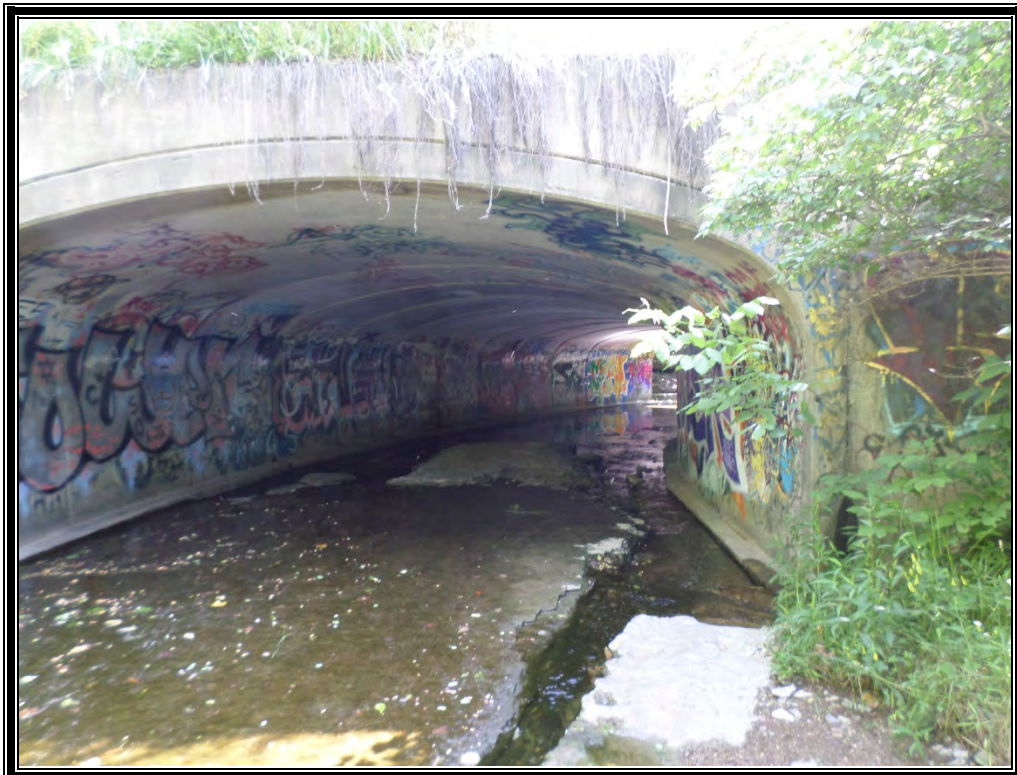
Photo 4 (6/14/16): Easterly view along Roberts Millikin Ditch and the culvert beneath Dublin Road. This photo is from off-site, west of Dublin Road.

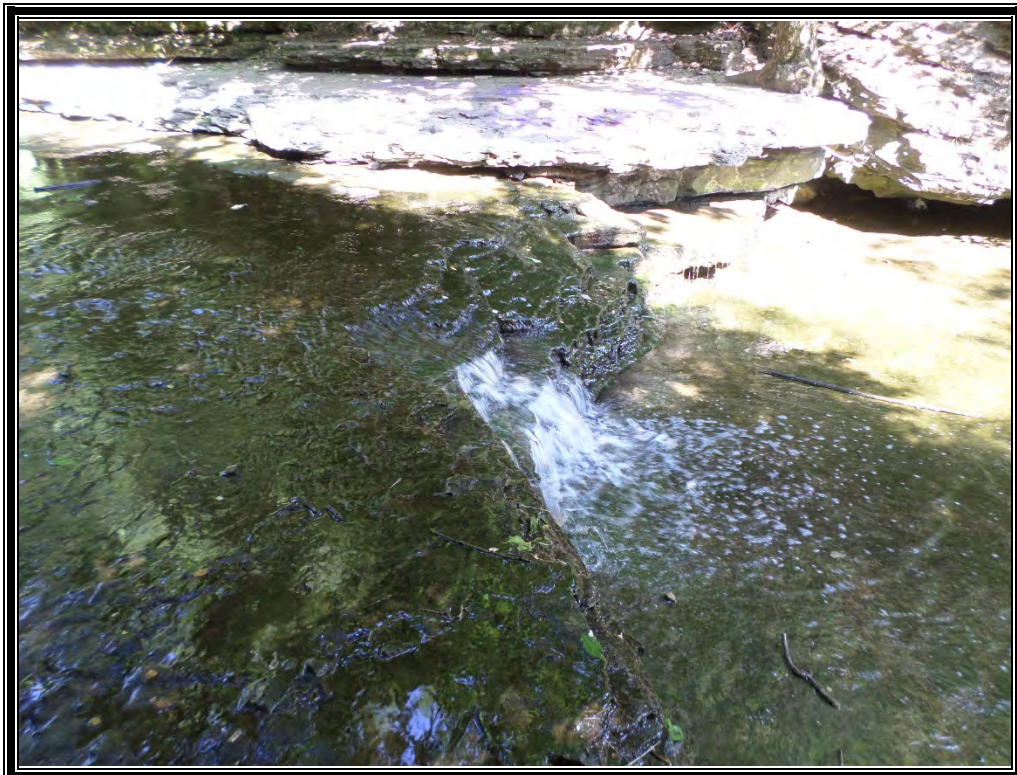
Photo 8 (6/14/16): View of the flow of water just before the quarried rock face.

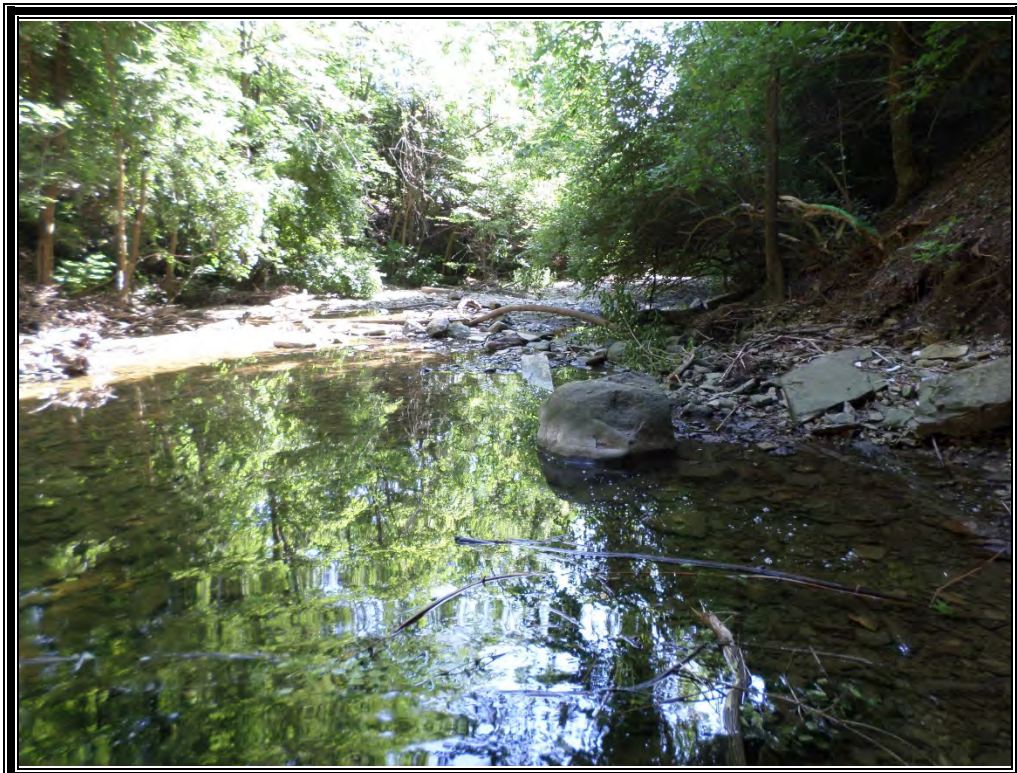
Photo 12 (6/14/16): Easterly view along the drainage exiting the plunge pool beneath the waterfall.

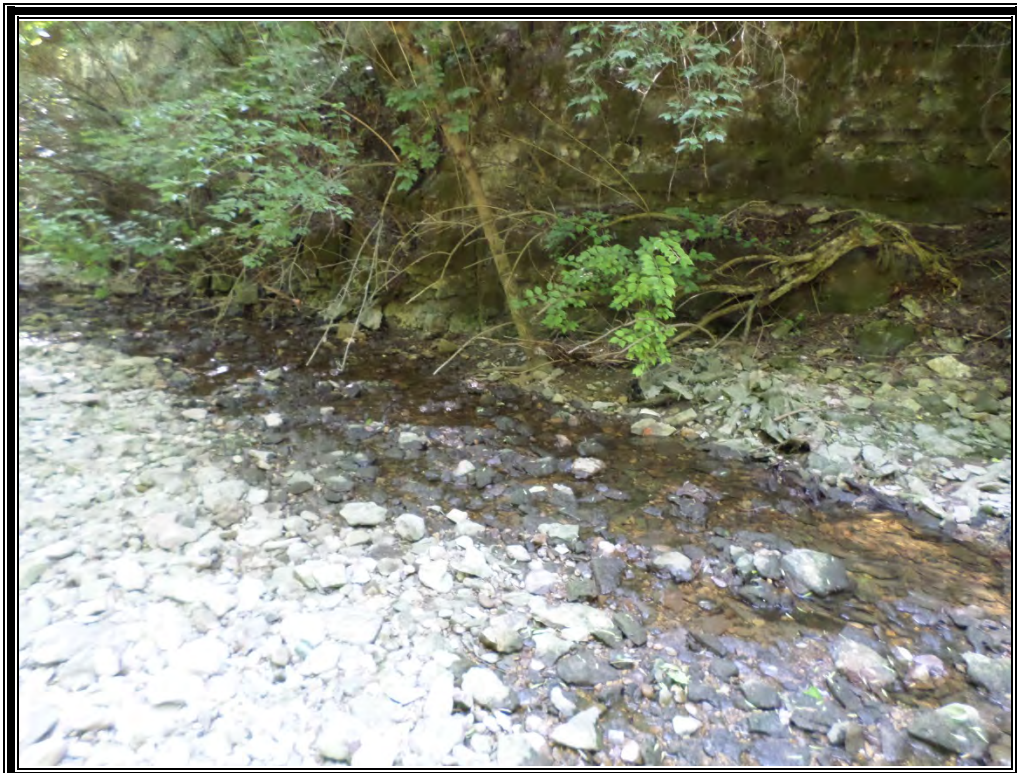
Photo 14 (6/14/16): View of surface water drainage just east of the plunge pool. The drainage is limited to a 2-3 feet wide area at this point.

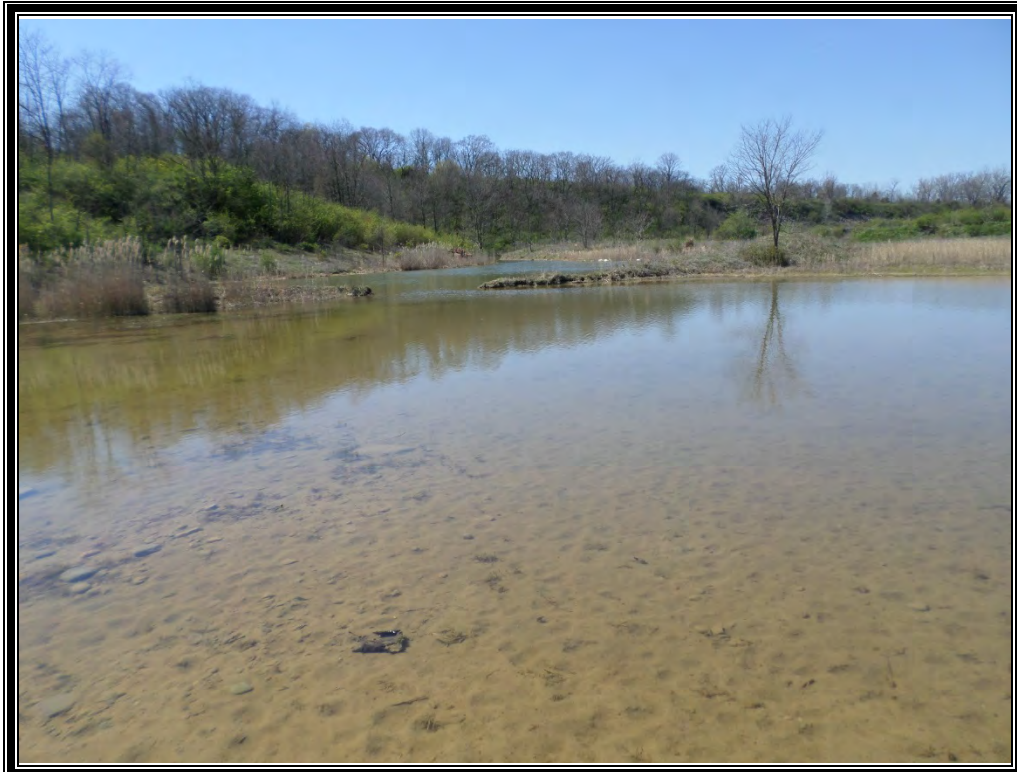
Photo 43 (4/15/16): Northwesterly view across shallow water areas on the west central portion of the property. These shallow water areas were considered the southwestern portion of Pond #1.
