City of Columbus  
**Olde North Columbus  
Traffic Management Plan**  
*Final Report*

# **OLDE NORTH COLUMBUS TRAFFIC MANAGEMENT PLAN**

## **Final Report**

Prepared By:  
**City of Columbus**  
**Department of Public Service**  
**Division of Transportation**  
**Planning Services Section**  
109 N. Front Street  
Columbus, Ohio 43215  
Phone: 614.645.8376  
Fax: 614.645.7921

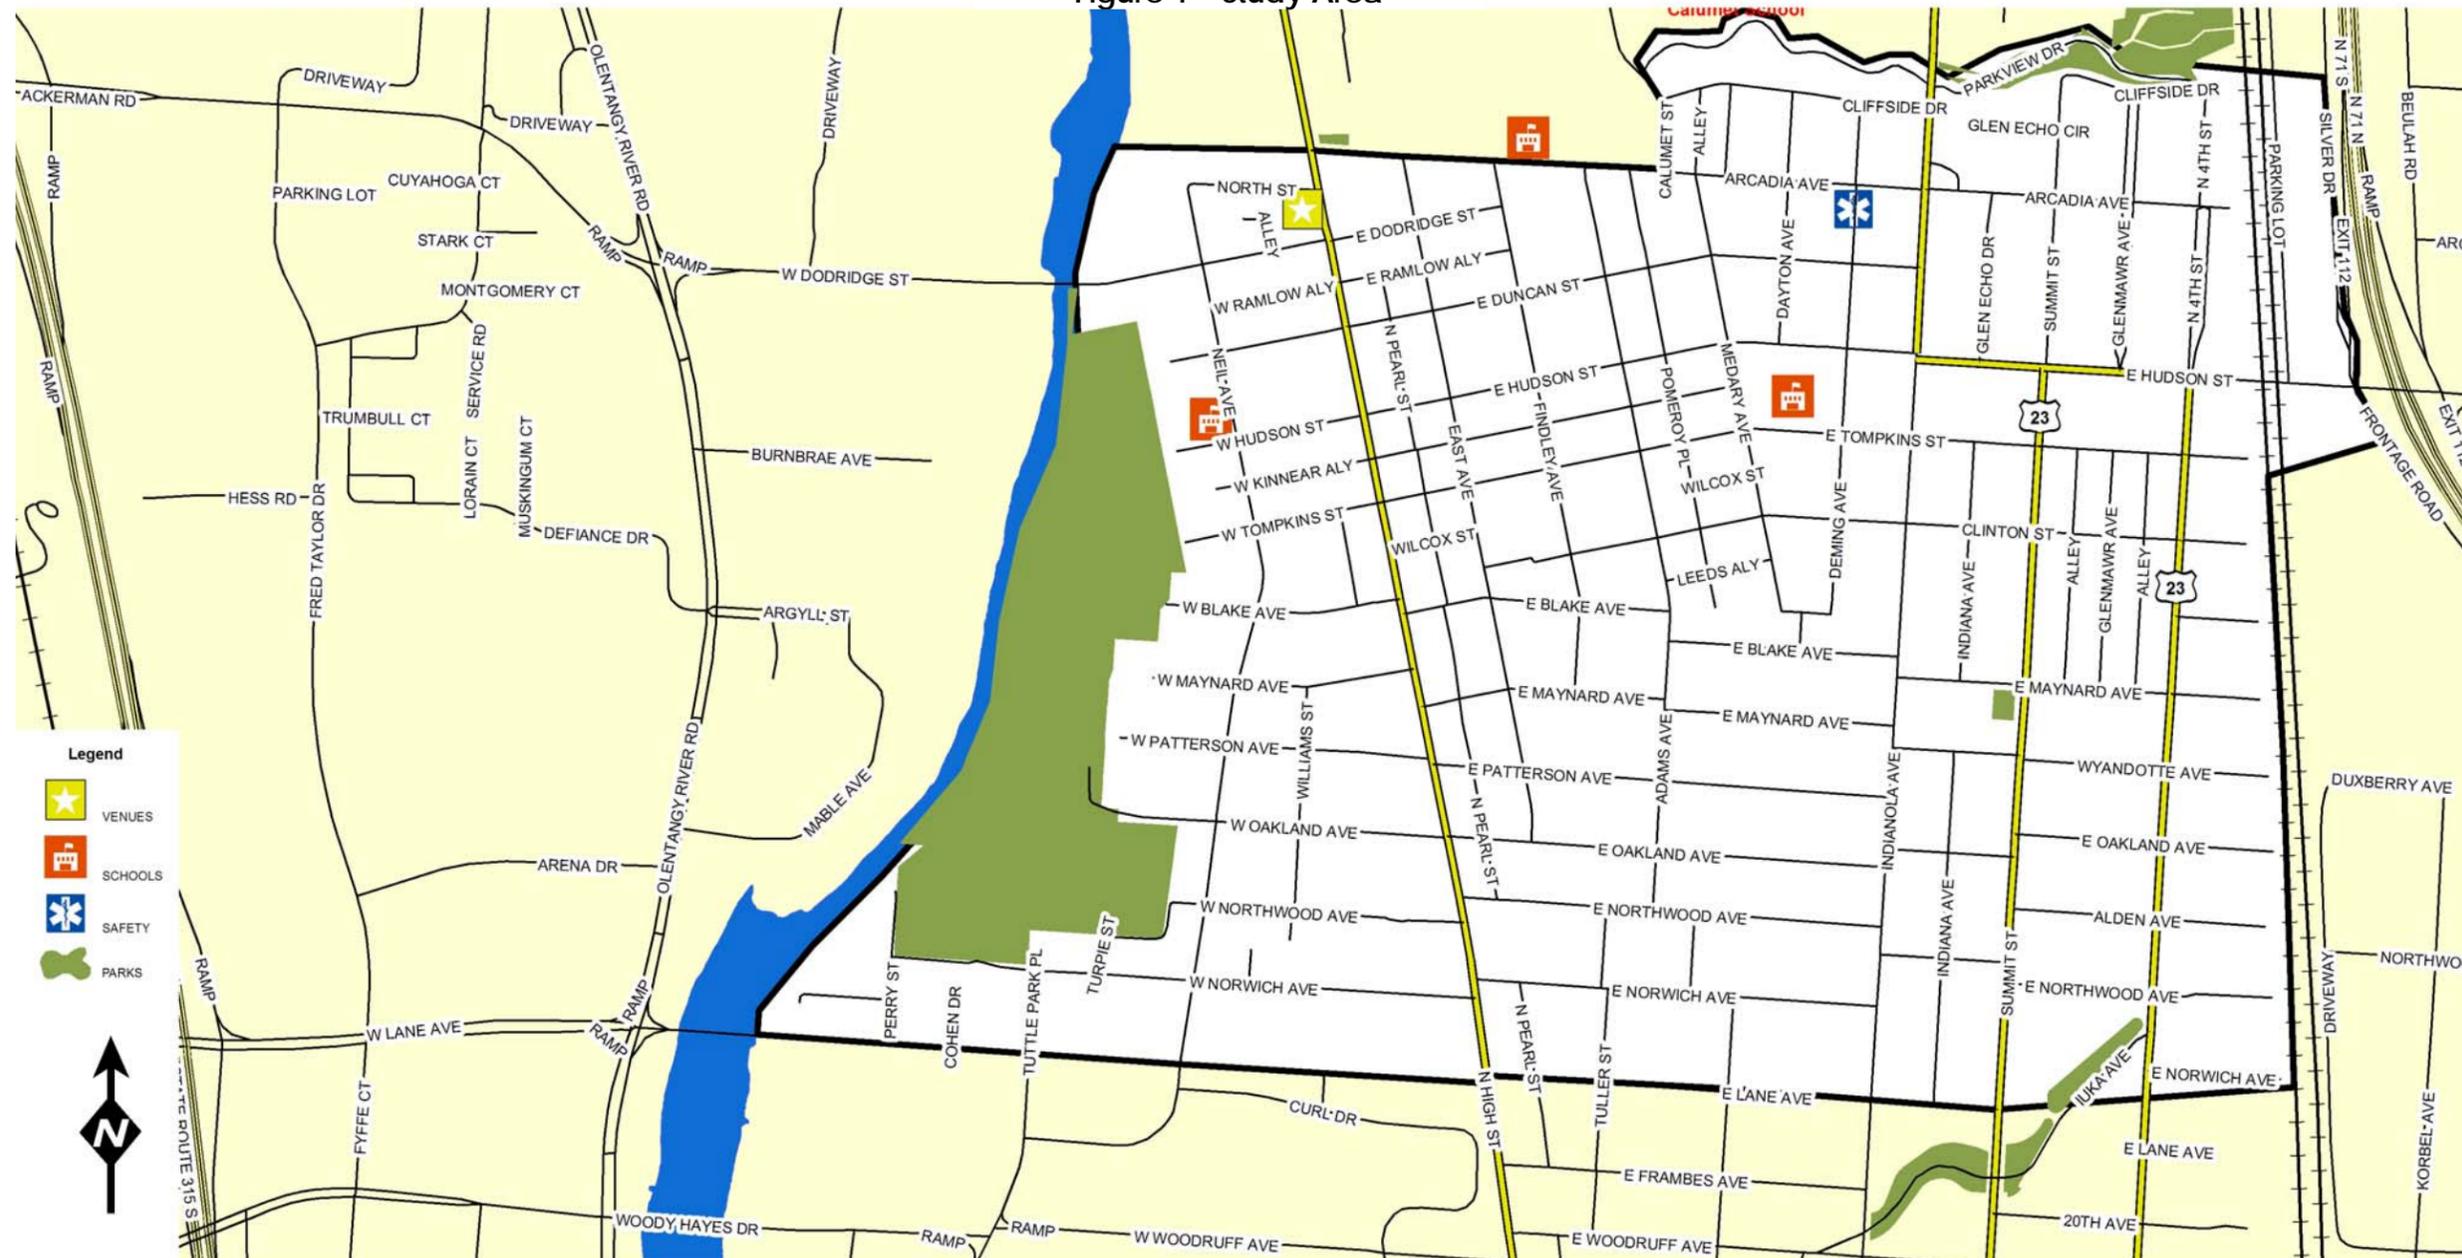
Figure 1 - Study Area

The study area limits were determined in a meeting held between division staff and community leadership representing Olde North Columbus as well as the Findley Avenue Community Watch Collaborative and the Northwood Park Homeowners Association. The study area is highlighted in white in **Figure 1** on the next page. The general project area is bound by the Olentangy River on the west, I-71 on the east, Glen Echo Ravine on the north and Lane Avenue on the south.

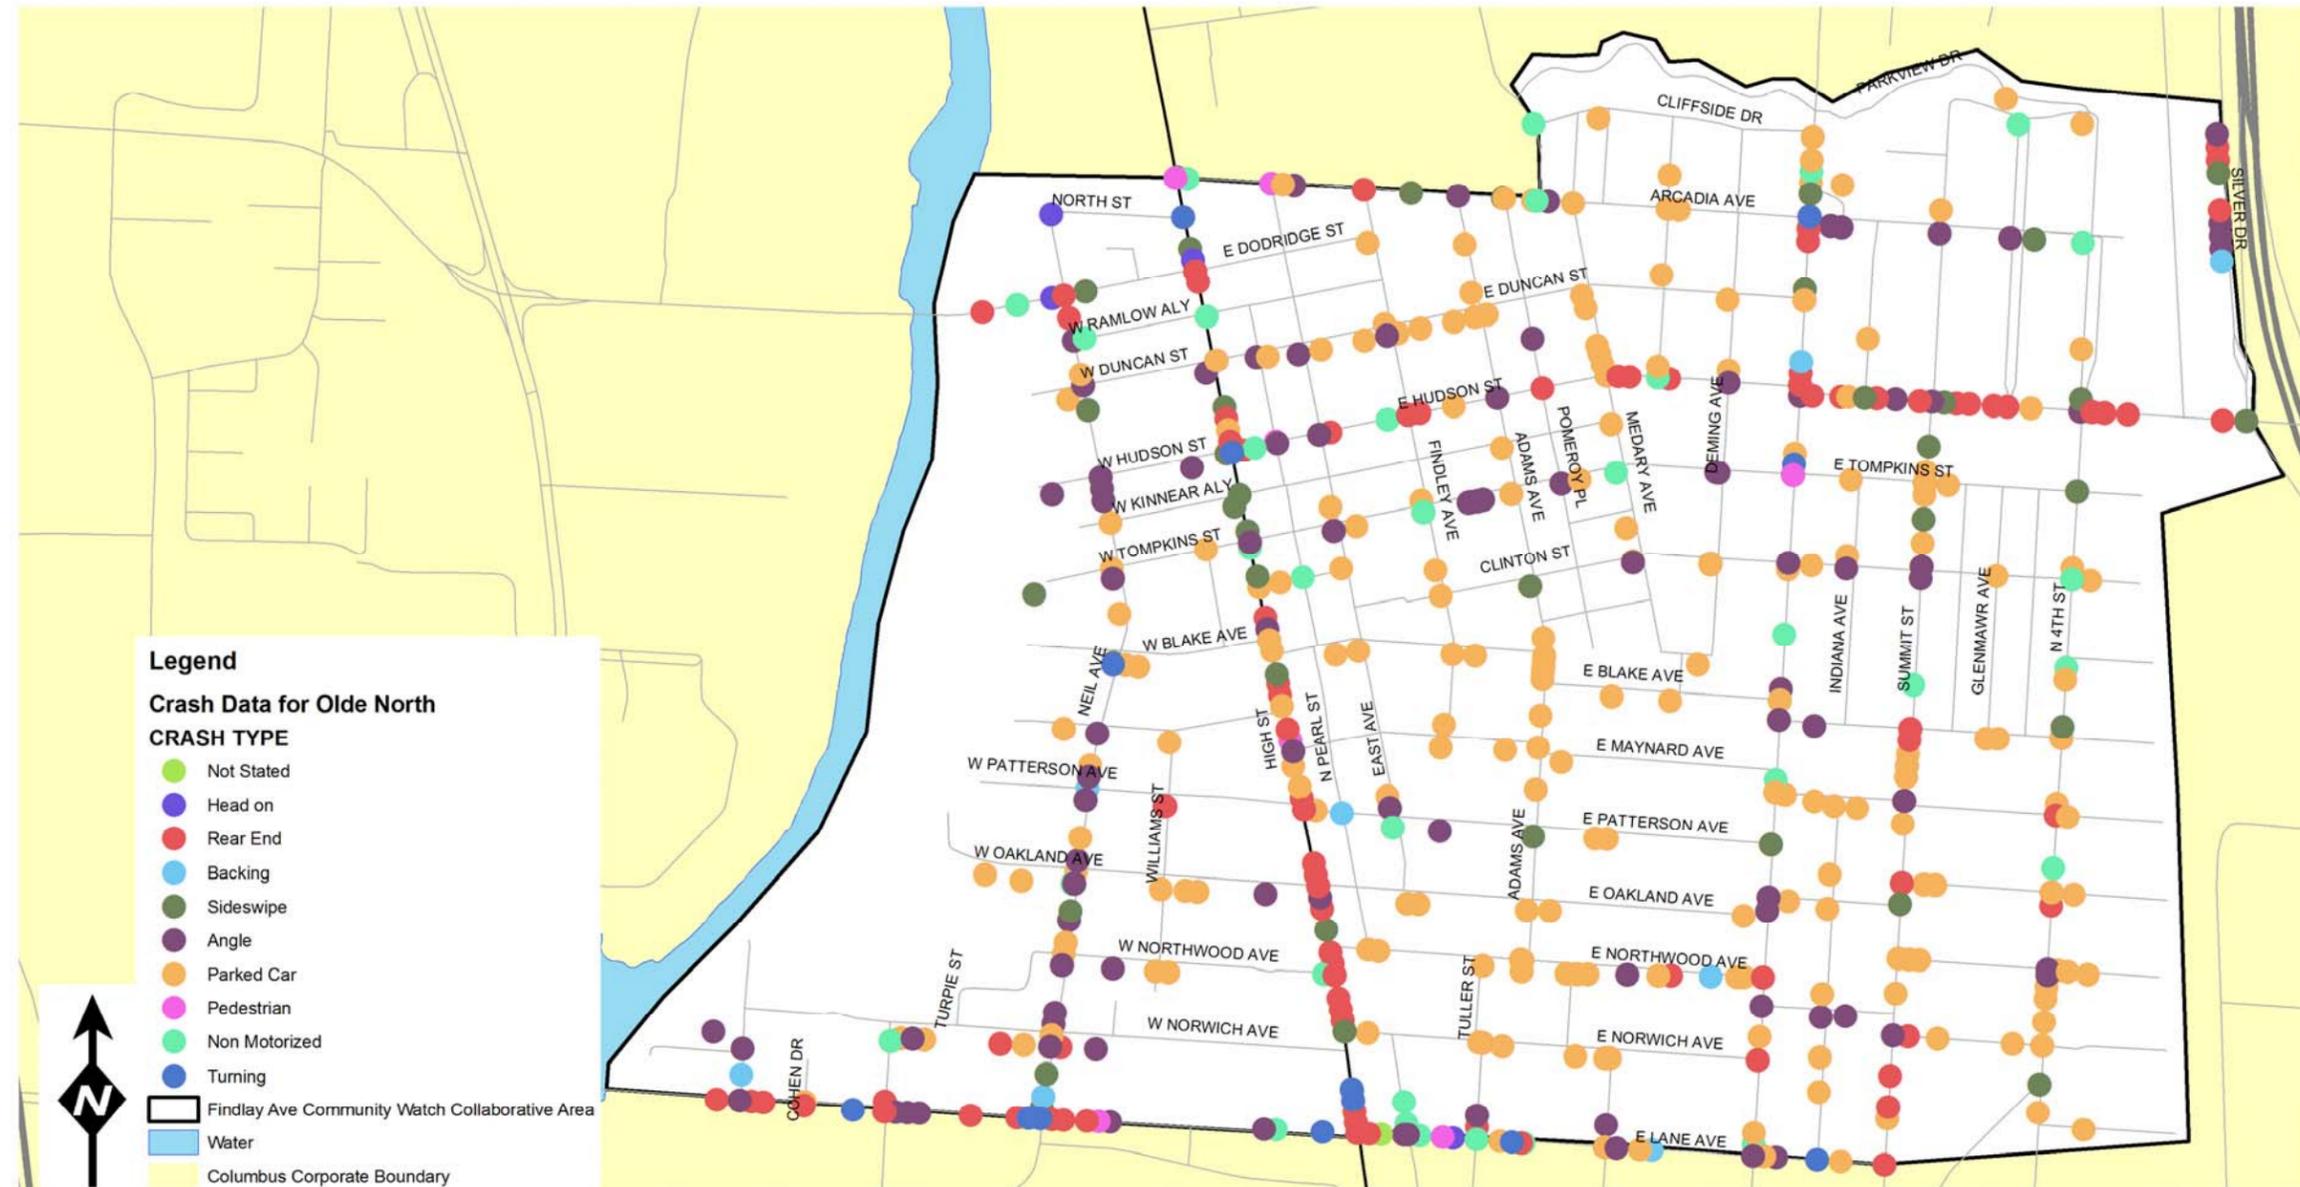
Figure 3 Vehicle Crashes - 3yr History

Vehicle crash data from the three years including 2004, 2005 and 2006 has been analyzed by City staff and plotted on a GIS map for the Olde North area. Crash data obtained from the Columbus Police Division and the Ohio Department of Public Safety can be found in **Figure 3 Vehicle Crashes**. Three years of Pedestrian crash data is mapped in **Figure 4 Map of Pedestrian Crashes**. Fortunately, no pedestrian fatalities were reported during this period.

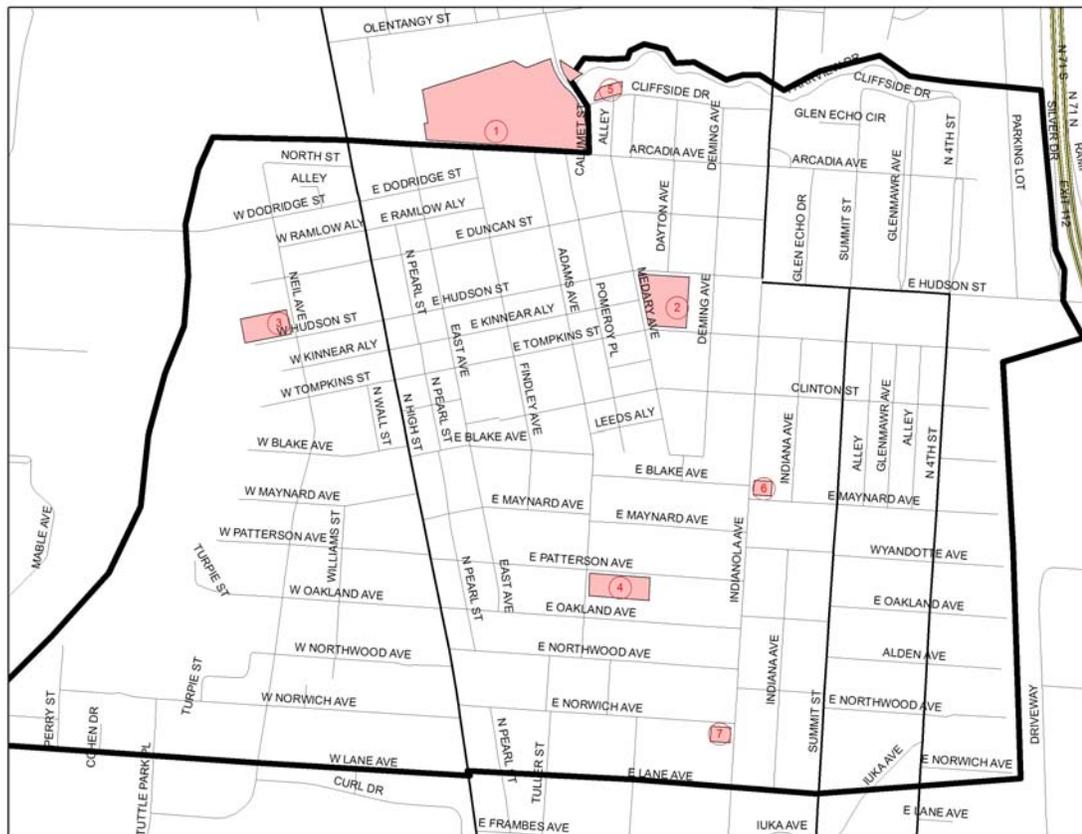
Figure 5 – School Locations

There are three school facilities in the Olde North area and are documented on Figure 5 – School Locations. None of these operate as a traditional elementary, middle or high school. Medary Elementary School has closed and now is operated as a Helping Hands Center for children with autism. The former North High School now operates as a Welcome Center for the English as a Second Language program. It will however become a new school in spring of 2009. The Neil Ave Center is used as offices for staff that deals with students that have various types of disabilities.

Label	School	Status
1	North High ESL Welcome Center	Open – Swing school for East H.S.
2	Helping Hands Center	Open
3	Neil Ave Center	Special Education Services
4	Catholic Latino Center	Open
5	Glen Echo Presbyterian Day Care	Open
6	Maynard Ave UMC after school program	Open
7	Tree of Life Christian School	Open

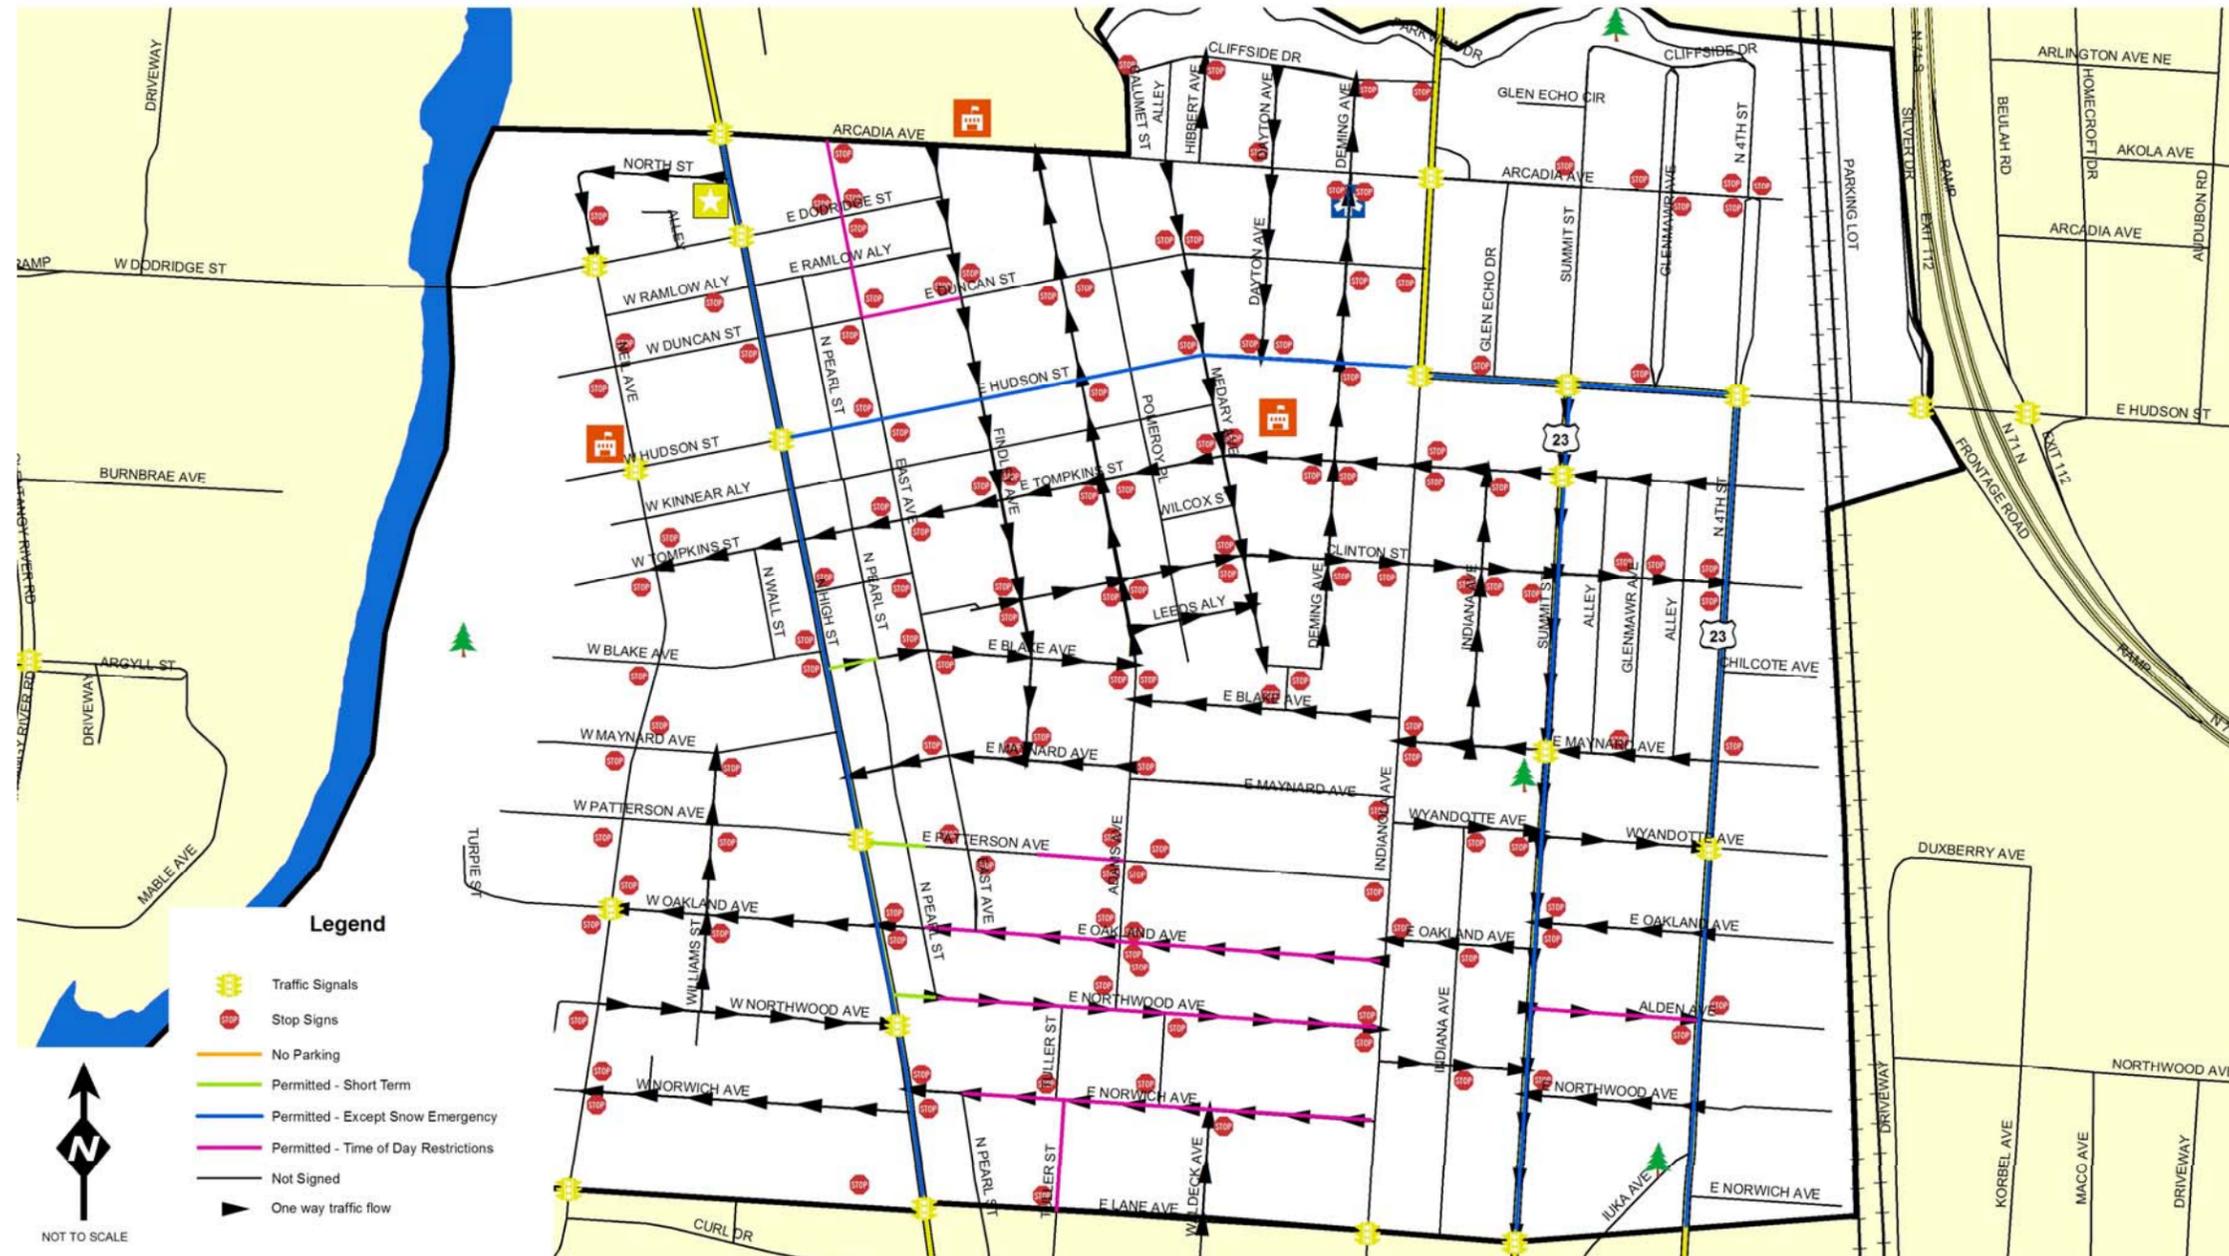
Figure 8 Roadway Inventory

Roadway inventories were performed by division staff through field visits and records review. Aerial photography was used to supplement field inventory efforts. Table 6 summarizes the items inventoried, as well as the parameters attributed to each item. All inventory items have been included with GIS mapping.

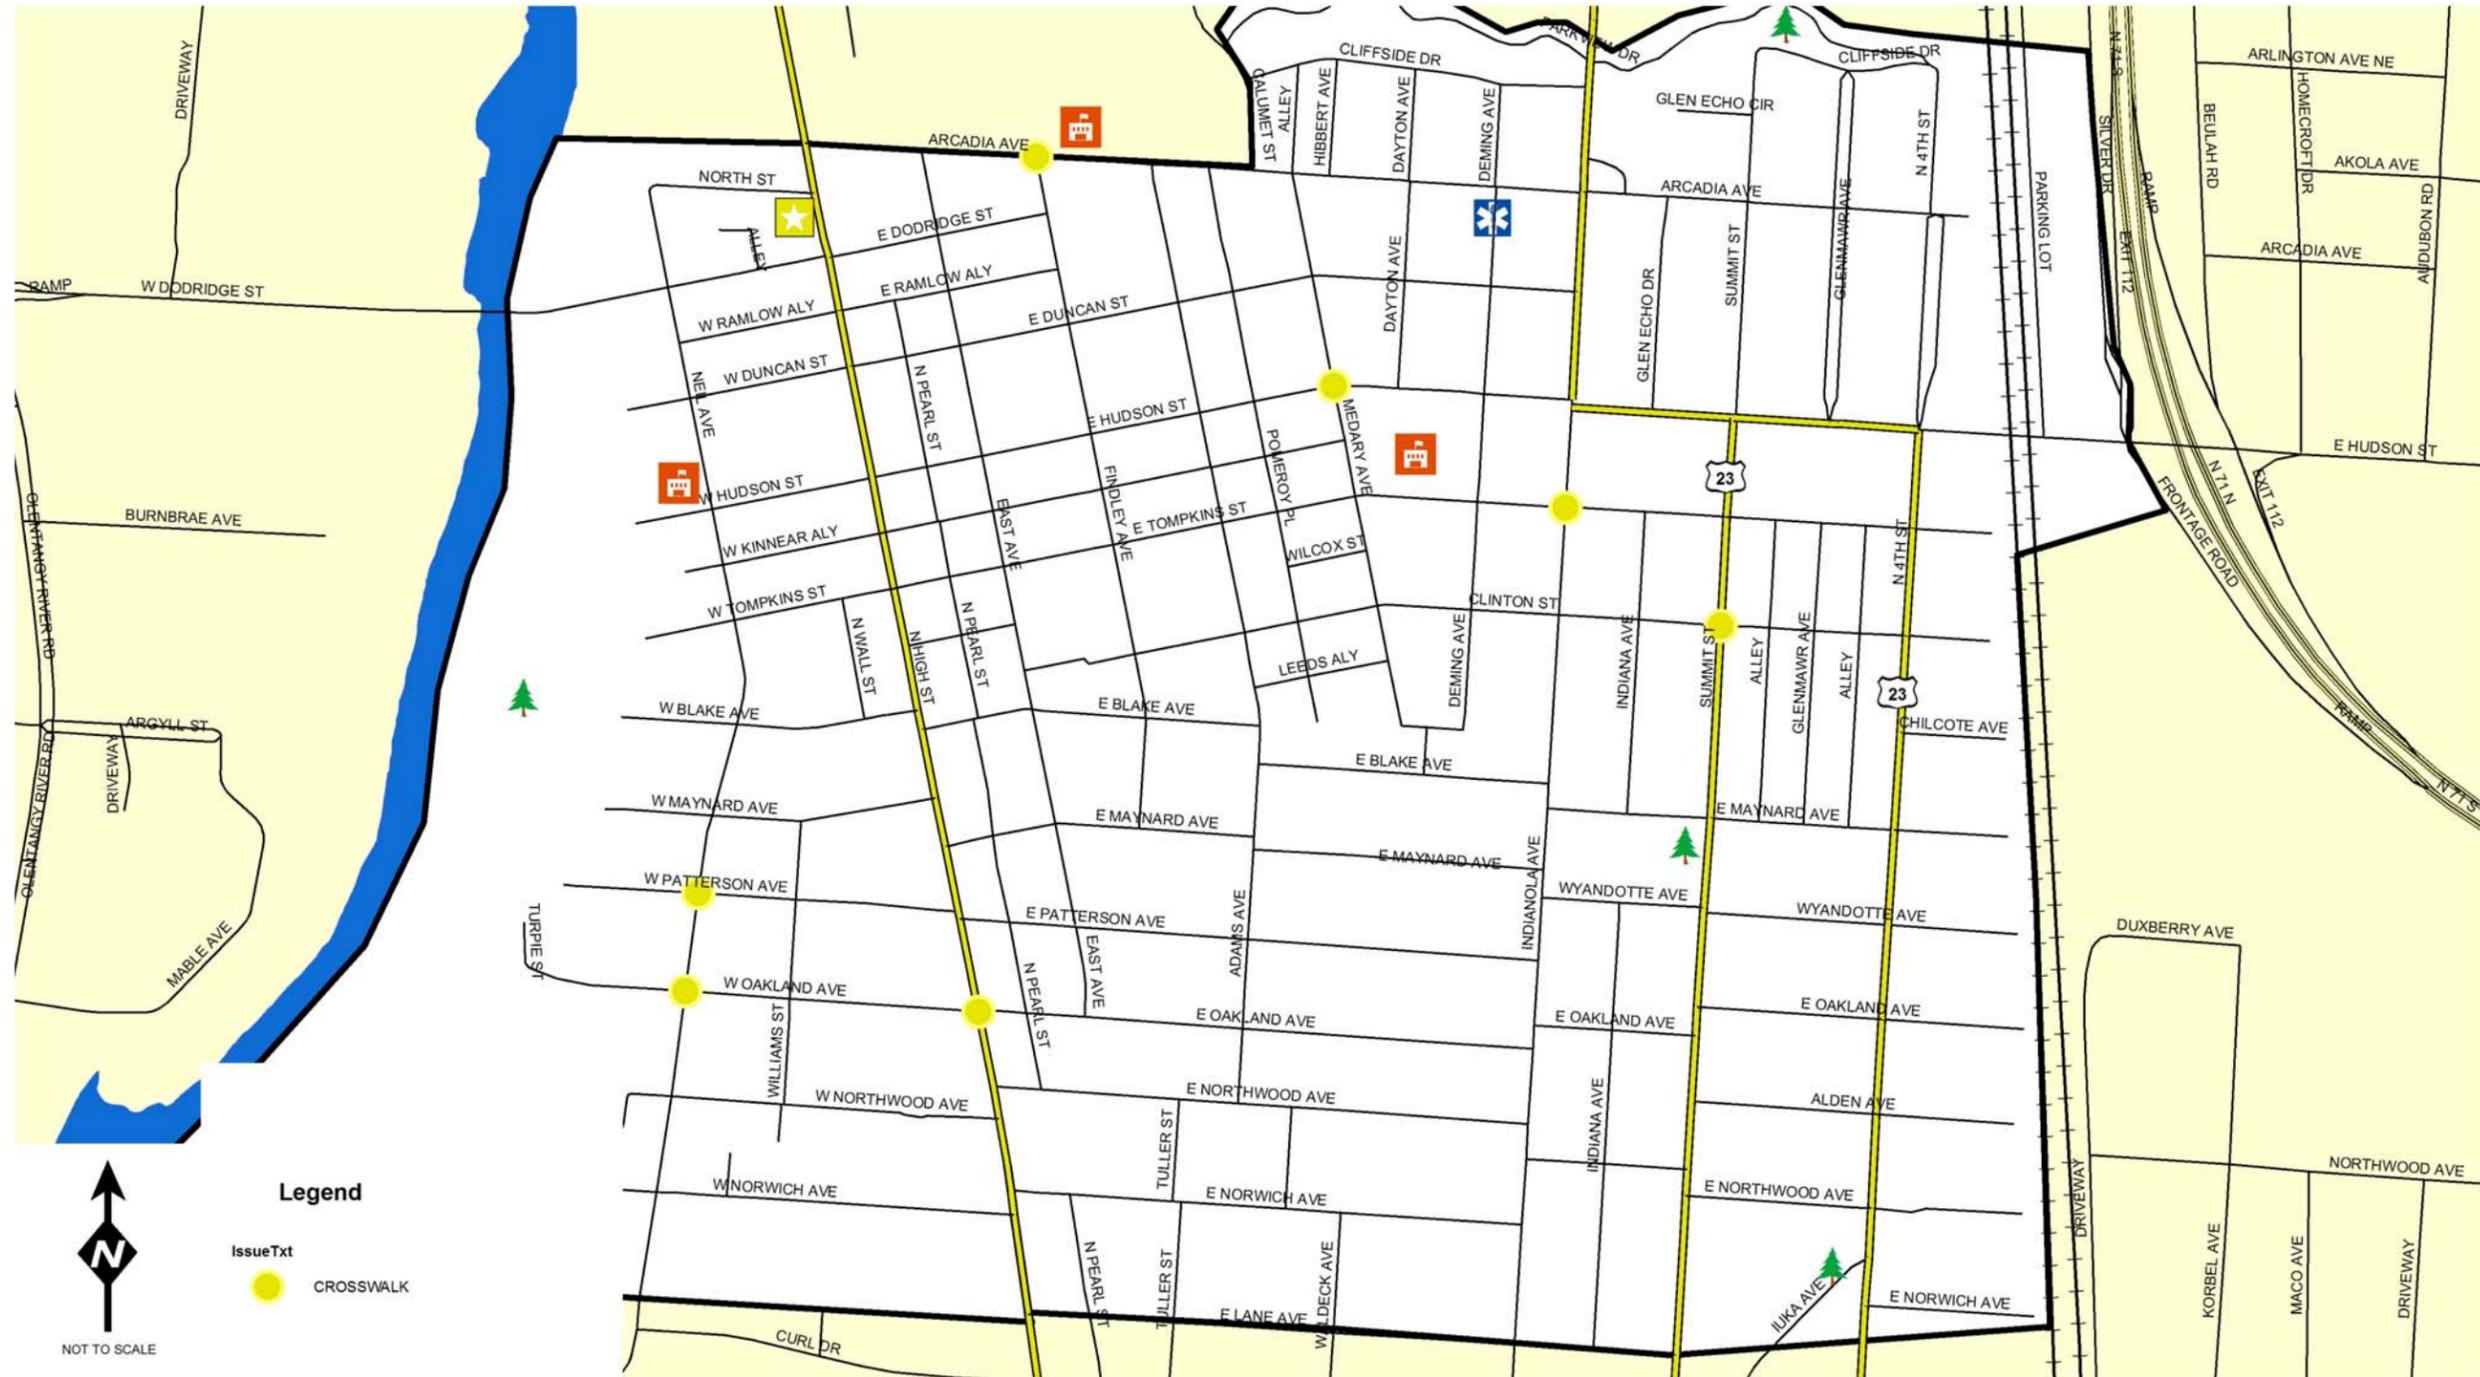
Figure 9 - Marked Crosswalk Locations as Requested

Engineering analysis is used to determine the appropriate treatment.

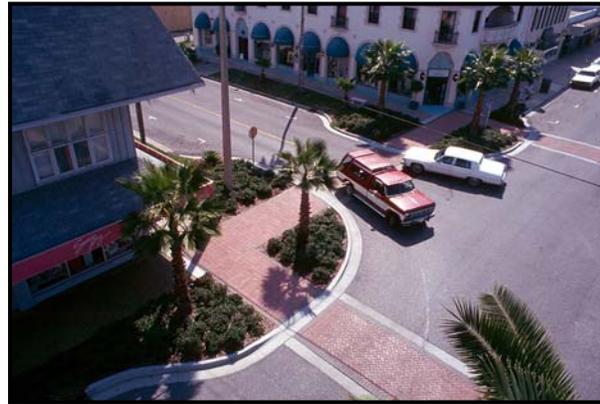
Curb extensions essentially move the curb line into the existing roadway, narrowing the total street width at intersections or at mid block locations. They reduce the total width of the street that must be crossed and constrain vehicle travel to appropriate lane width at intersections. If parking is permitted along a street, curb extensions define the parking lane by inseting parking

areas between intersections. The narrower traveled portion of the roadway remaining after curb extensions are installed is more accessible to pedestrians and helps to control speed. Extensions can be applied at intersections or mid-block locations. Curb extensions may improve lines of sight and reduce illegal parking. Placed on one side of a street, they can also create a chicane effect to deflect the vehicle path and slow travel speeds.

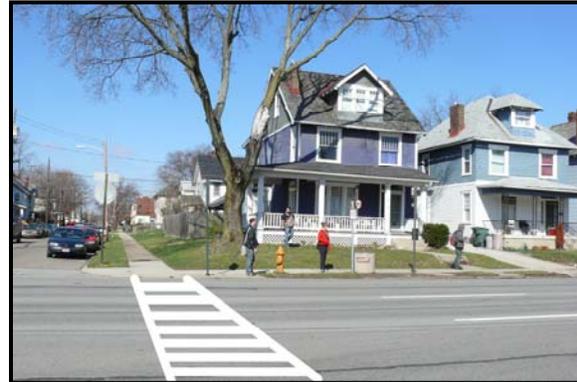
This location is not currently marked and requires pedestrians to cross 3 lanes of vehicular traffic. Approximately 9000 vehicles pass the crossing location on Summit Street each day. During the field visit, a pedestrian count was performed resulting in 20 pedestrians in one hour which meets the minimum criteria for a marked crosswalk. Additional considerations for marking this crosswalk include: presence of ADA ramps as well as the distance from Hudson St. which is over 700 ft. This distance gives drivers more time to focus on pedestrians than the turning movement from Hudson to Summit.

Photo: Clinton St at Summit St showing proposed striping

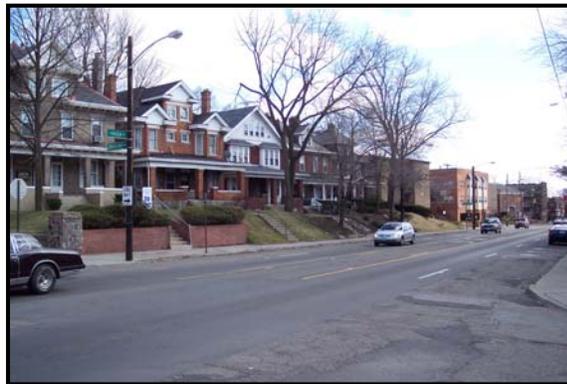
Photo: Crosswalk at Tompkins St and Indianola Ave

A crosswalk was requested at this location, primarily because of several businesses located near the intersection. High Street has 29,500 vehicles per day. A pedestrian count was performed and found only 2 pedestrians in an hour, well below the 20 minimum recommended. As well, a review of pedestrian crashes did not reveal a crash issue that could potentially be solved by a marked crosswalk. In addition, pedestrian crash risk may be

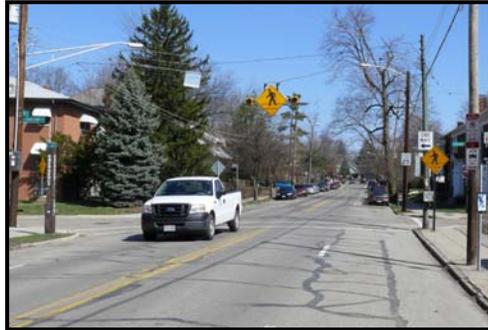
Photo: Neil Ave facing north

This location is on Neil Ave just north of OSU campus. It is used by pedestrians and bicyclists to access Tuttle Park. The speed limit, like many arterials is 35 mph Neil Ave in this location has a volume of over 6000 vehicles per day. Unlike other locations, sight distance is fairly good at this location. There are also sidewalks that provide access to Tuttle Park.

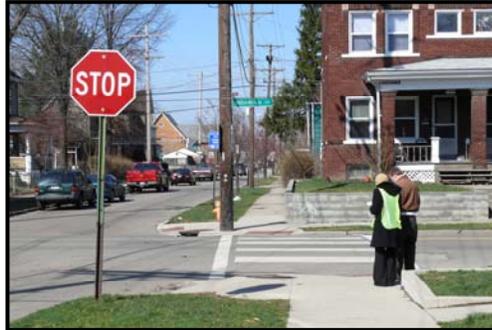
Photo: Crosswalk at Tompkins and Indianola

This location had previously been marked due to proximity to Medary Elementary School (now the Helping Hands Center school for children with developmental disabilities). Indianola has a speed limit of 30 mph but 85% of vehicles travel at 34 mph or less. Pedestrians only have to cross 2 lanes of traffic compared to 5 on High St but sight distance can be a problem when many cars are parked on the street. The traffic volume on Indianola is nearly 8000 vehicles per day.

The resource, “Safety Effects of Marked vs. Unmarked Crosswalks at Uncontrolled Locations” considers the existing markings and signage to be an appropriate treatment based on the speed, volume and street width. Therefore, some upgrades are recommended.

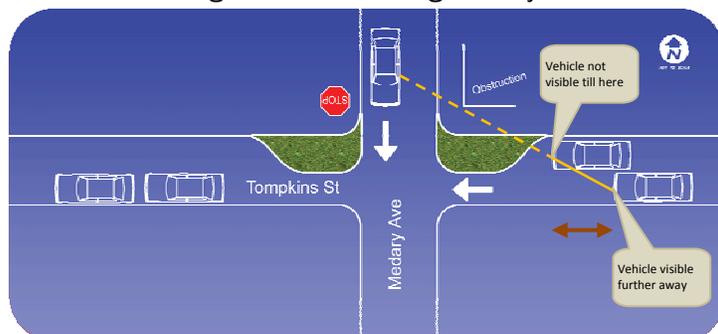
Tompkins St has a posted speed limit of 25 mph, is 20 ft wide, is one-way westbound, and is very heavily parked. The profile of the street generally slopes down from N. 4th St. to High St. There is generally no horizontal curvature but there is a deflection at Medary Ave. There are no stop signs on Tompkins between Indianola Ave. and High St.

Graphic depicting possible curb extension at intersection of Tompkins St with both Medary Ave and Findley Ave

Also at Findley Avenue, vehicles are again travelling along the north curb on Tompkins. This has a similar affect to conditions on Medary Avenue. There is a fence and a house on the northeast corner of this intersection that sit very close to the corner. There are also plants close to that intersection.
