Proposed river corridor immediately after installation:

Proposed river corridor restoration + 5 years

Proposed river corridor restoration + 25 years

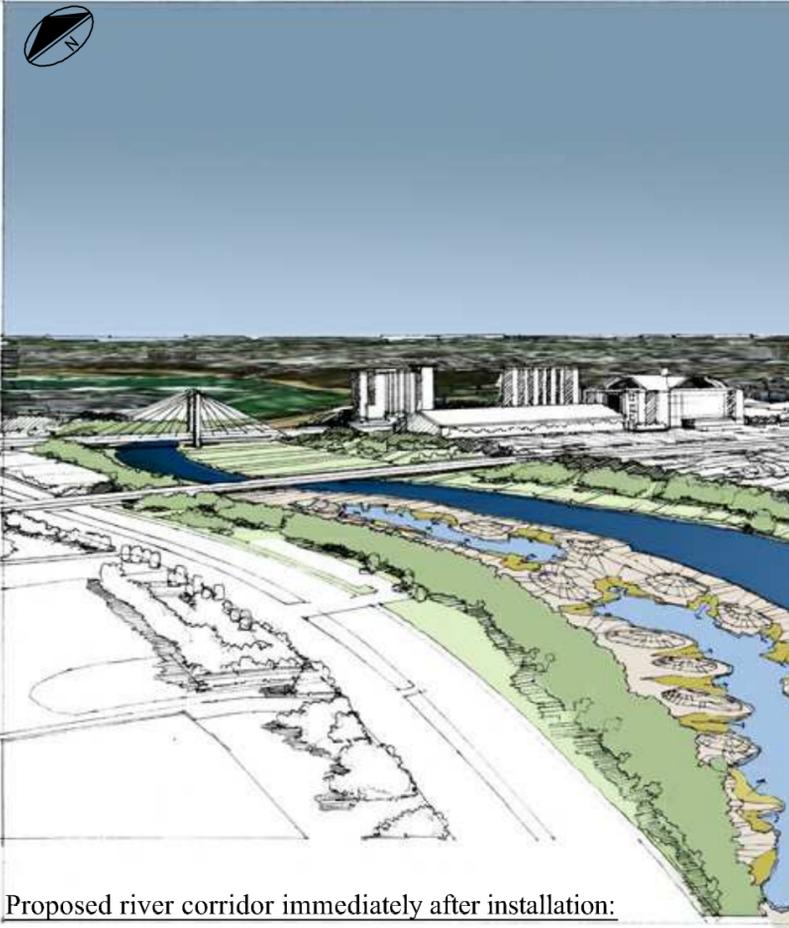
- River banks are secured with live branch layering. Wetland areas are defined.
- Immature plants are installed with room to mature.
- Existing vegetation adjacent the river is largely preserved.

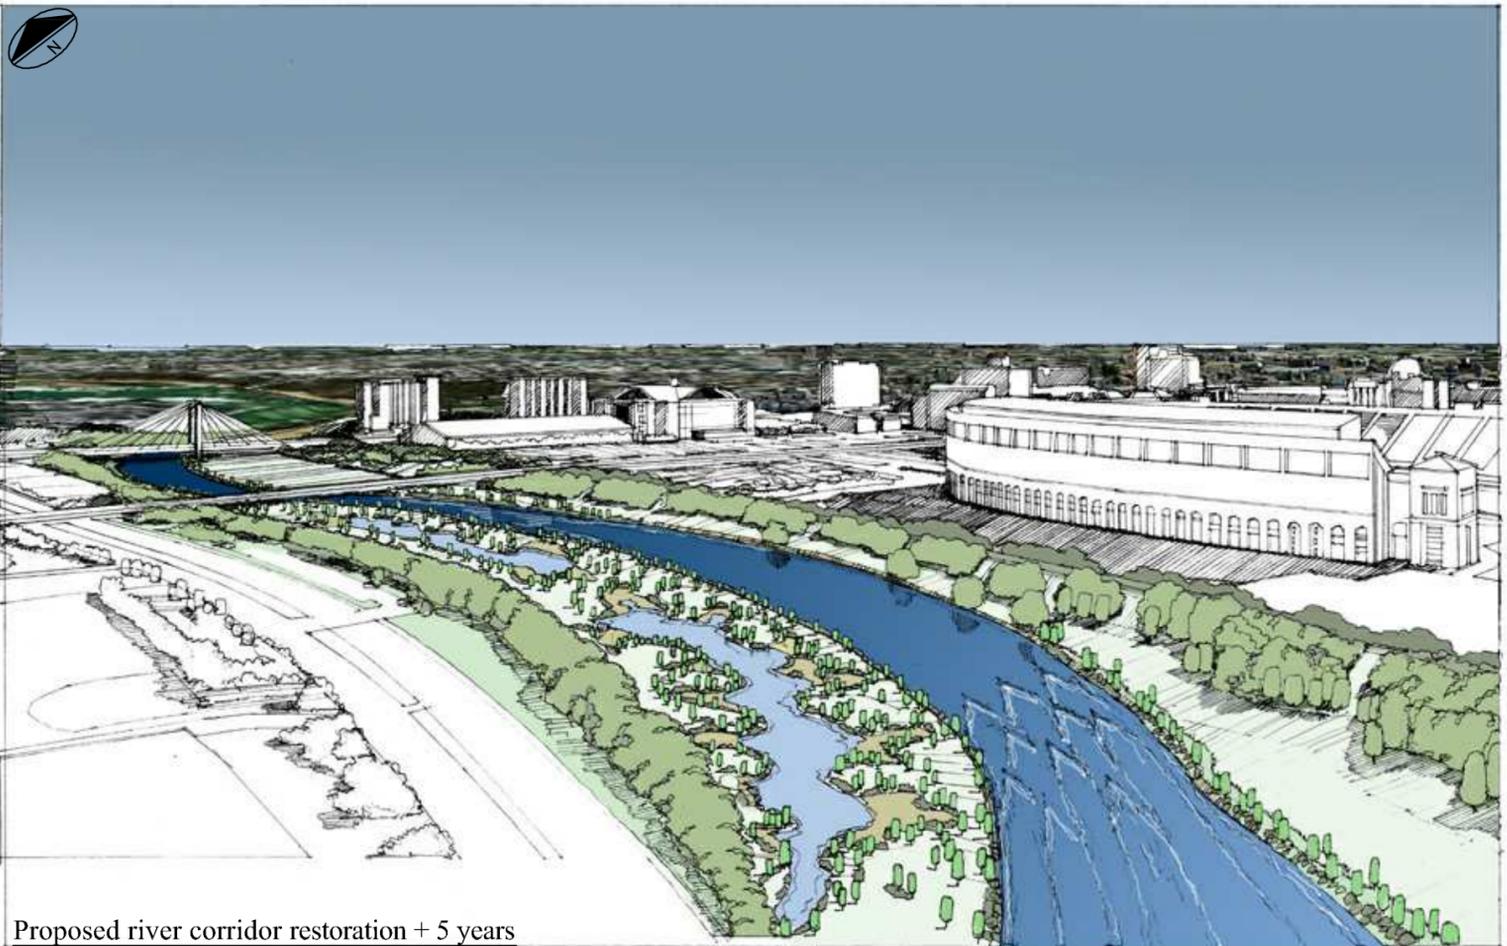
- Native plants at edge of wetlands have matured creating varieties of textures and seasonal colors.
- Understory shrubs are out-competing cover crops and starting to form mature masses.
- Open water areas are defined and providing wildlife habitat.
- River bank plantings have matured and look natural.
