IKEA Polaris Tree Preservation and Mitigation Report

15345-272 1900 Ikea Way Columbus, Franklin County, Ohio

January 2016

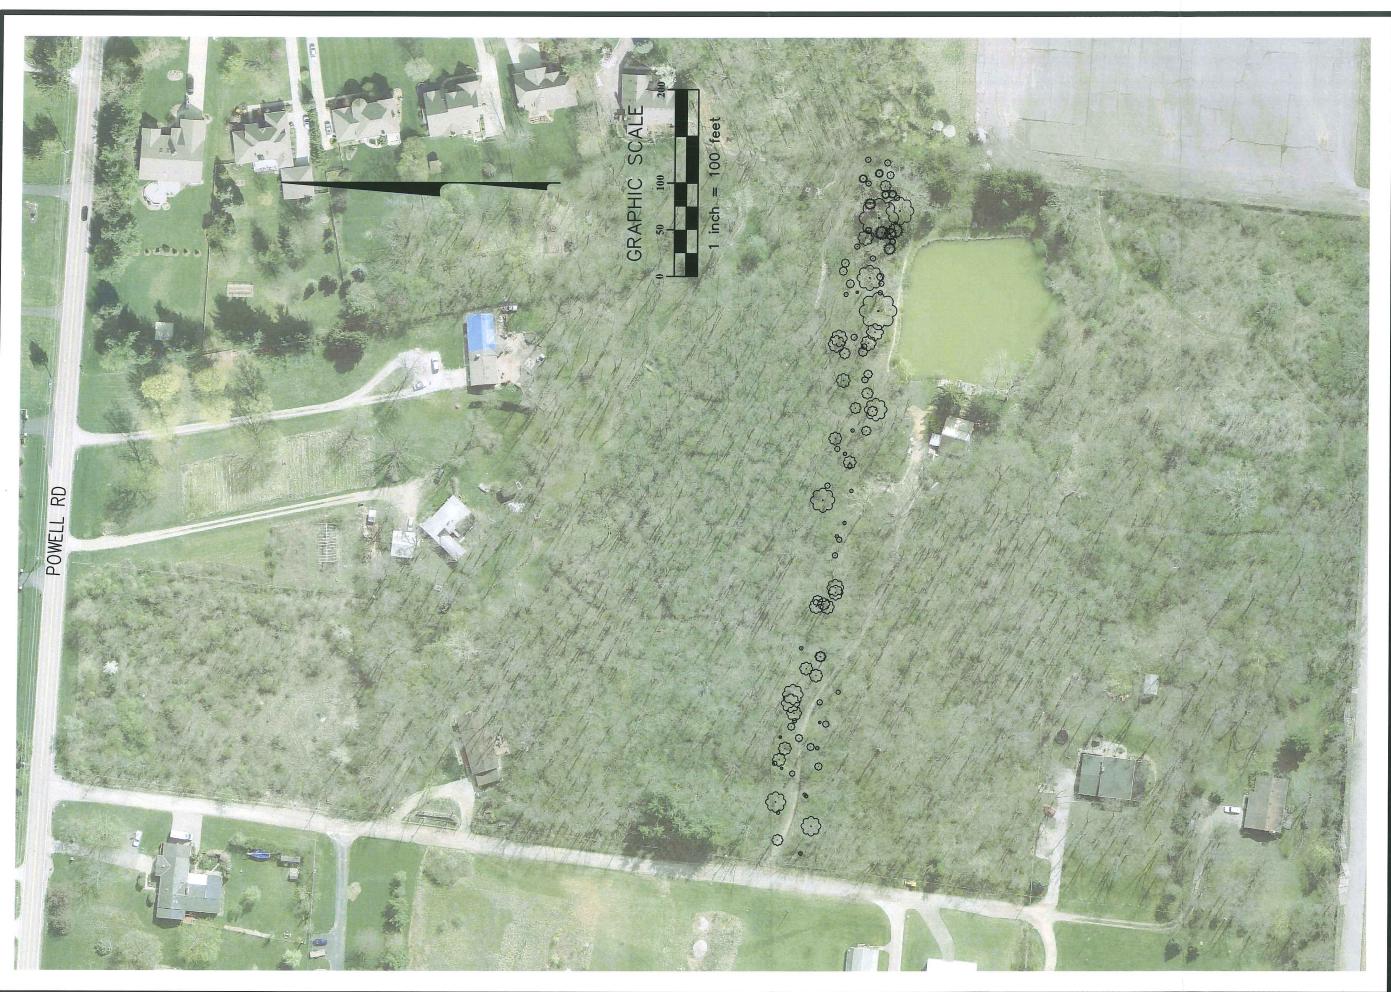
Appendix F Off-Site Mitigation Site Map

DELAWARE COUNTY, OHIO
COLONIAL MEADOWS
TREE INVENTORY EXHIBIT
