VICTORIAN  
VILLAGE  
HANDBOOK

Including Guidelines for Rehabilitation and New Construction

# Victorian Village Commission

Autumn, 1988

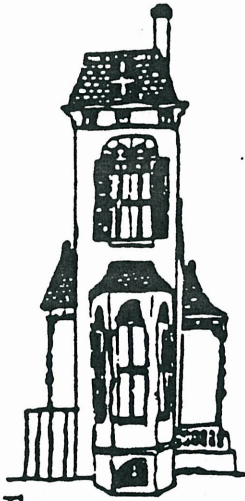
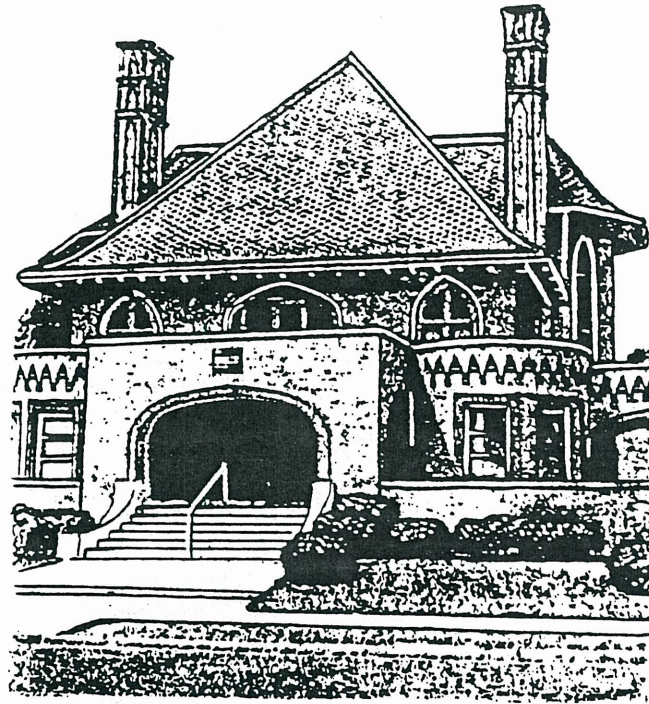
Figure 2

Figure 2: Victorian Gothic house  
at 755 Dennison Avenue.  
Photograph by Greg Miller.

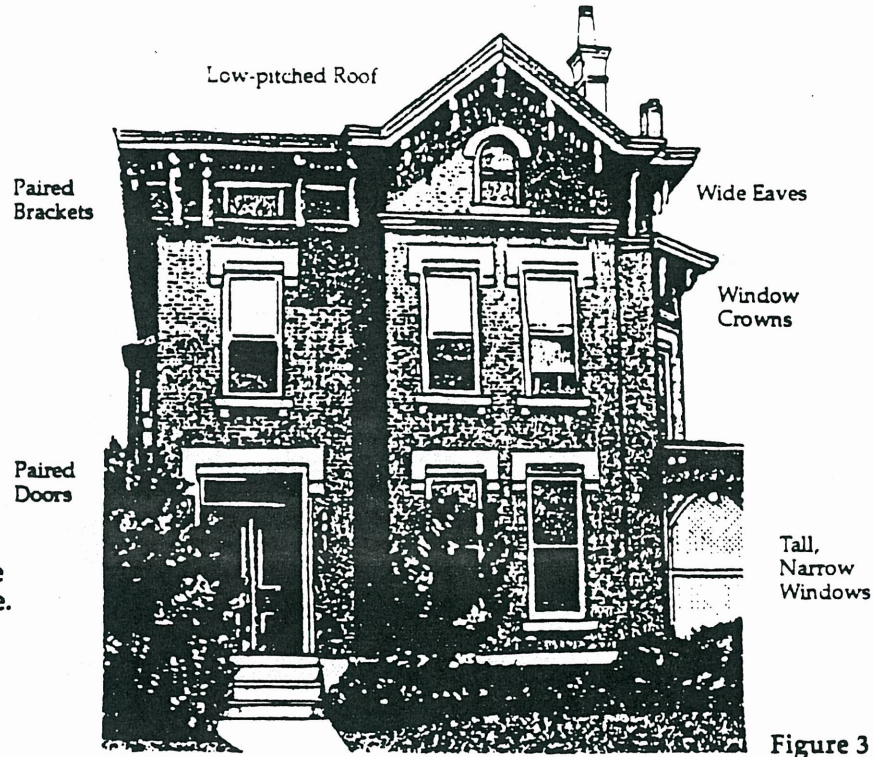
Figure 3

Italianate houses typically are symmetrical, rectangular structures, two or three stories high. Low, hipped roofs with wide eaves supported by large, often paired, brackets contribute to the detailing of this style. Tall, narrow windows, often grouped together, are common, especially on the first story. Windows may have elaborate carved crowns, which may be pedimented, rectangular, or arched. Detailed entrances are common. These often are characterized by paired doors, either rectangular or arched, and small entry porches with beveled wood columns and enframements above doors similar to, but more pronounced than, window crowns. Some Italianate buildings have belt courses between floors and Classical quoins that define corners. Italianate is a common house, rowhouse, and storefront design in Victorian Village.

Figure 3: High Italianate style house at 76 West Starr Avenue. Photograph by Greg Miller.

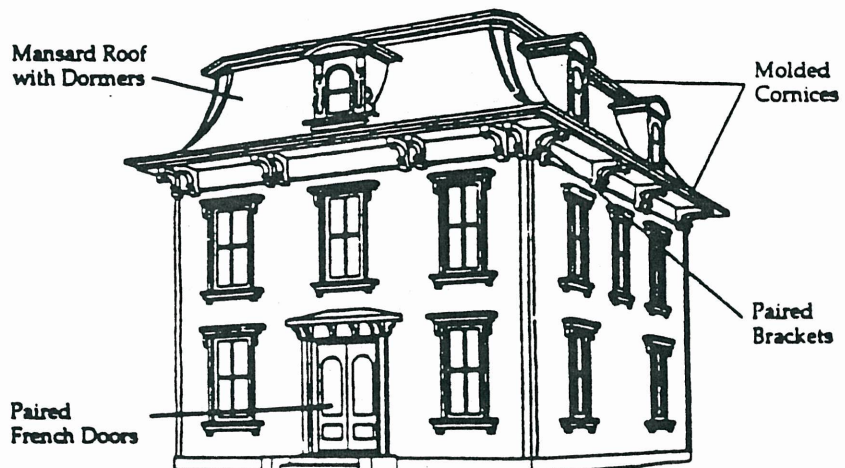
Figure 4

Otherwise, Second Empire buildings are similar in overall shape, mass, and decoration to Italianate structures. They have a strong three-dimensional appearance. Surfaces prominently project and recede. The facade usually is symmetrical. Tall decorated chimneys are common, as are wide cornices with brackets, paired windows, double doors, paired porch columns, belt courses, and Classical pediments. Second Empire influences are seen on several rowhouses in Victorian Village and on a few single-family dwellings.

Figure 4: Second Empire house showing characteristic features. Source: McAlester.

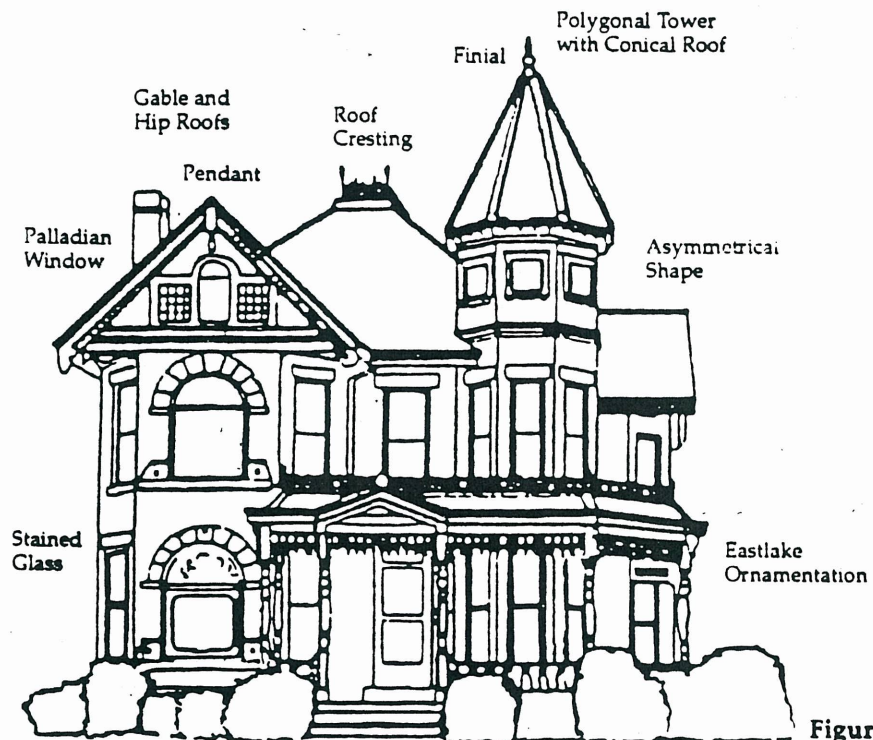
Figure 5

This style is distinctive for its varying textures and colors. For example, brick may be used on one story, shingle on another, and horizontal boards on a third. Yet, the overall facade retains a vertical appearance. A steeply pitched roof, usually with a dominant gable in the front, characterized this style. Queen Anne buildings are asymmetrical and eclectic. "L"-shaped porches that run across the front and one side of Queen Anne houses are common, as is decorative woodwork such as lattice and turned balusters and posts. Queen Anne houses may contain a round or polygonal tower, both gabled and hipped roofs on the same structure, finials and other roof decorations, stained glass windows, often in small squares outlining upper sashes, and stained glass transoms. There are many examples of Queen Anne architecture in Victorian Village. Its descendent, the "Princess Anne" style, is one of the Village's most common house styles.

Figure 5: Queen Anne house with Eastlake ornamentation at 1265 Neil Avenue.

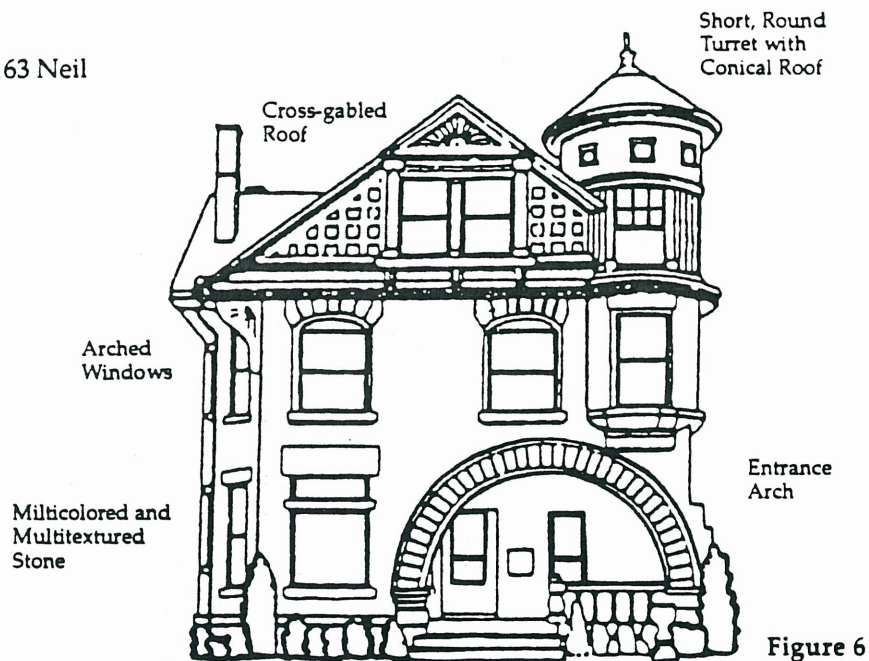
Figure 6

door openings. Most Richardsonian houses have one or more cross gables, sometimes accompanied by a round tower with a conical roof. Richardsonian houses are always made of stone and appear dense, weighty, and permanent. There are relatively few Richardsonian buildings in Victorian Village.

Figure 6: Richardsonian Romanesque house at 1163 Neil Avenue.

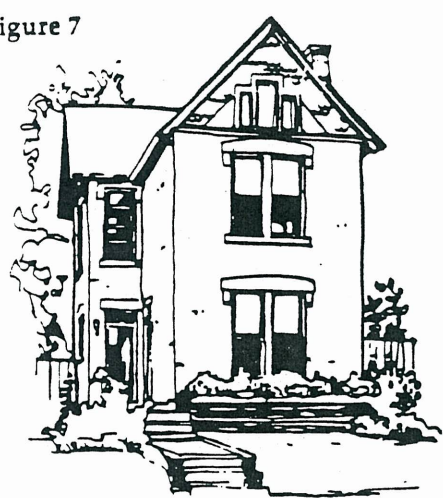
Figure 7

Figure 7: Typical Vernacular Victorian house showing Queen Anne and other influences at 1035 Hunter Avenue. Drawing by Don Slobodien.

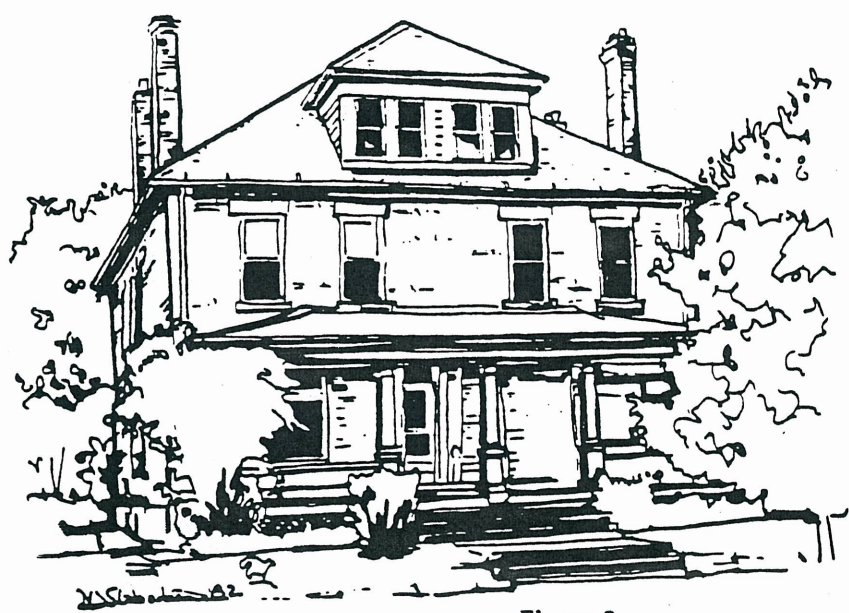
Figure 8

Foursquare houses typically have a nearly square, box-like appearance, flat walls, two full stories capped by a third story containing one or more large dormers (although not more than one per side), low hipped roofs, and a prominent porch that spans all or most of the front of the house. Some porches contain Classical columns, usually with Doric capitals, simple round rails, and no spindles. Others bear Eastlake porch posts and spindles, but little decoration elsewhere on the exterior. Colonial Revival entrance treatments sometimes are seen on these houses in Victorian Village. But, generally, doors and windows are simple. Windows may vary in size and shape; symmetry may occur, but is not required. In Victorian Village, most Foursquare houses are brick.

Figure 8: Foursquare at 1045 Hunter Avenue. Drawing by Don Slobodien.

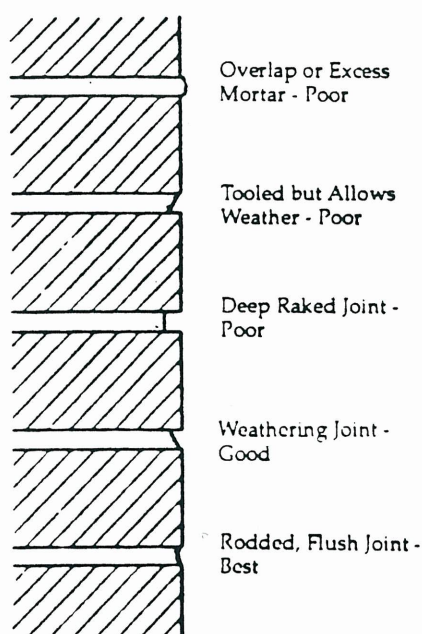
Figure 9

Figure 9: Types of brick joints. Source: Cape May Guidelines.

- a. Careful removal of loose mortar without damaging the edges of the brick. New mortar to match the old in composition, color, and joint profile.
- b. Careful finishing of new joints in order not to make them wider than the old ones. Joints slightly recessed to allow for expansion when the temperature rises.
- c. Replacement bricks that match the original undamaged brick in size, shape, color, and texture.

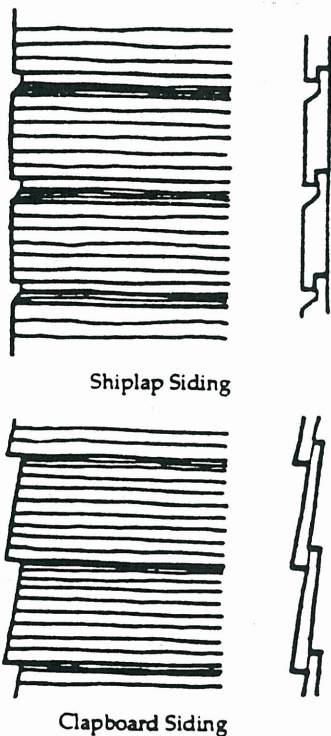
Figure 10

Figure 10: Historic sidings.

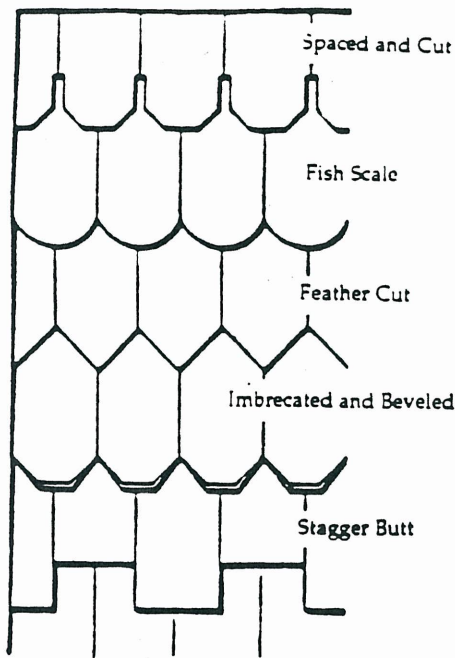
Figure 11

Figure 11: Types of cut wood or artificial siding shingles. Source: Cape May Guidelines.

- d. Restoration of all wooden details such as porch columns and decorative trim rather than covering with aluminum or vinyl.
7. Use of cut wood shingles, or synthetic shingles having the appearance of cut wood shingles, when historically appropriate.

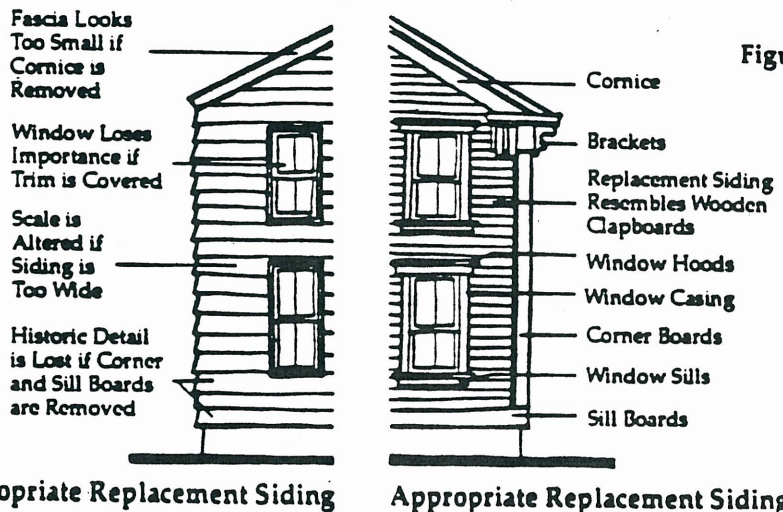
Figure 12

Inappropriate Replacement Siding

Appropriate Replacement Siding

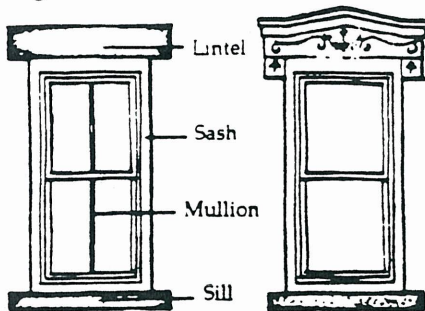
Figure 14

Figure 14: Typical Victorian Village windows.

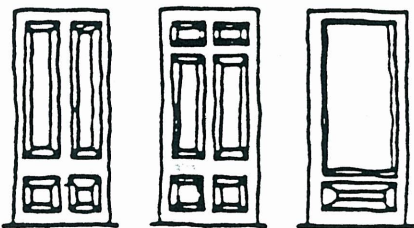
Figure 15

Figure 15: Appropriate doors

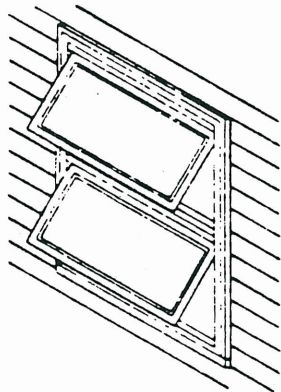
Figure 20

Figure 20: Modern awning type window - not appropriate as replacement. Source: Cape May Guidelines.

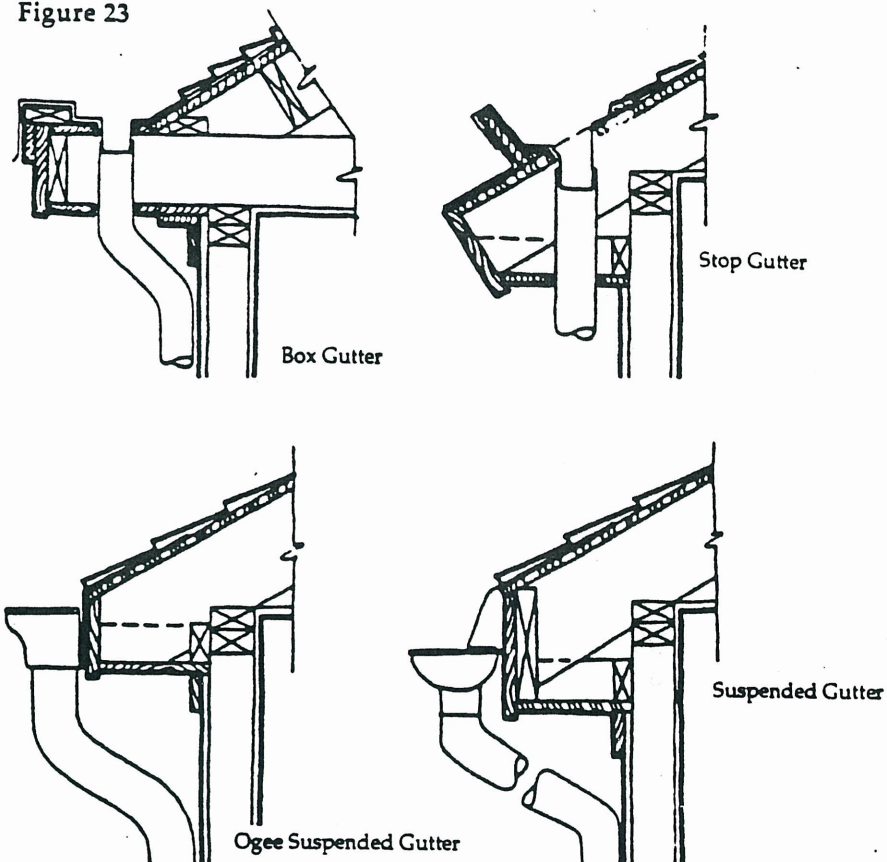
Figure 23

Original gutter types found in Victorian Village include box, stop, and metal half-round gutters. These are often essential design features. Changing the gutter design could irreparably alter the building's historic appearance.

Figure 23: Types of gutters.  
Source: Italian Village Guidelines.

It is possible to line the inside of a box gutter using synthetic rubber material that will help to prolong the life of the gutter. Before relining box gutters, it may be necessary to replace rotted wood and damaged or corroded metal.

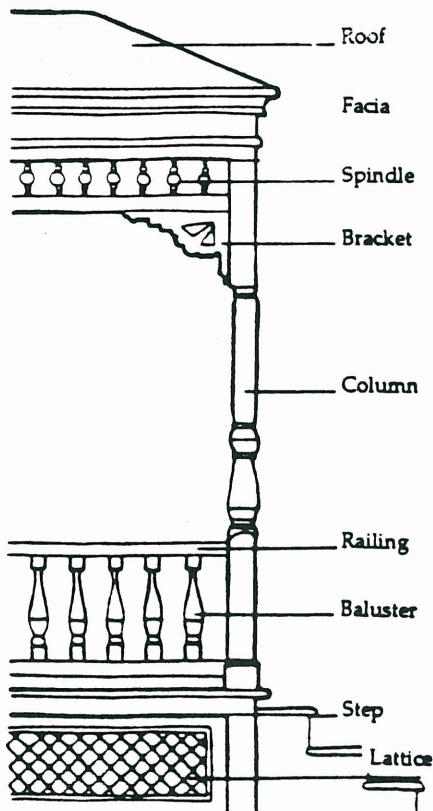
Figure 25

Figure 25: Typical porch elements. Source: Italian Village Guidelines.

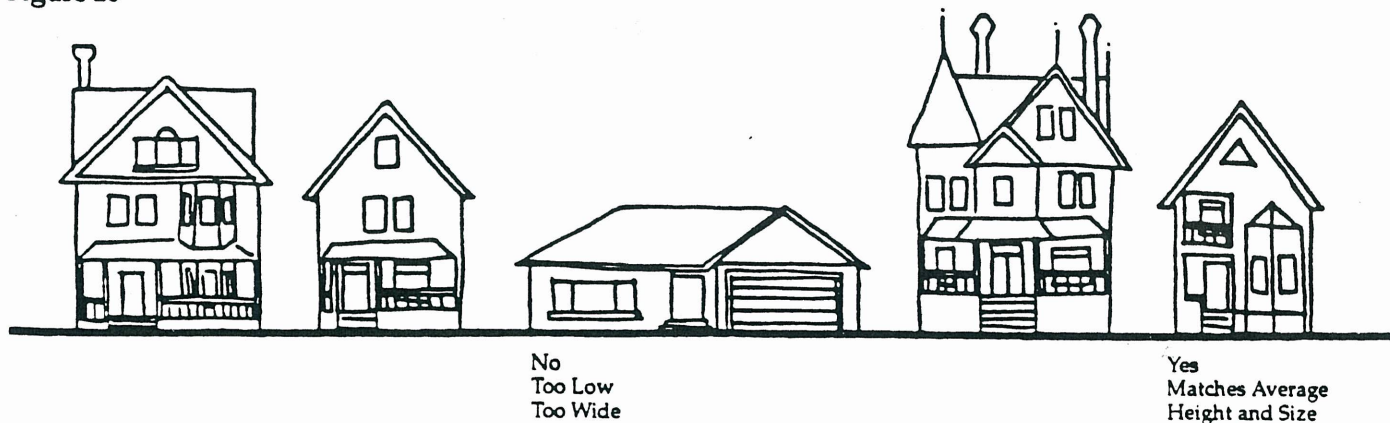
Figure 26

Figure 26: Proportion of building facades. Source: Gainesville, Florida Guidelines.

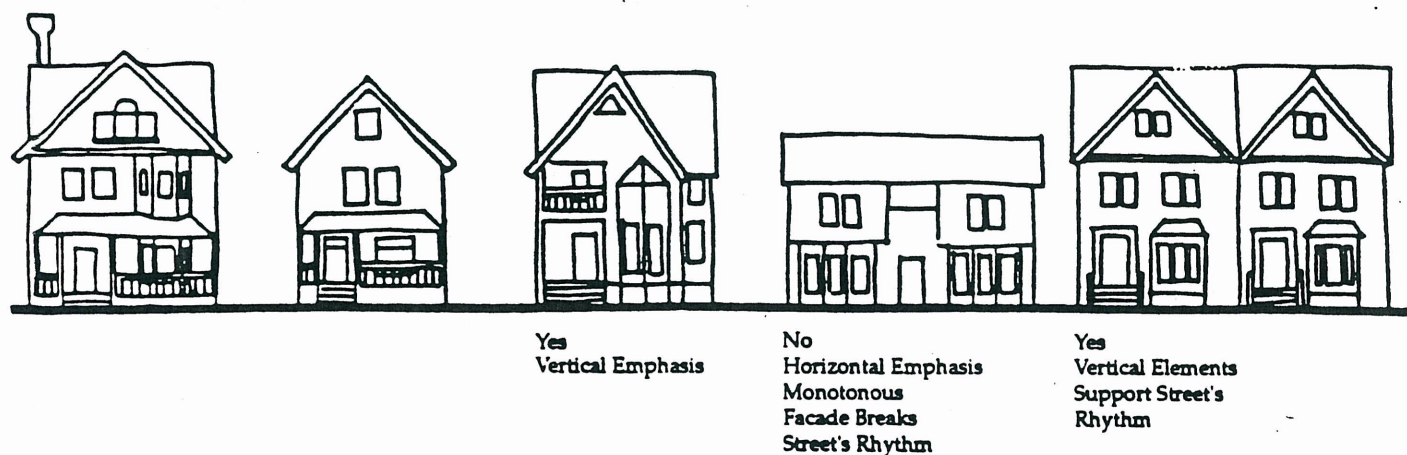
Figure 27

Figure 27: Rhythm of buildings. Source: Gainesville, Florida Guidelines.

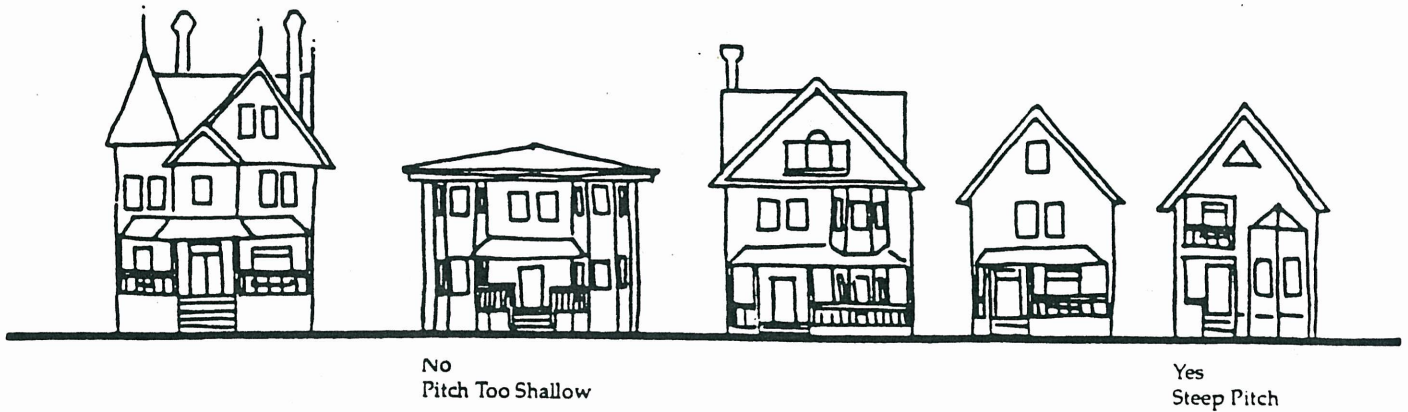
Figure 28

2. Detailing similar in form, proportion, scale, texture, materials, and color to those on surrounding structures.
3. Roof pitch, height, and shingles compatible with those on existing, surrounding structures. Generally, no roof pitch less than 6 over 12 is approved unless the roof is hipped or flat.

Figure 28: roof shapes. Source: Gainesville, Florida Guidelines.

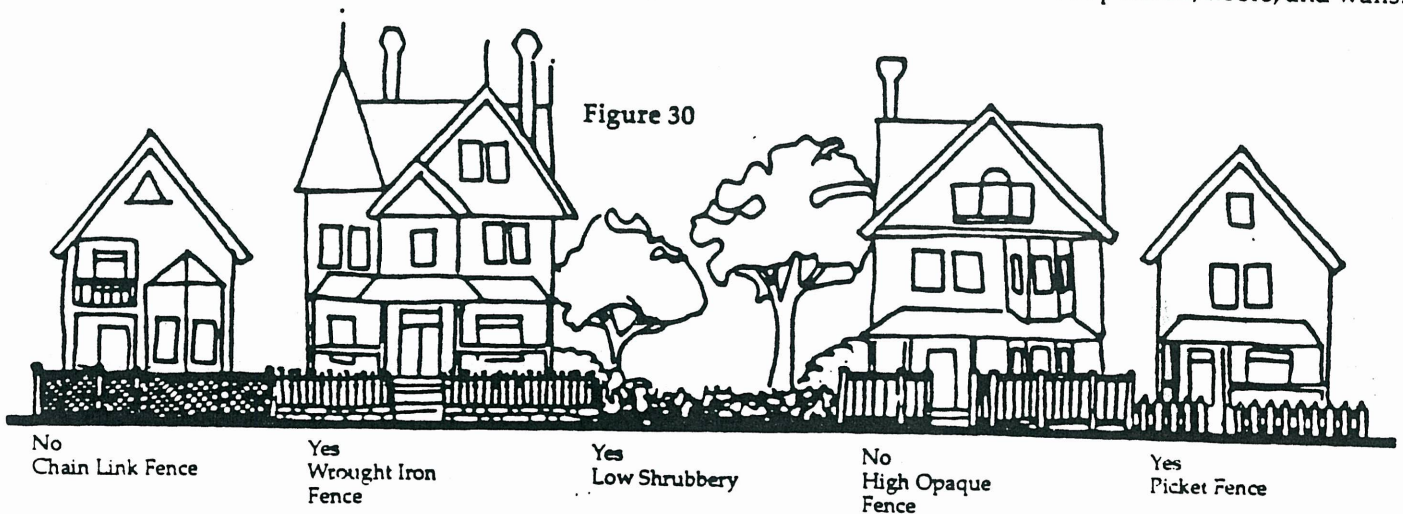
Figure 30: Continuity of Fences.  
Source: Gainesville, Florida  
Guidelines.

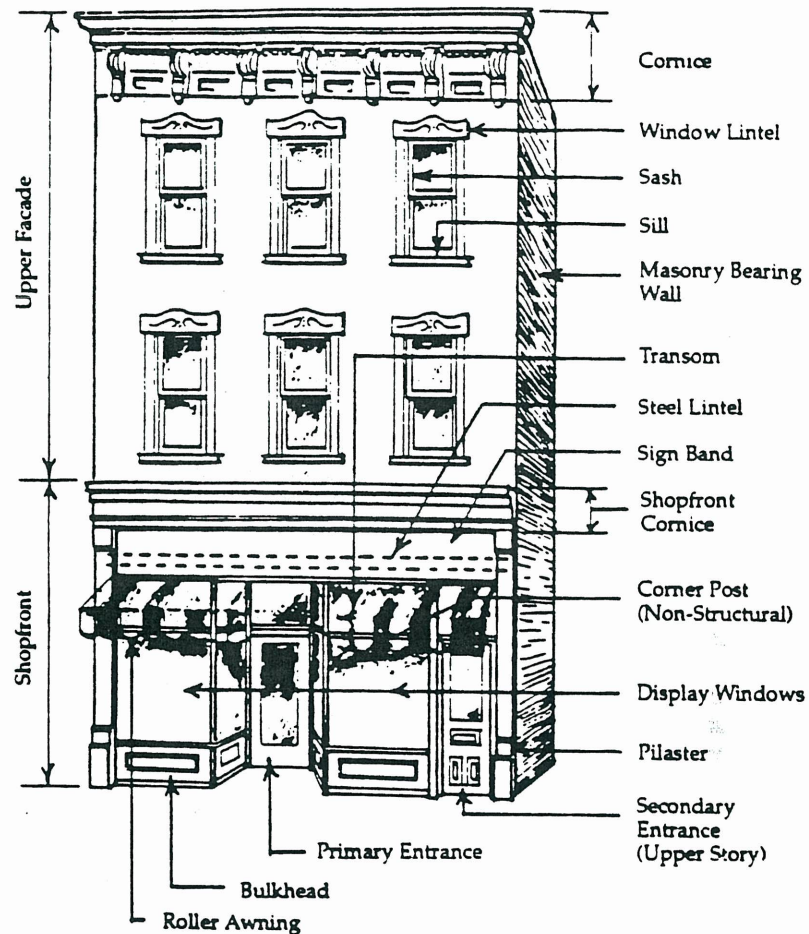
Figure 33

Figure 33: Victorian era storefront features. Source: The Old House Journal, Illustration by Jonathan Poore.

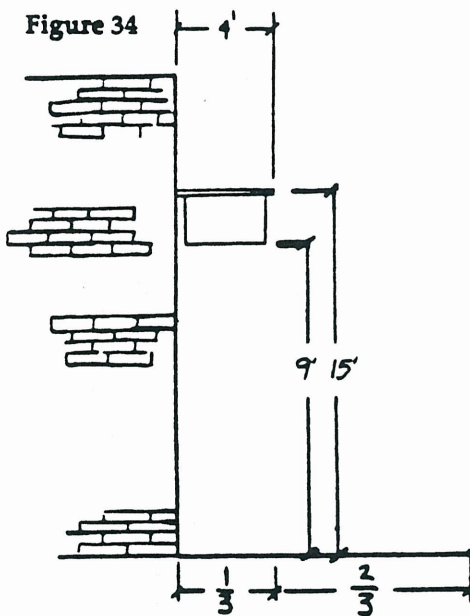
Figure 34: Projecting sign requirements.
