City of Columbus

Stormwater NPDES Permit

January 1, 2014 – December 31, 2014
(Ohio EPA Permit Numbers: 4PI00000*CD)

ANNUAL REPORT

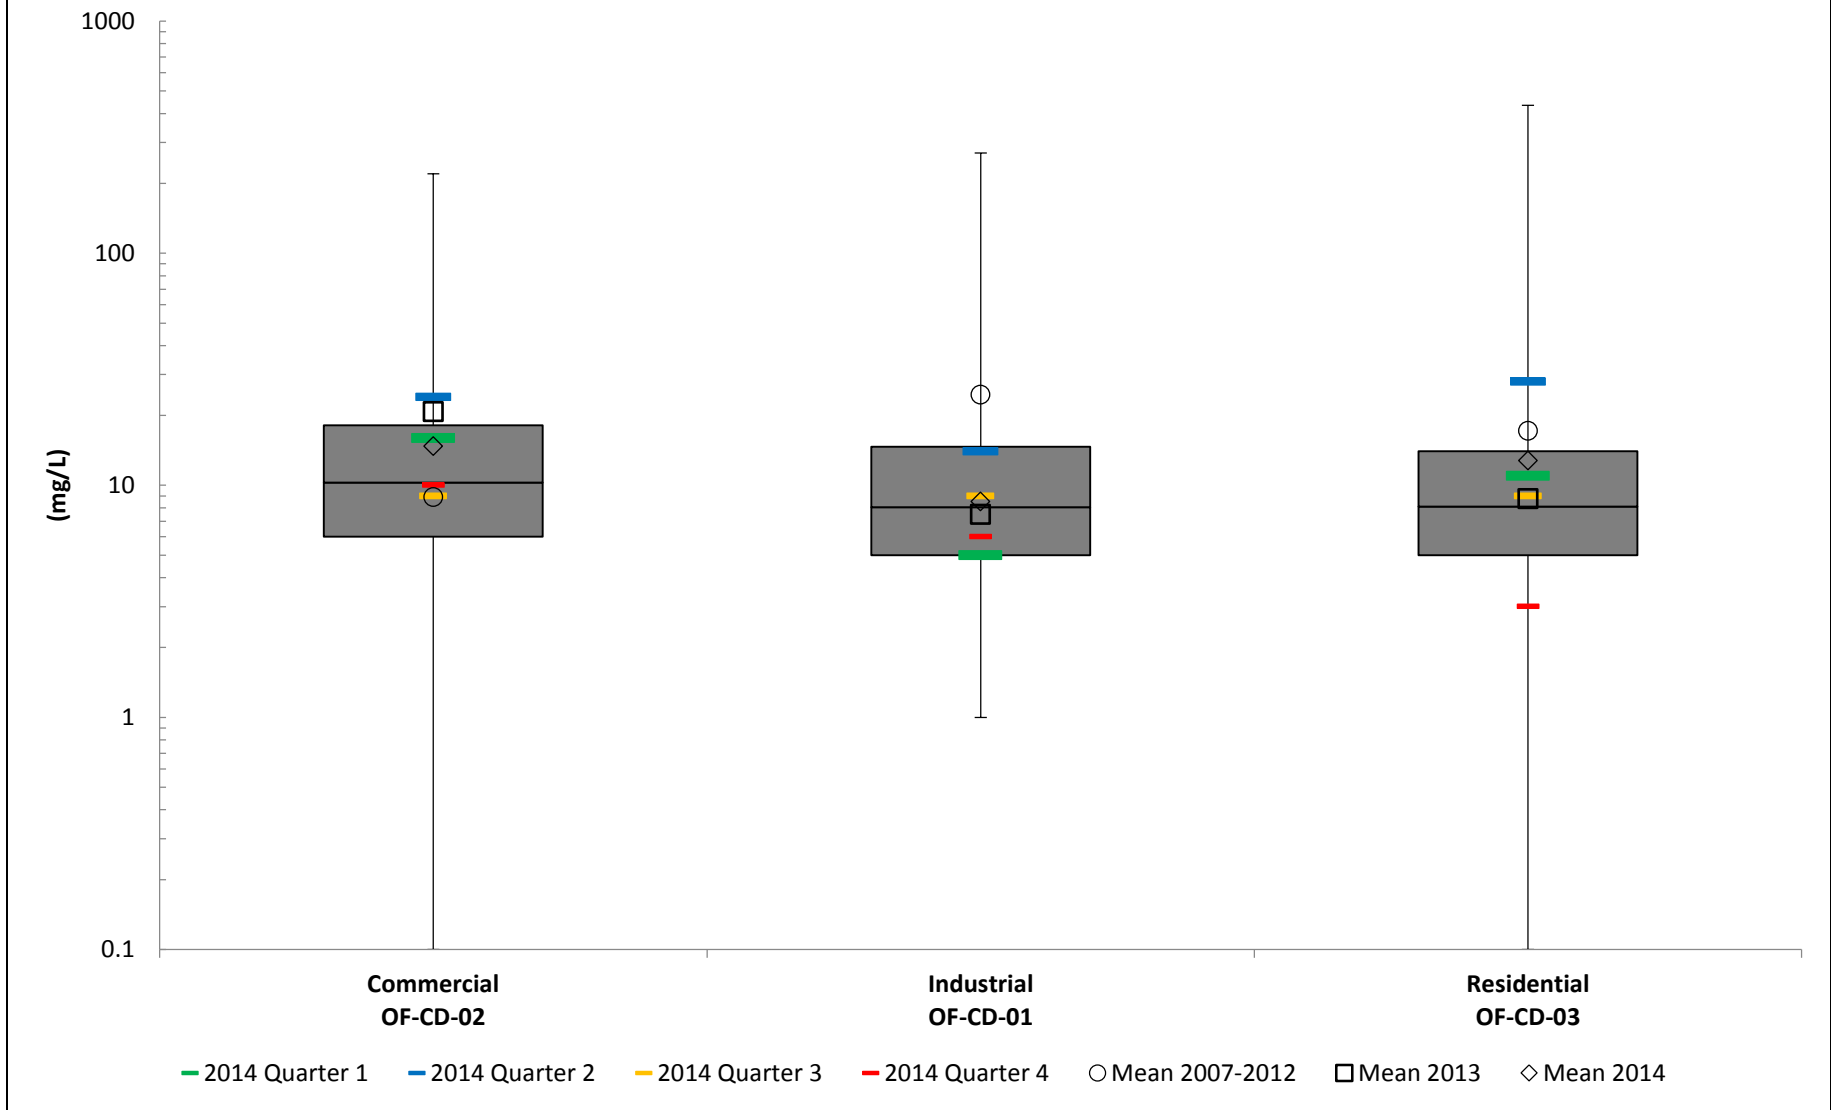
BOD₅
2014 EMC¹ Comparison with
NSQDv3² Box and Whisker Plots

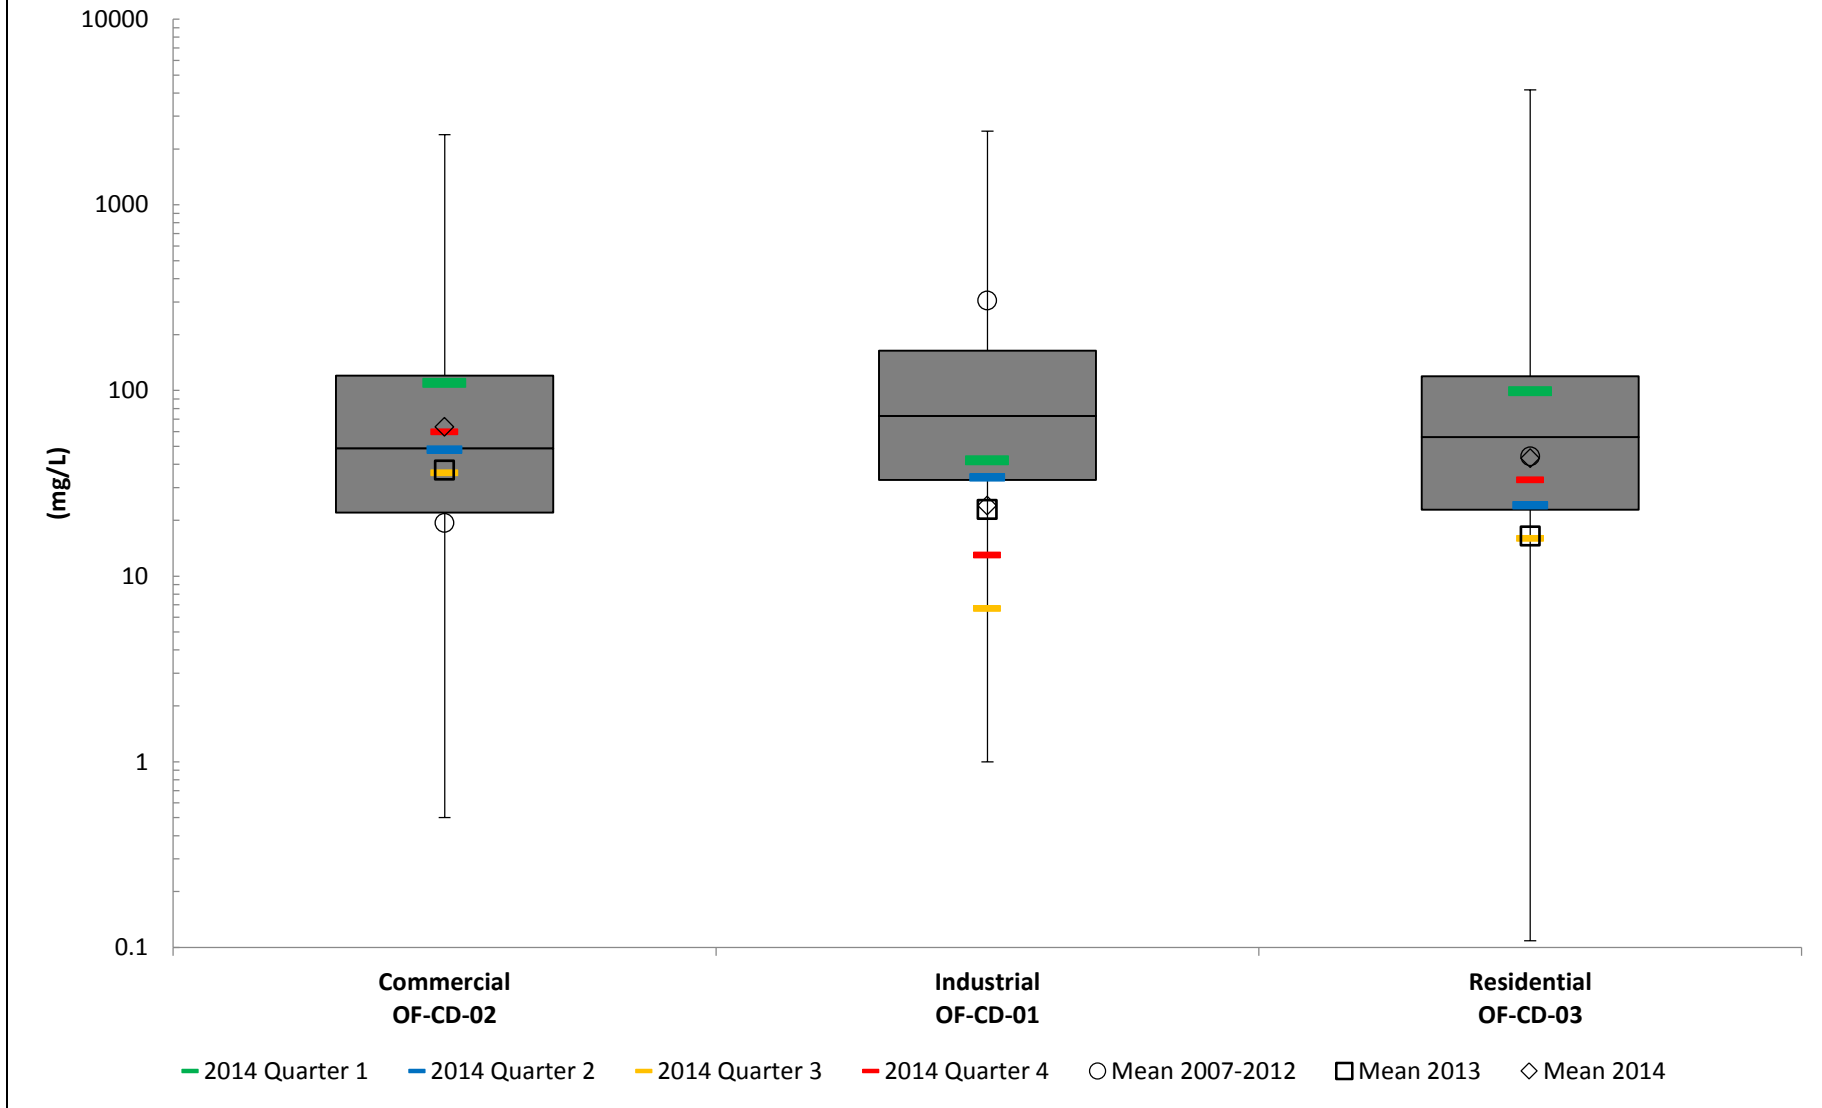
**Total Suspended Solids
2014 EMC¹ Comparison with
NSQDv3² Box and Whisker Plots**

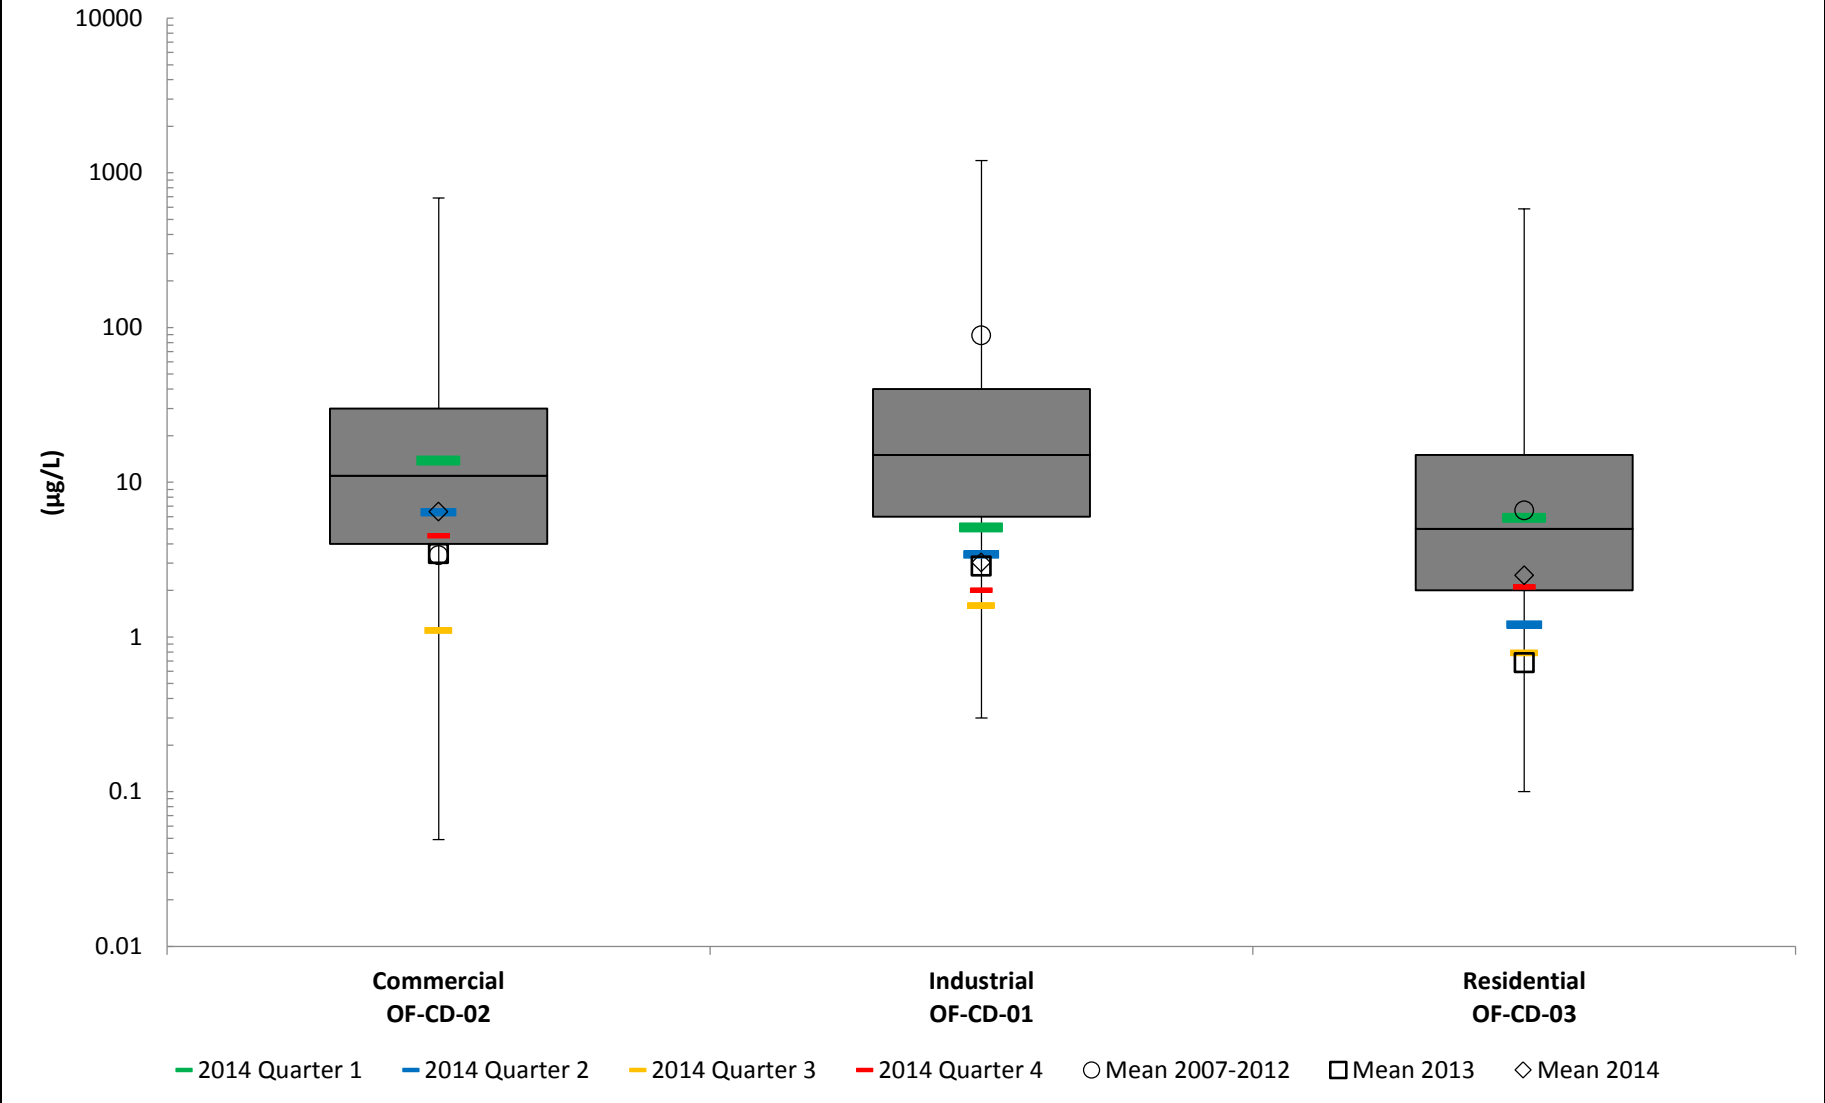
Lead
2014 EMC¹ Comparison with
NSQDv3² Box and Whisker Plots

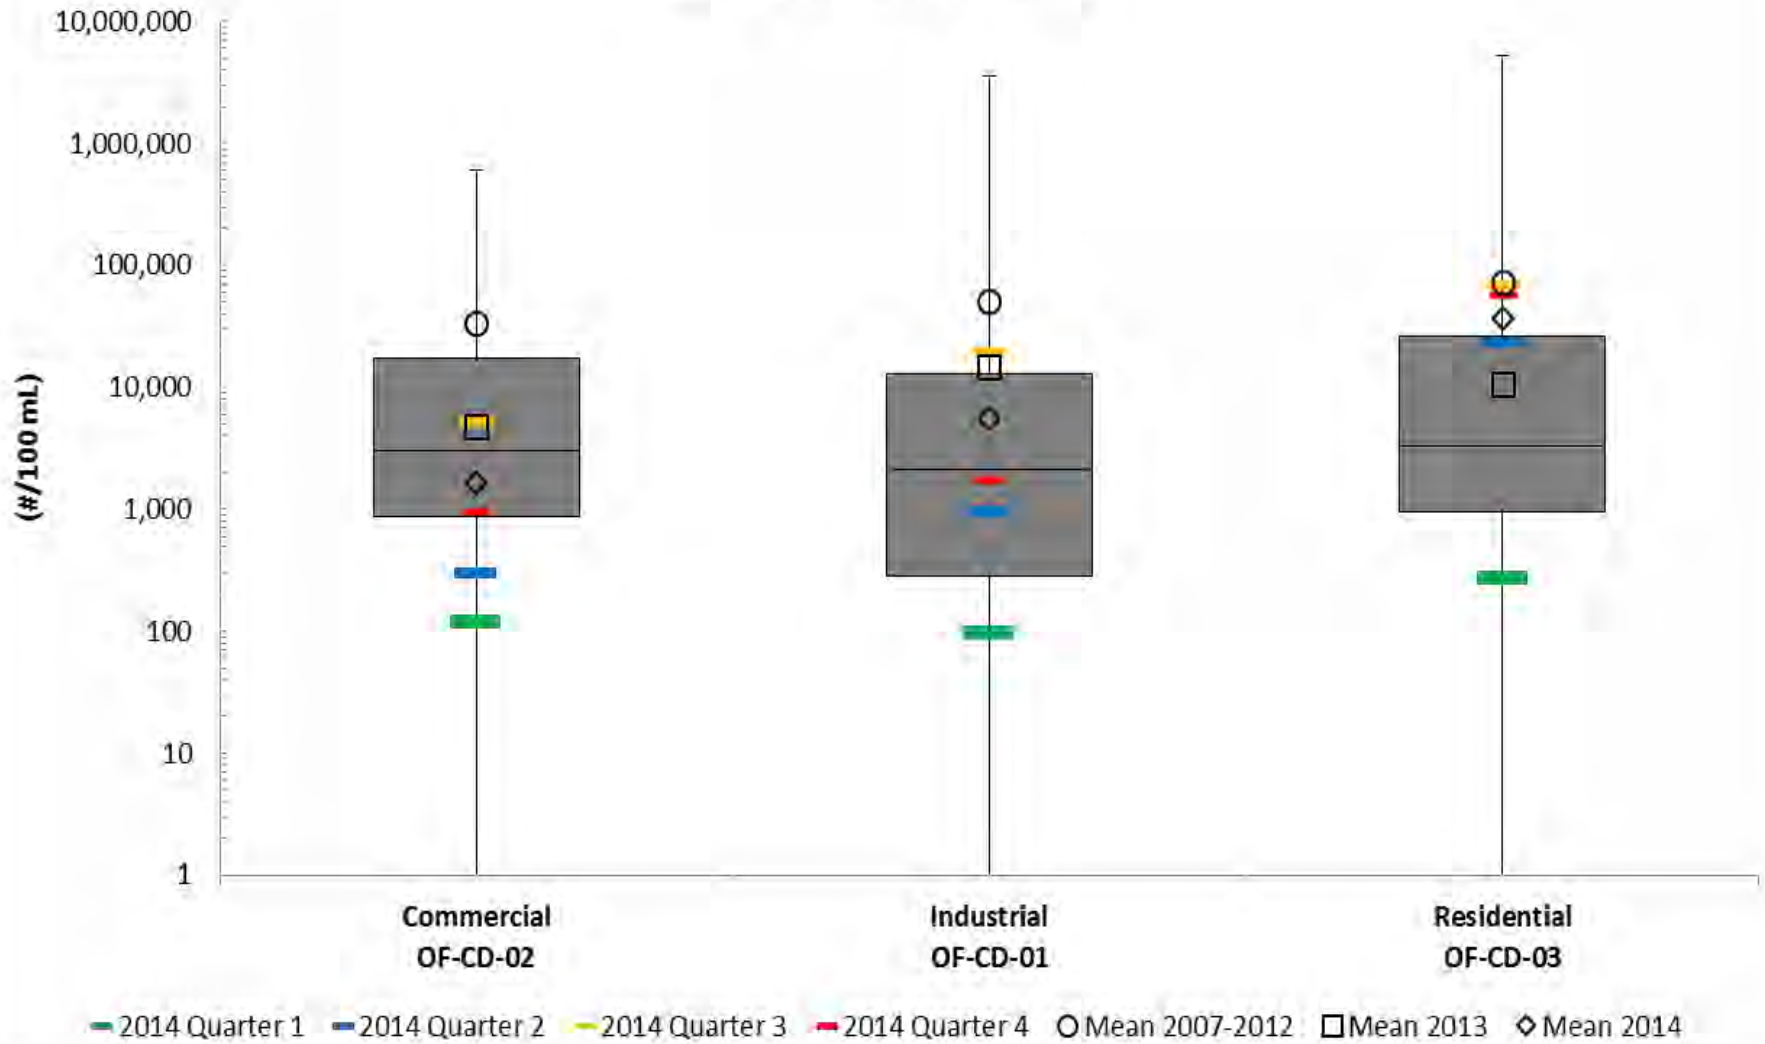
Fecal Coliform 2014 EMC¹ Comparison with NSQDv3² Box and Whisker Plots
